AC CORROSION - CASE HISTORIES, TEST PROCEDURES, & MITIGATION

R.G. Wakelin, R.A. Gummow, and S.M. Segall
Correng Consulting Service Inc.*
369 Rimrock Road
Downsview, Ontario, Canada M3J 3G2

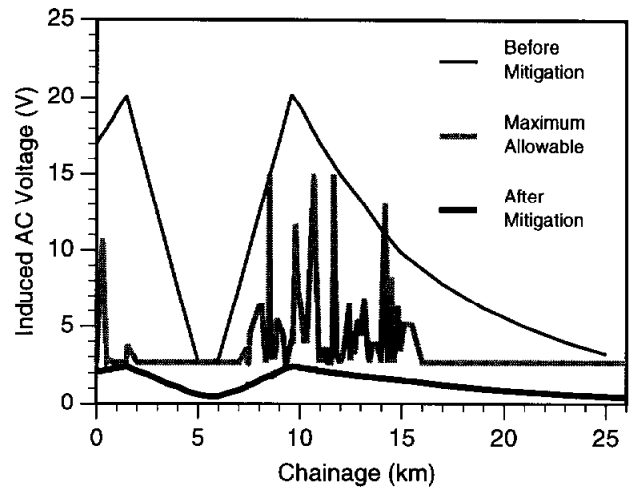
Using the graphical calculation methods outlined in the EPRI Report^[9], induced AC voltages were calculated for the pipeline. Without any mitigation, it was determined that pipeline voltages would exceed 20 V, as shown in Figure 8. A detailed soil resistivity survey was conducted along the route of the pipeline, and this data, when used in conjunction with the AC voltage calculations, produced a profile of AC current densities (for the worst case assumption of a 1 cm² holiday area), as shown in Figure 9. This plot indicated that approximately half of the pipeline could experience AC current densities of 100 A/m² or more, with some locations exceeding 400 A/m².

FIGURE 8 - Induced AC Voltages on Pipeline Before and After Mitigation (Case History N° 4)

The possible criteria for mitigation were considered. It was mandatory that AC current densities be reduced to less than the 100 A/m² threshold value where AC corrosion is expected to occur, but current densities could not practically be lowered at all locations to less than the 20 A/m² level where AC corrosion does not occur. As a compromise, it was decided that the voltages be mitigated to levels which would limit the AC current density at a 1 cm² holiday to 50 A/m² or less, as shown in Figures 8 and 9.

By installing a total of 1125 m of zinc ribbon at key locations along the pipeline, and by utilizing bonds to other existing pipelines, the induced AC voltages and resulting AC current densities could be reduced to the levels shown in Figures 8 and 9 respectively.

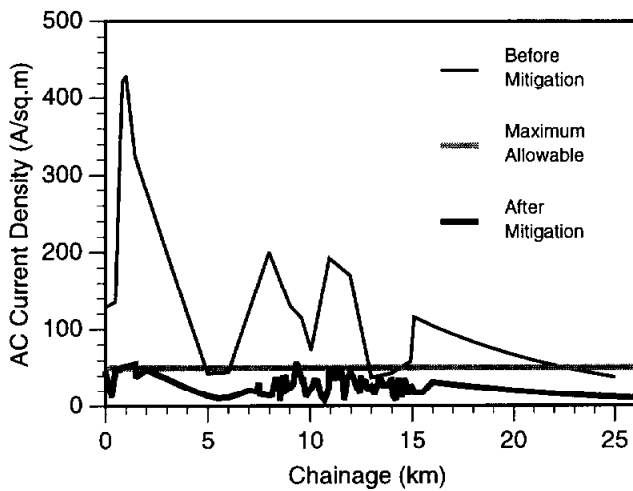
FIGURE 9 - Induced AC Current Densities on Pipeline Before and After Mitigation (Case History N° 4)
