Dealing with Severe Corrosion on a Recently Installed Pipeline

S.M. Segall, P. Eng.
R.A. Gummow, P. Eng.
D. Fingas
Corrosion Service Company Limited
2-498 Markland St.
Markham, ON L6C 1Z6 Canada

John Shore, P. Eng.
Union Gas Limited
A Spectra Energy Company
50 Keil Drive North
Chatham, ON N7M 5M1 Canada

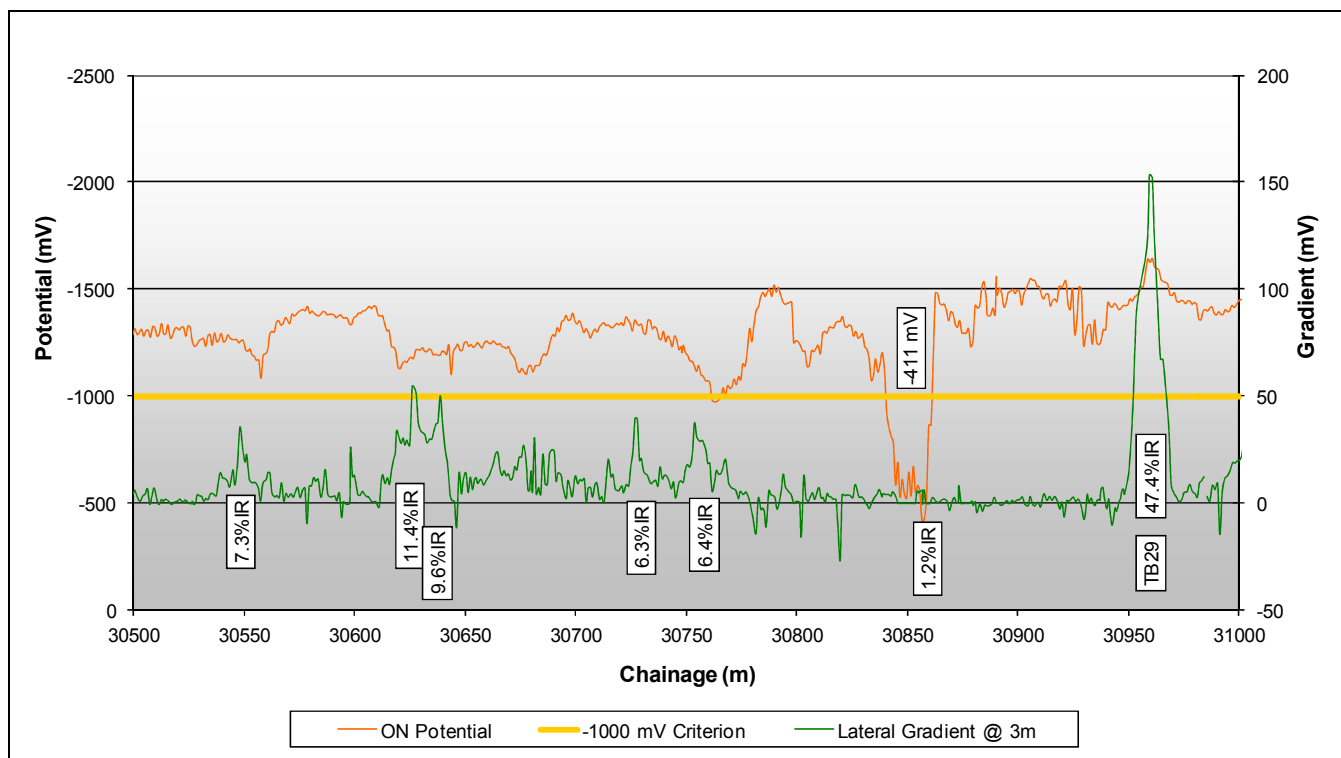
The data were then aligned using GPS coordinates. Close-interval potential survey (CIPS) and DCVG indications were identified and classified using ECDA methodology. Twenty-eight areas displayed CIPS indications, of which two areas displayed severe indications, with potentials as electropositive as $-411 \text{ mV}_{\text{CSE}}$ – see Figure 1.

Figure 1: NPS6 Line. Ch. 30500 m to 31000 m. CIPS/DCVG Aligned Data

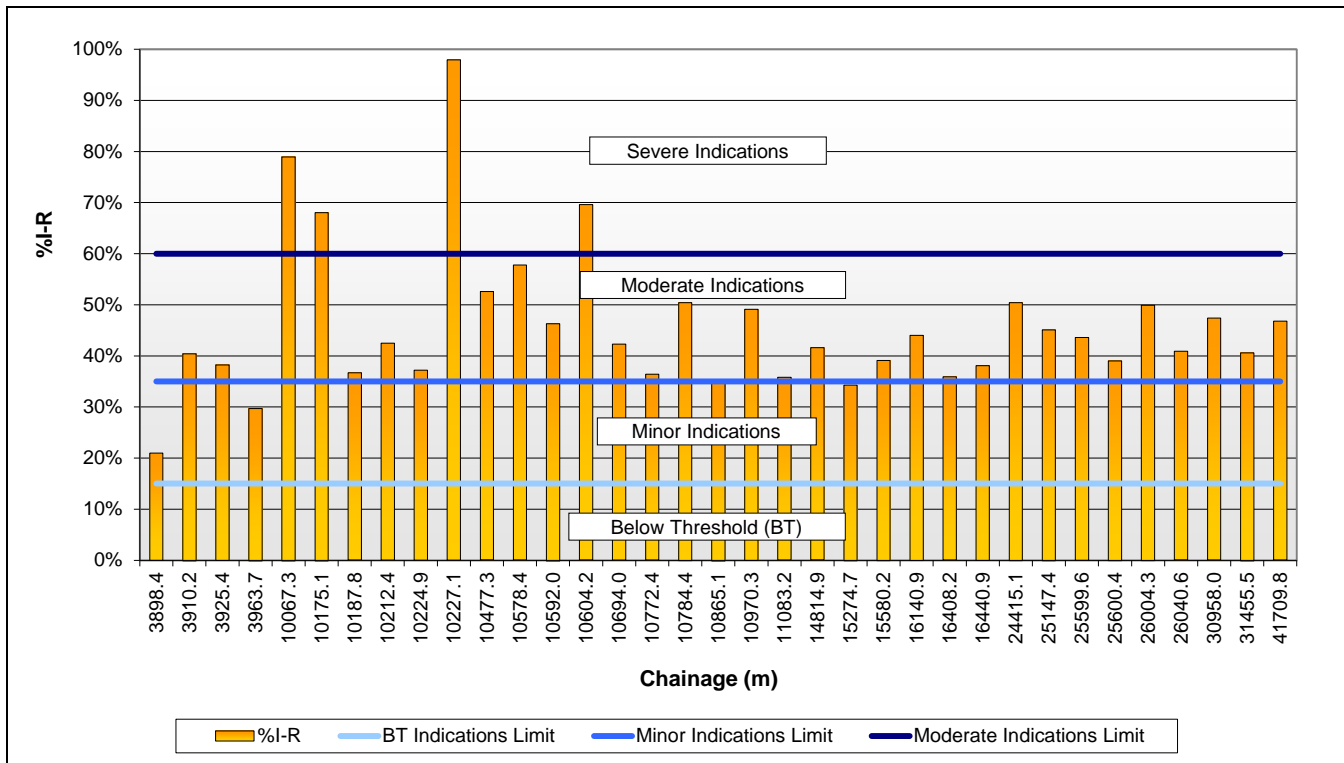
Thirty-five DCVG indications were identified along the surveyed sections, of which four were severe and 27 were moderate indications, as shown in Figure 2.

Figure 2: NPS6 Line. Summary of DCVG Indications along Surveyed Sections

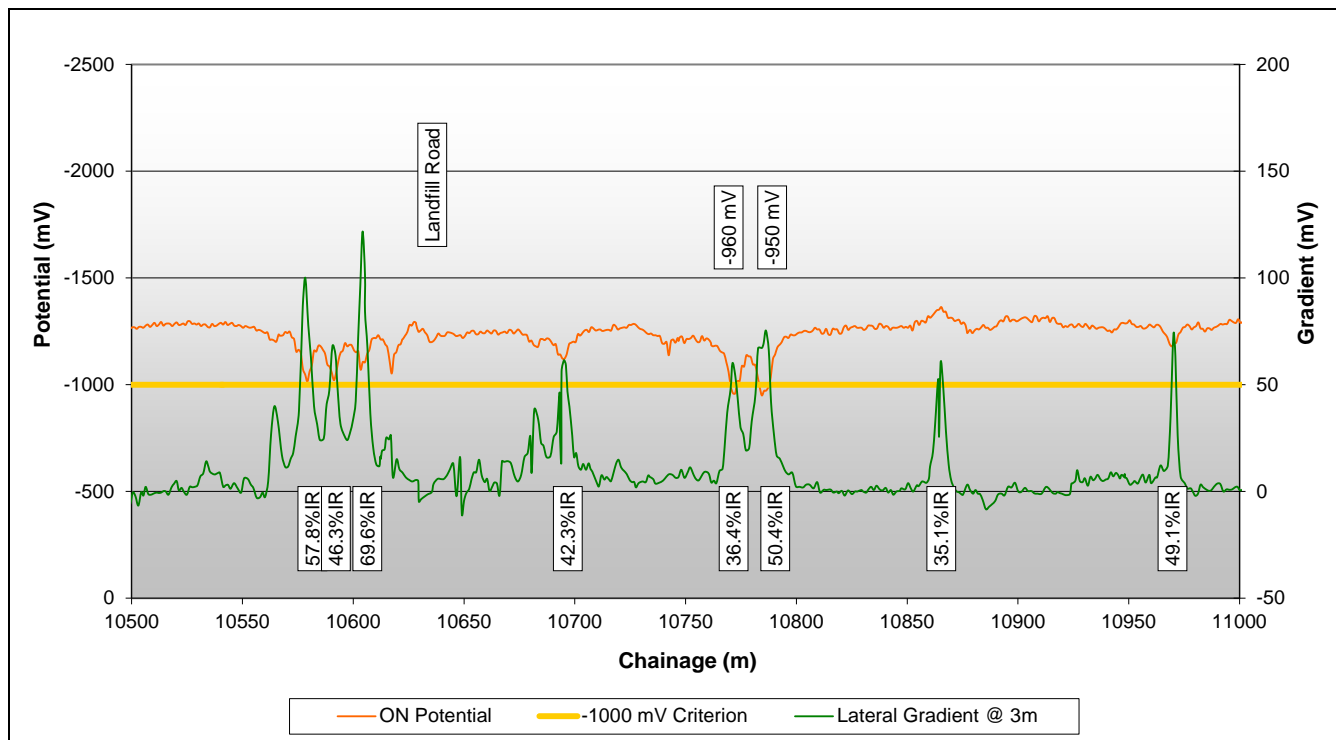
Figure 3: NPS6 Line. Ch. 10500m to 11000m. CIPS/DCVG Aligned Data

At chainage 10604 m, the line displayed a severe DCVG indication (i.e. 69.6%IR), however the pipe-to-soil potential measured on grade was -1,071 mV_{CSE}, which satisfied the -1,000 mV_{CSE} protection criterion.

The dig examination indicated that the field coating was in extremely poor condition (i.e., approximately 80% bare), matching the severe DCVG indication. However, the potential measured with the reference in the trench at pipe level was only -581 mV_{CSE}, indicating that the -1,000 mV_{CSE} criterion cannot compensate for the very high IR drop affecting the CIPS data. The sand resistivity in the upper layer exceeded 75,000 Ω-cm and dropped to 21,000 Ω-cm at pipe level.

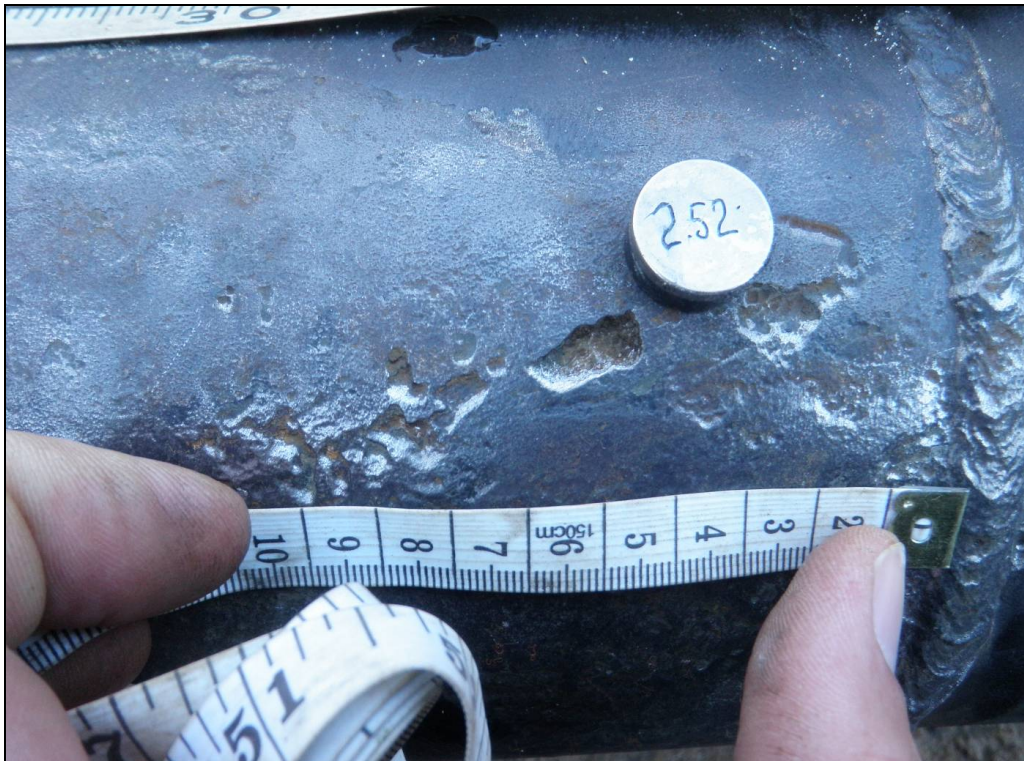
Pitting (up to 53% through wall) was found at digs #1, #4 and #6, as shown in Figure 4 to 6.

Figure 4: Pitting at Dig Site #1

Remedial action was performed, including installation of clock-spring repair sleeves at selected locations, recoating, and installation of magnesium anodes in selected areas.

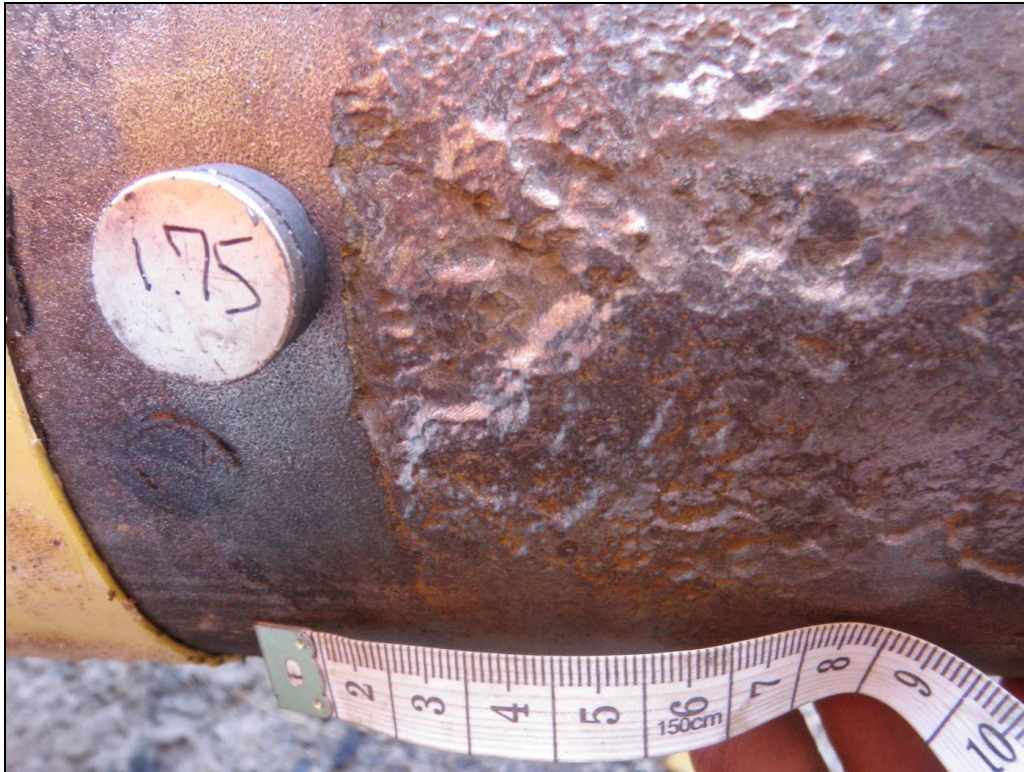
Figure 5: Pitting at Dig Site #4

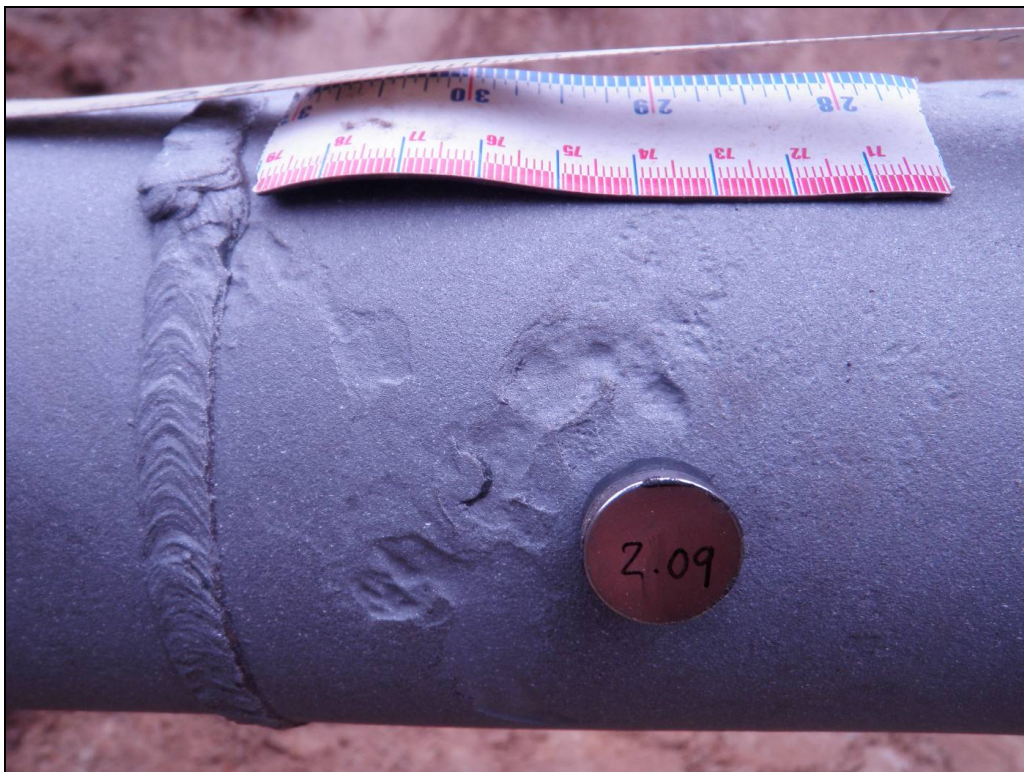
Figure 6: Pitting at Dig Site #6

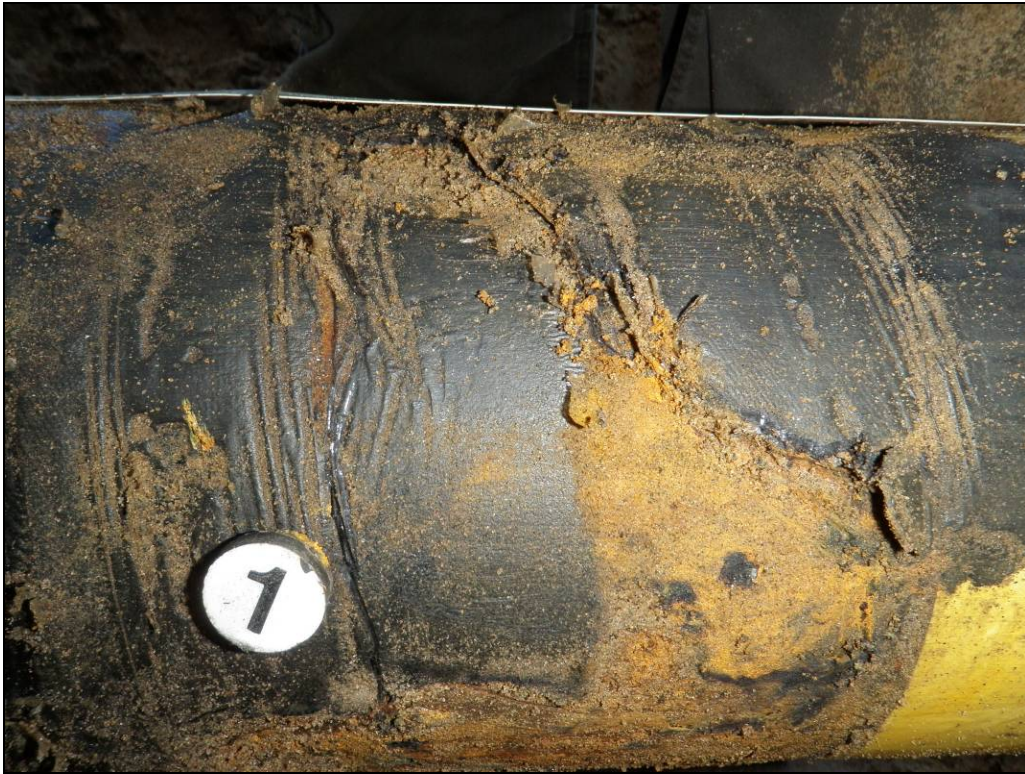
The factory applied coating was typically found in excellent condition, however at three dig sites, the field coating was either completely missing (Site 6) or almost entirely ripped off (Sites #1 and #4), as shown in Figure 7 to 9.

Figure 7: Dig Site #1. Bare Areas at Weld

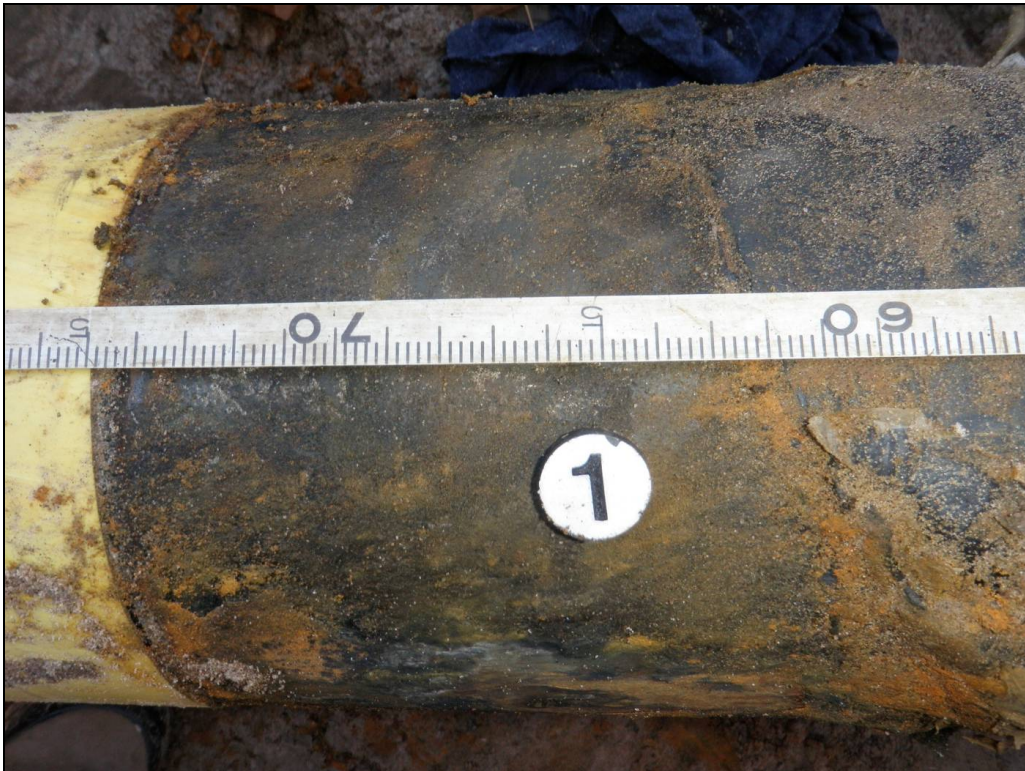
Figure 8: Dig Site #4. Bare Areas at Weld

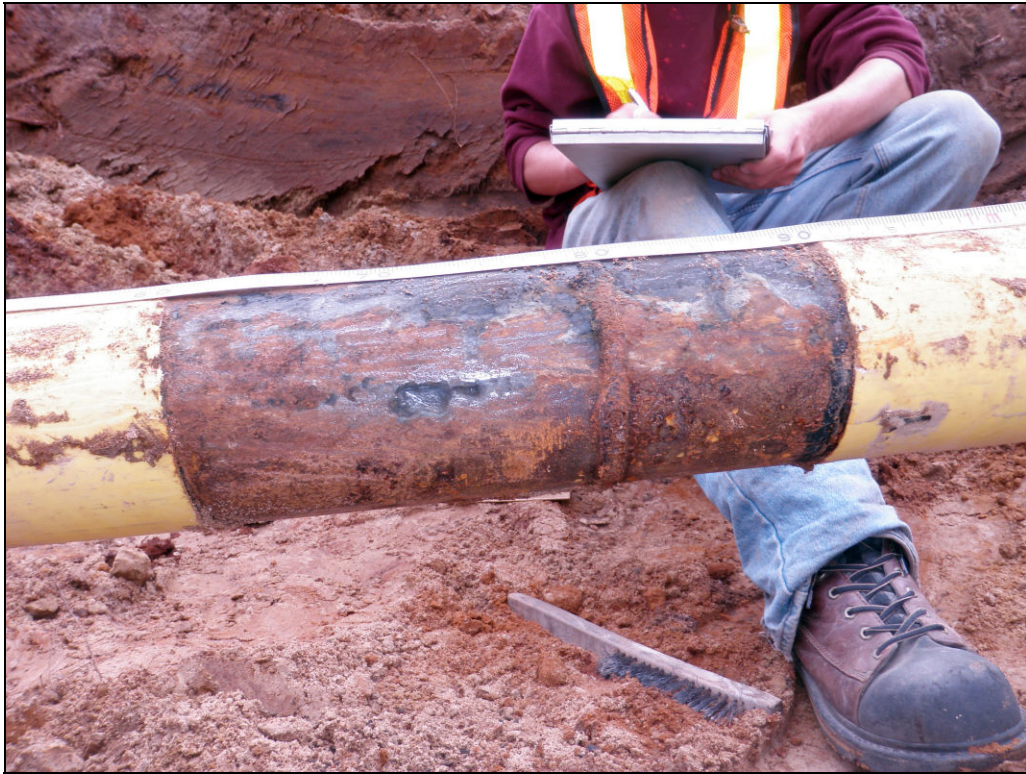
Figure 9: Dig Site #6. Bare Areas at Weld

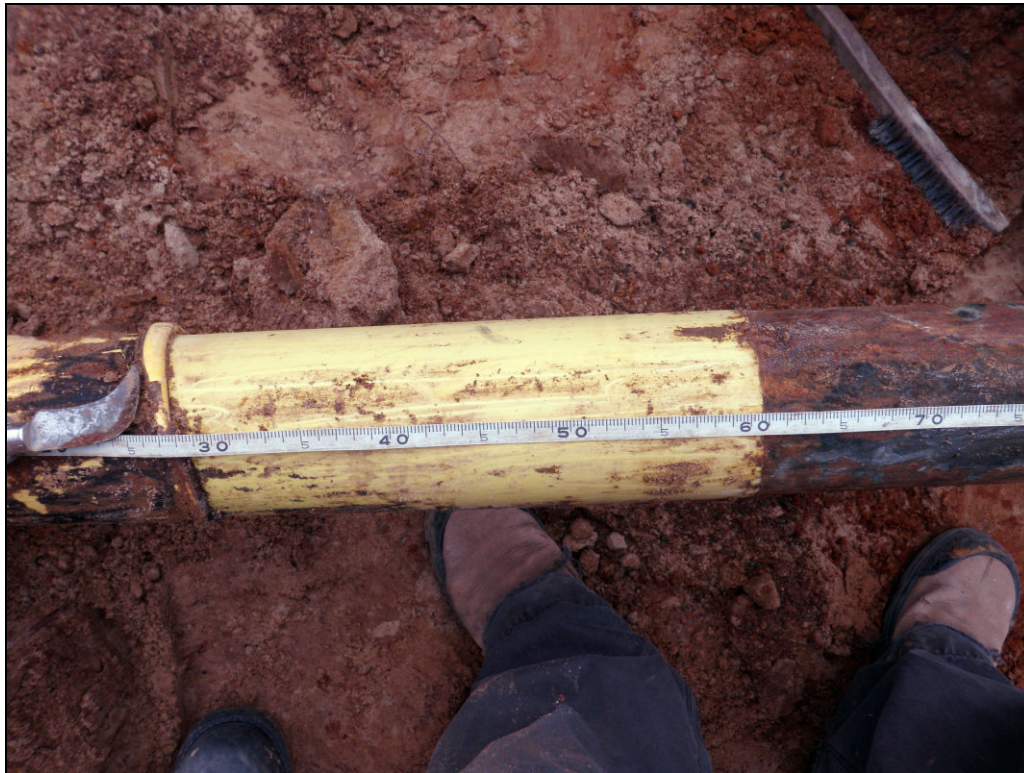
At Site 6, a double-layer of extruded polyethylene coating had been applied, but the outside layer had rolled back for 30 cm during pipe installation, as shown in Figure 10. It appears that the same mechanical stresses that damaged the factory coating completely ripped away the field coating.

Figure 10: Dig Site #6. Damaged Factory Coating in Vicinity of Weld
