Evaluation of Classification and Prioritization Criteria Based on the Results of Direct Examinations

S.M. Segall, P. Eng.
R.A. Gummow, P. Eng.
Corrosion Service Company Limited
205 Riviera Drive
Markham, ON, Canada L3R 5J8

R.G. Reid, P. Eng.
Union Gas Limited
A Spectra Energy Company
50 Keil Drive North
Chatham, ON, Canada N7M 5M1

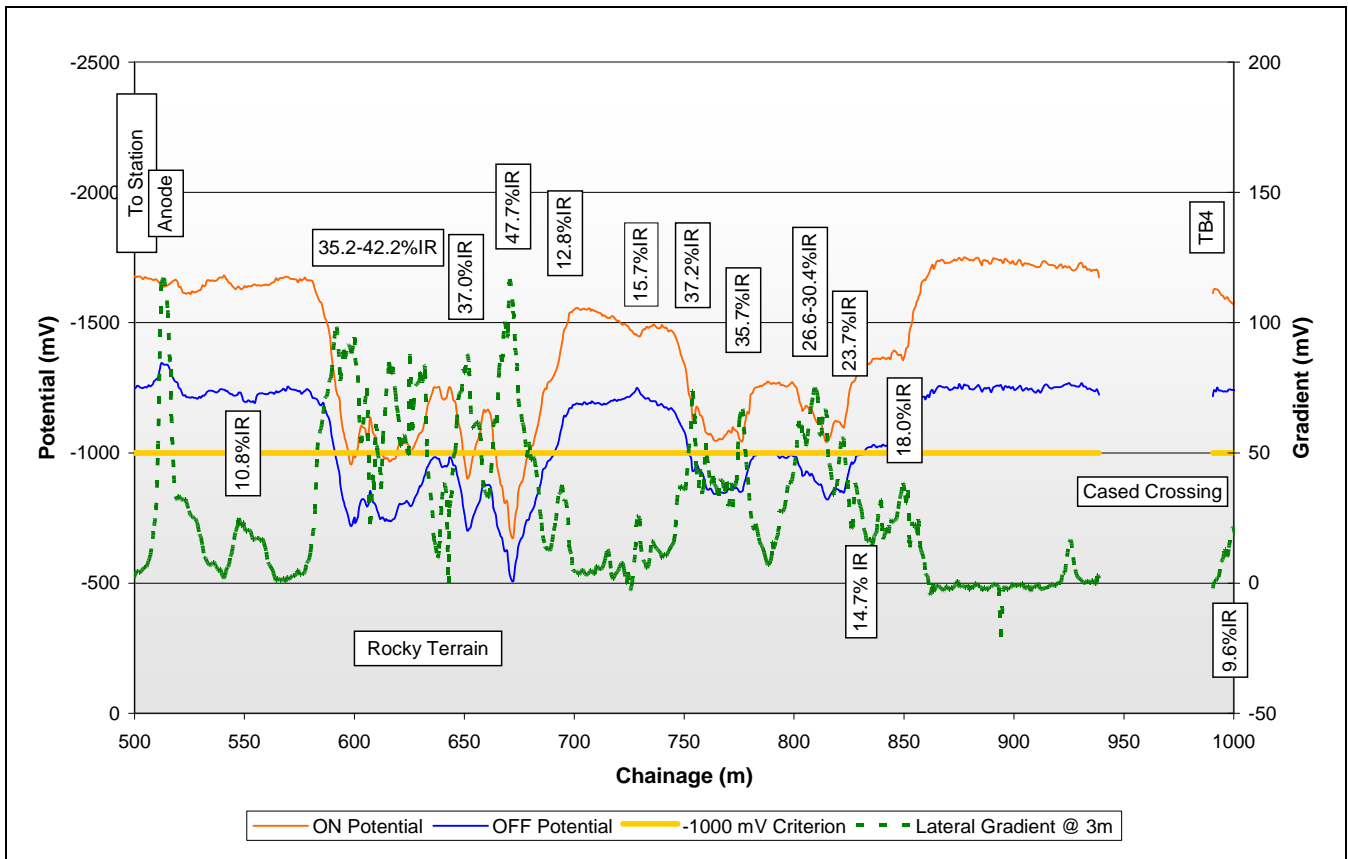
FIGURE 1 • 6" Line. Ch. 500 to 1000m. Integrated CIPS/DCVG Survey

An integrated CIPS/DCVG survey was conducted in 2005 on a 6" dia. pipeline in northern Ontario, protected by a mixed CP system (i.e. 6" lateral pipeline having its own dedicated magnesium anodes bonded into a main line protected by impressed current rectifiers). A moderate DCVG indication (i.e. 47.7%IR) in conjunction with a severe CIPS indication (i.e. -533 mV_{CSE}) was identified at chainage 670.6 m, as shown in Figure 1.

The indication was prioritized as “Scheduled Action Required”, according to the prioritization criteria summarized in Table 1. In this case, the intersecting cell between the 2nd row (DCVG-MD) with the 5th column (CIPS-SV) indicates that a location displaying a moderate DCVG indication in conjunction with a severe CIPS indication is prioritized as scheduled action required (S).

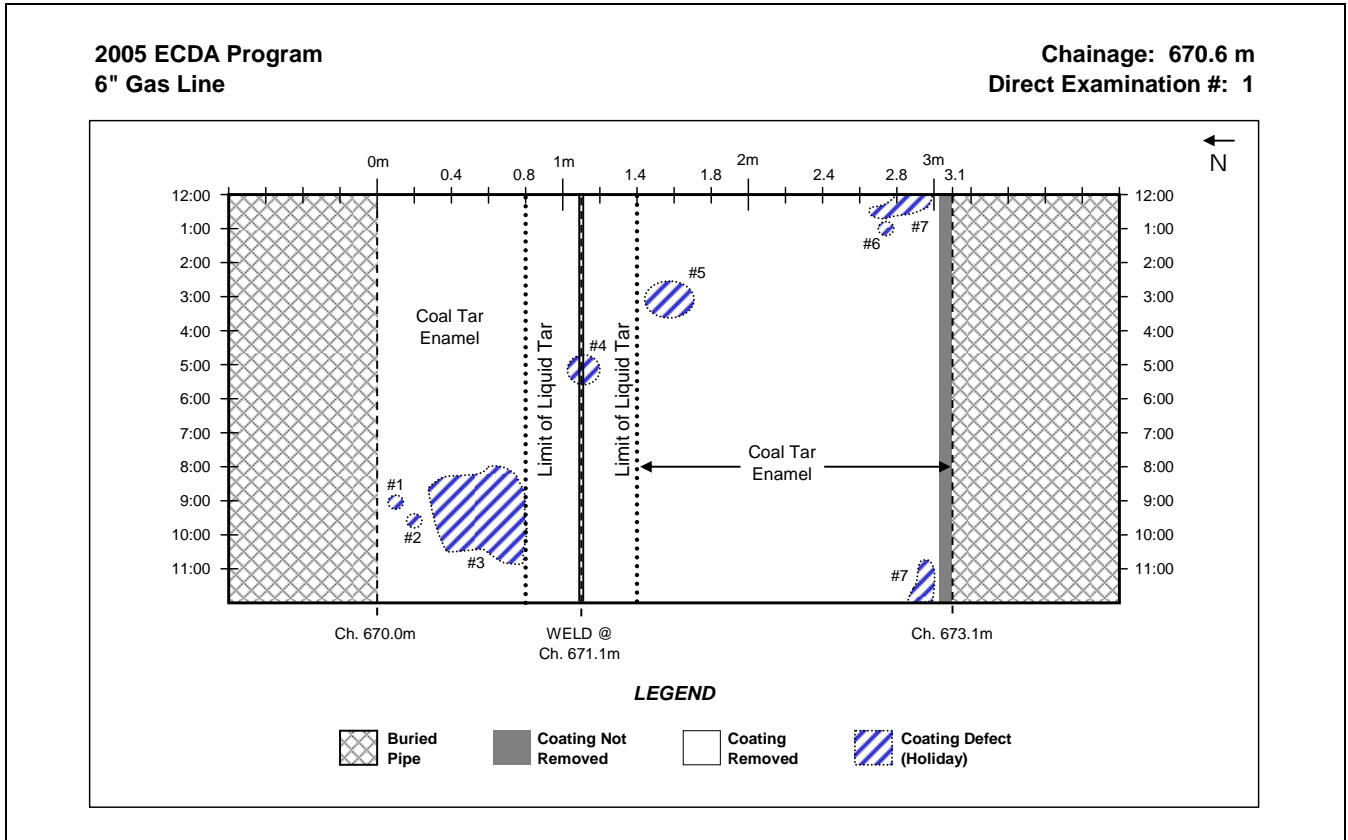
FIGURE 2 • Coating Inspection Map #1

The direct examination was performed in August 2006 and revealed a total of seven holidays. For details, see Coating Inspection Map #1 (Figure 2) and Figures 3 and 4 (only holidays #1 and #2 shown).

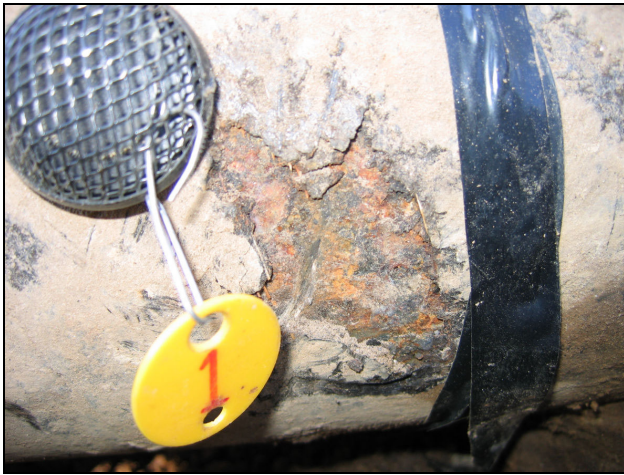
**FIGURE 3 • Site #1. Coating Damage.
4 cm Dia. Holiday #1**

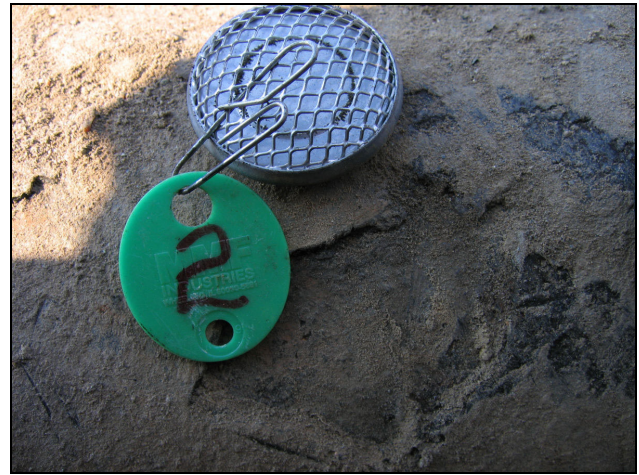
**FIGURE 4 • Site #1. Coating Damage.
3 cm Dia. Holiday #2**

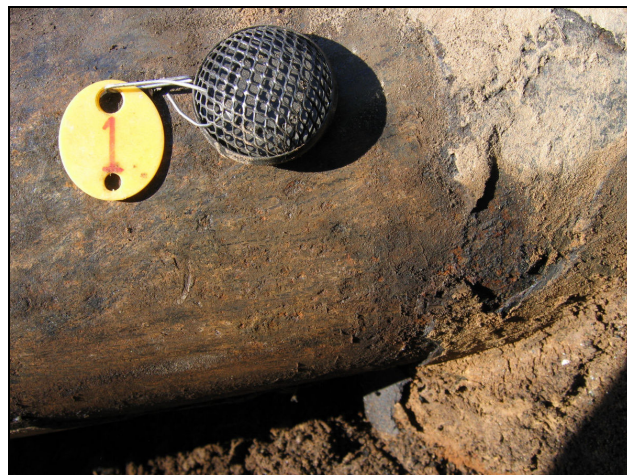
After removing the coating, the pipe displayed surface corrosion, with multiple very shallow pits (i.e. up to 0.015" deep), as shown in Figure 5.

**FIGURE 5 • Site #1. Pipe Exposed.
Close View at Holiday #1**

The corrosion attack was milder than expected at a severe CIPS indication (i.e. $-533\text{mV}_{\text{CSE}}$ pipe-to-soil OFF potential). The shallowness of the pitting was attributed to the mitigating effect of the very high resistivity soil (i.e. $1,000,000\ \Omega\text{-cm}$) on the corrosion rate. The CIPS indication classification criteria used for this line^[1] appear therefore to be too conservative in high resistivity aerated areas. Paragraph 6.2.2.3 of NACE RP0169-2002 states that in such soils OFF potentials less negative than $-850\ \text{mV}_{\text{CSE}}$ may be sufficient for protection. The European Standard ISO 15589-1, paragraph 5.3.2.1 recommends a minimum polarized potential of $-650\ \text{mV}_{\text{CSE}}$ for resistivities greater than $1,000\ \Omega\text{-m}$ ($100,000\ \Omega\text{-cm}$).

Note that although the identification and prioritization CIPS criteria for this line appear to be too severe, they were not downgraded, since the ECDA process was applied for the first time (NACE Standard RP0502-2002, Paragraph 5.8.4.2). Consideration would be given to using less conservative criteria for future applications under similar conditions.

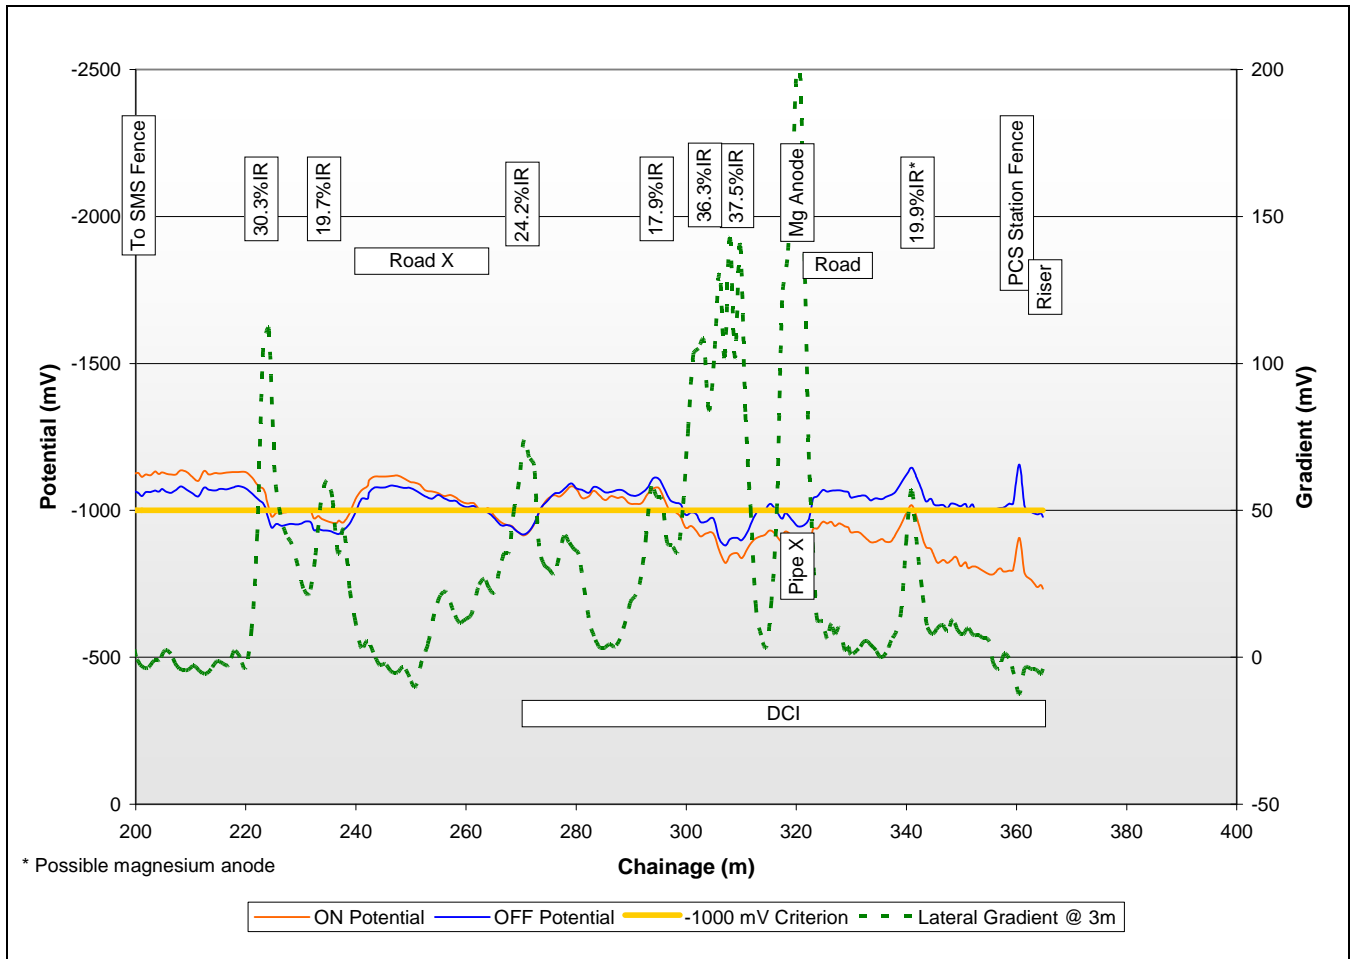
FIGURE 6 • 8" Gas Line. Ch. 200 to 365m. Aligned CIPS/DCVG Data

A moderate DCVG indication (i.e. 36.3%IR in conjunction with a minor CIPS indication (-903 mV_{CSE}) and a moderate DCI indication (i.e. 40 mV positive shift, with a foreign rectifier turned ON) were identified at chainage 306.00 m on an 8" gas pipeline protected by magnesium anodes (see Figure 6).

The indication was prioritized as “Scheduled Action Required”, according to the prioritization criteria summarized in Table 2. In this case, the intersecting cell between the 6th row (DCVG-MD & CIPS-MN) with the 6th column (DCI-MD) indicates that a location displaying a moderate DCVG indication in conjunction with a minor CIPS indication and a moderate DCI indication is prioritized as scheduled action required (S).

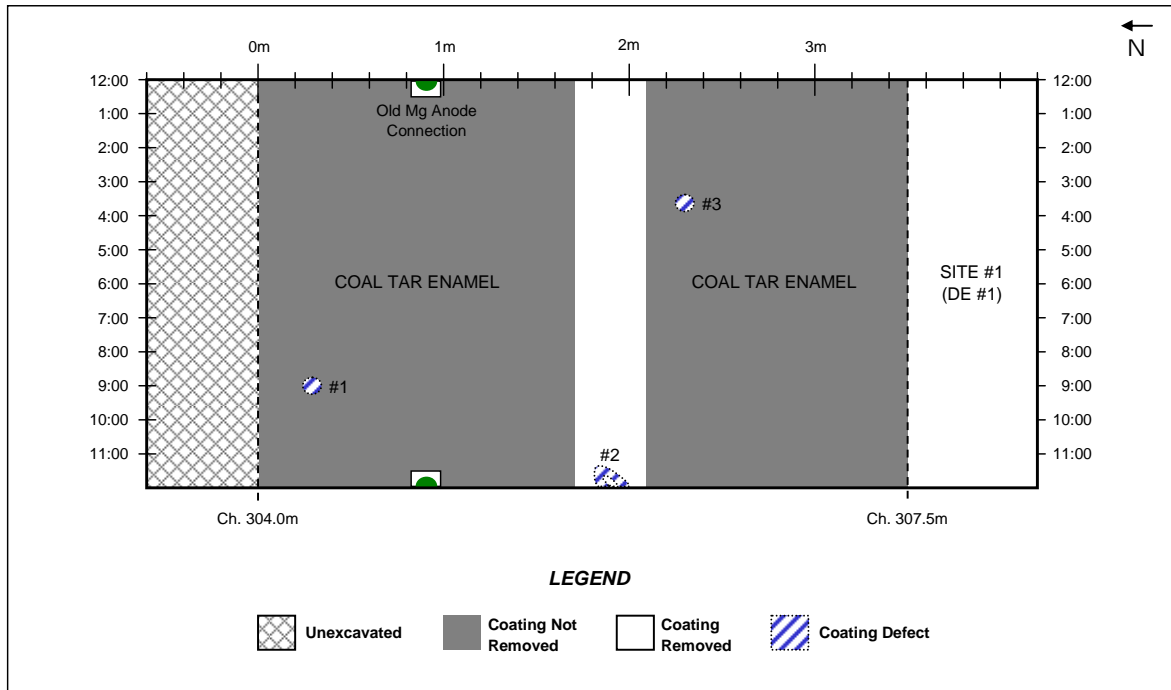
FIGURE 7 • Coating Inspection Map #2

The direct examination was performed in July 2006 and revealed three coating holidays and a depleted anode connected to the pipe. For details, see Coating Inspection Map #2 (Figure 7) and Figures 8 and 9 (only holiday #1 and the anode connection are shown).

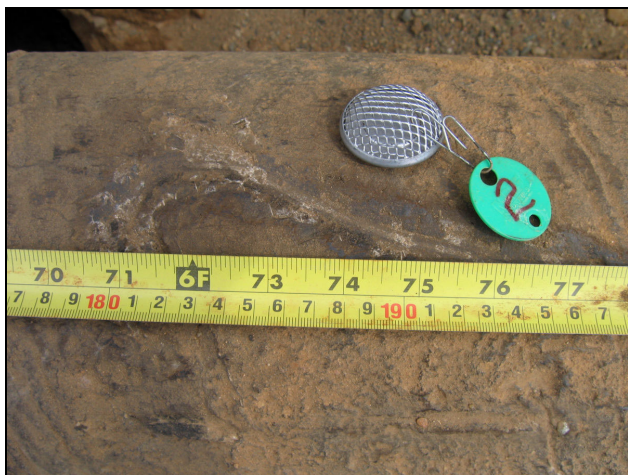
FIGURE 8 • DE #2. Coating Damage.
Holiday #1 (Tag #2).

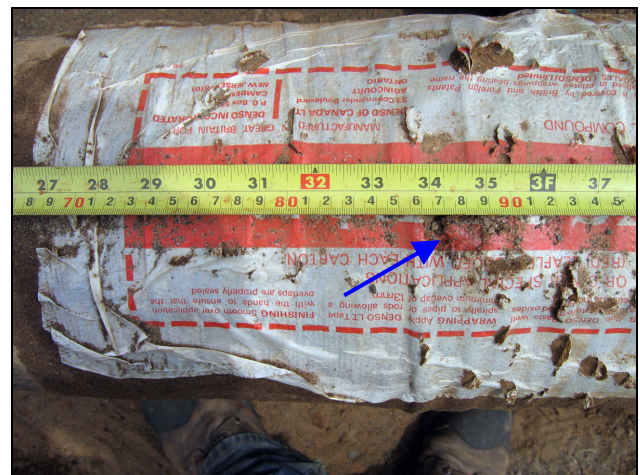
FIGURE 9 • DE #2. Connection of
Depleted Magnesium Anode.

The 36.3% IR is attributed in part to the depleted magnesium anode. Note that the CIPS/DCVG profile displays a drop in the protection level in conjunction with a high voltage gradient (Figure 10), as opposed to an increase in the protection level in conjunction with a high gradient, typical for magnesium anodes.^[2]

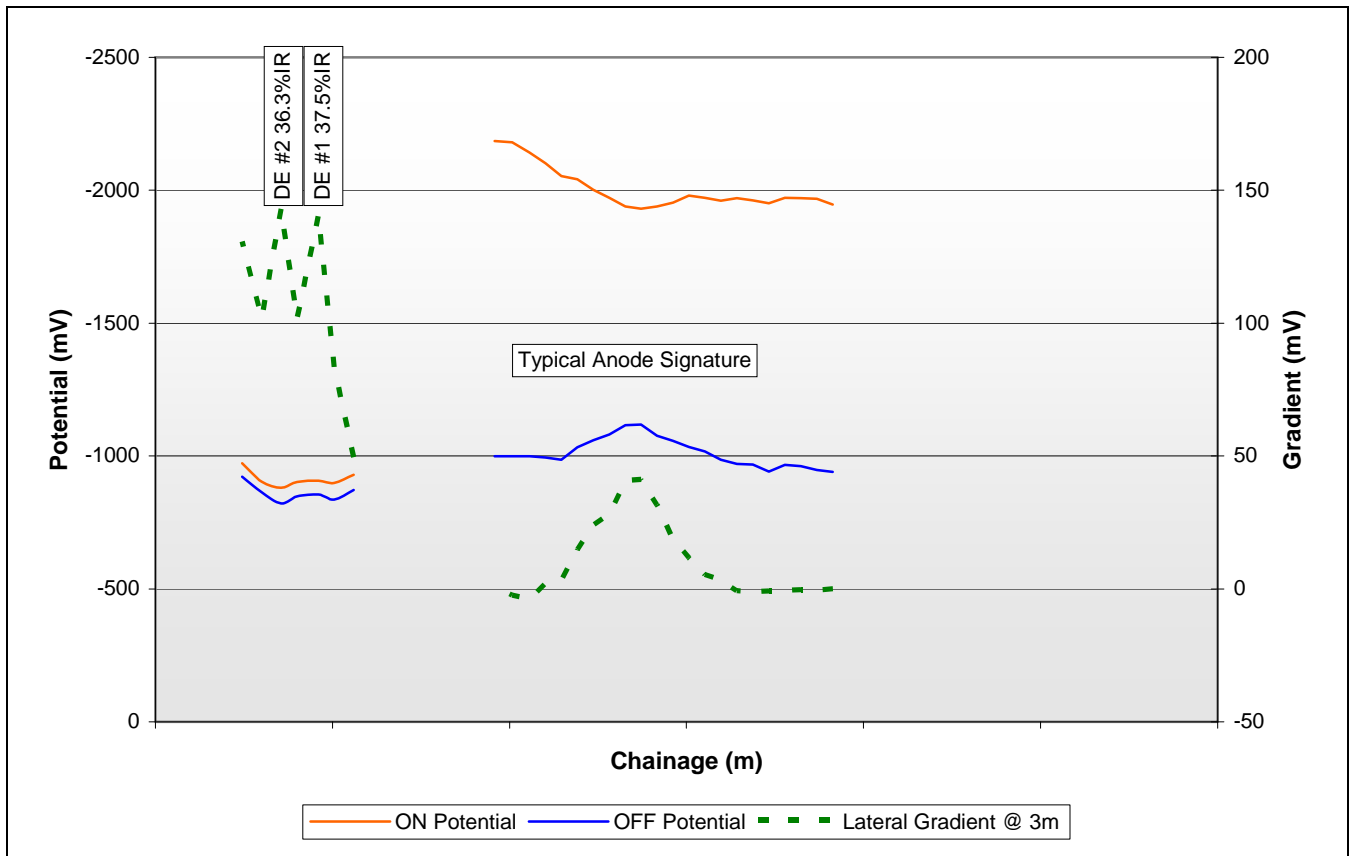
FIGURE 10 • CIPS/DCVG Profile @ Site #2

It should also be noted that depleted magnesium anodes could display atypical CIPS/DCVG profiles and could subsequently be misidentified as coating holidays, especially in a cluster of DCVG indications.

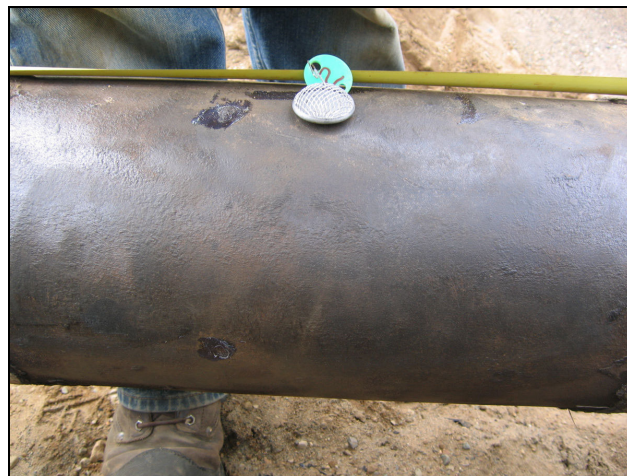
After removing the coating, the pipe was found in good condition, with only minor staining, as shown in Figure 11.

FIGURE 11 • DE #2 • Pipe Exposed. Close View.

No metal loss was found at this location, indicating that the CIPS identification and classification criteria were too severe for these aerated high resistivity soils.

Furthermore, with no CIPS indications (i.e. when the line is fully protected), all of the DC interference indications would be classified as minor. In hind sight, the prioritization status of this indication could have been downgraded to “Suitable for Monitoring”, matching the results of the direct examination.

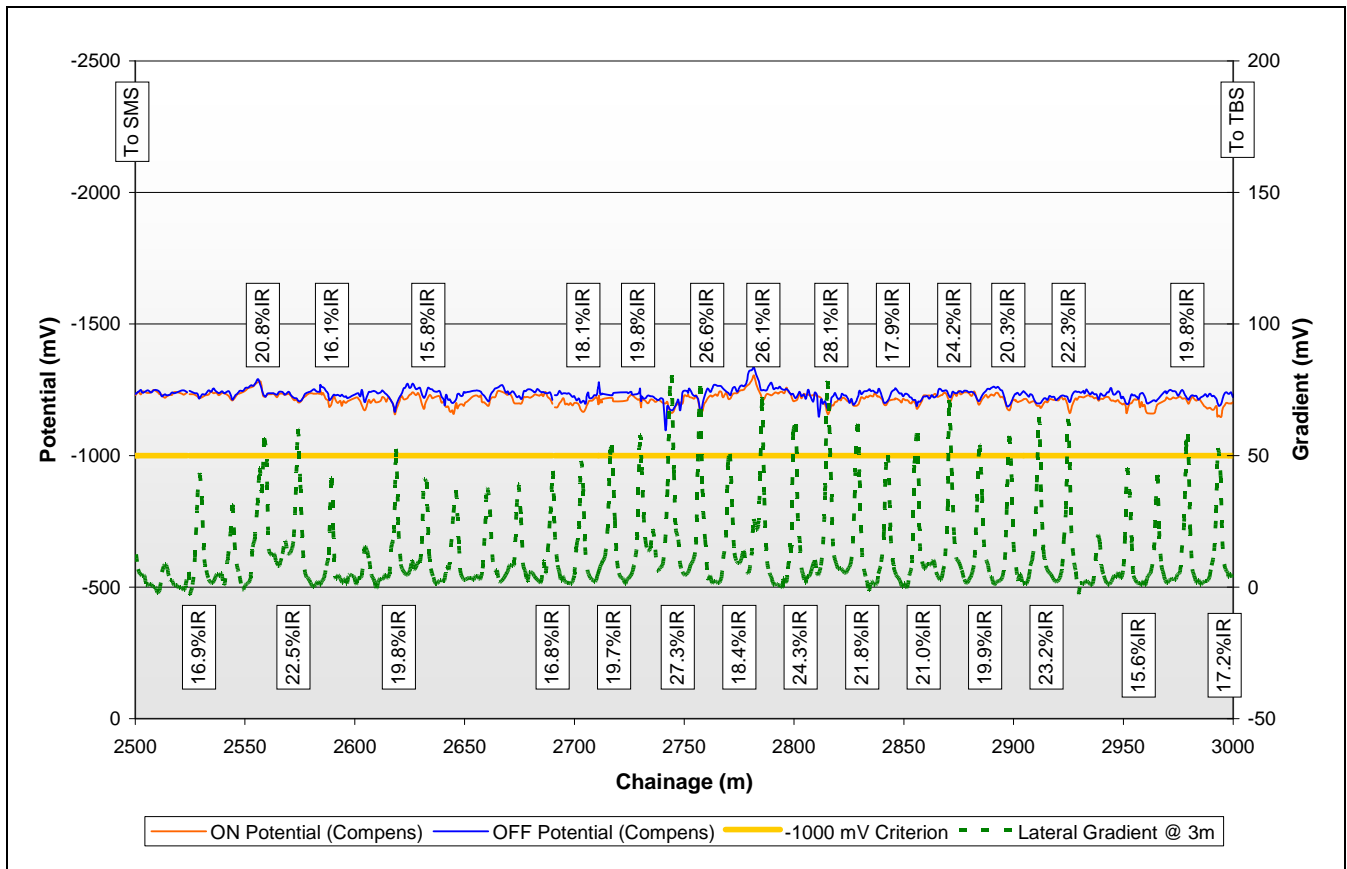
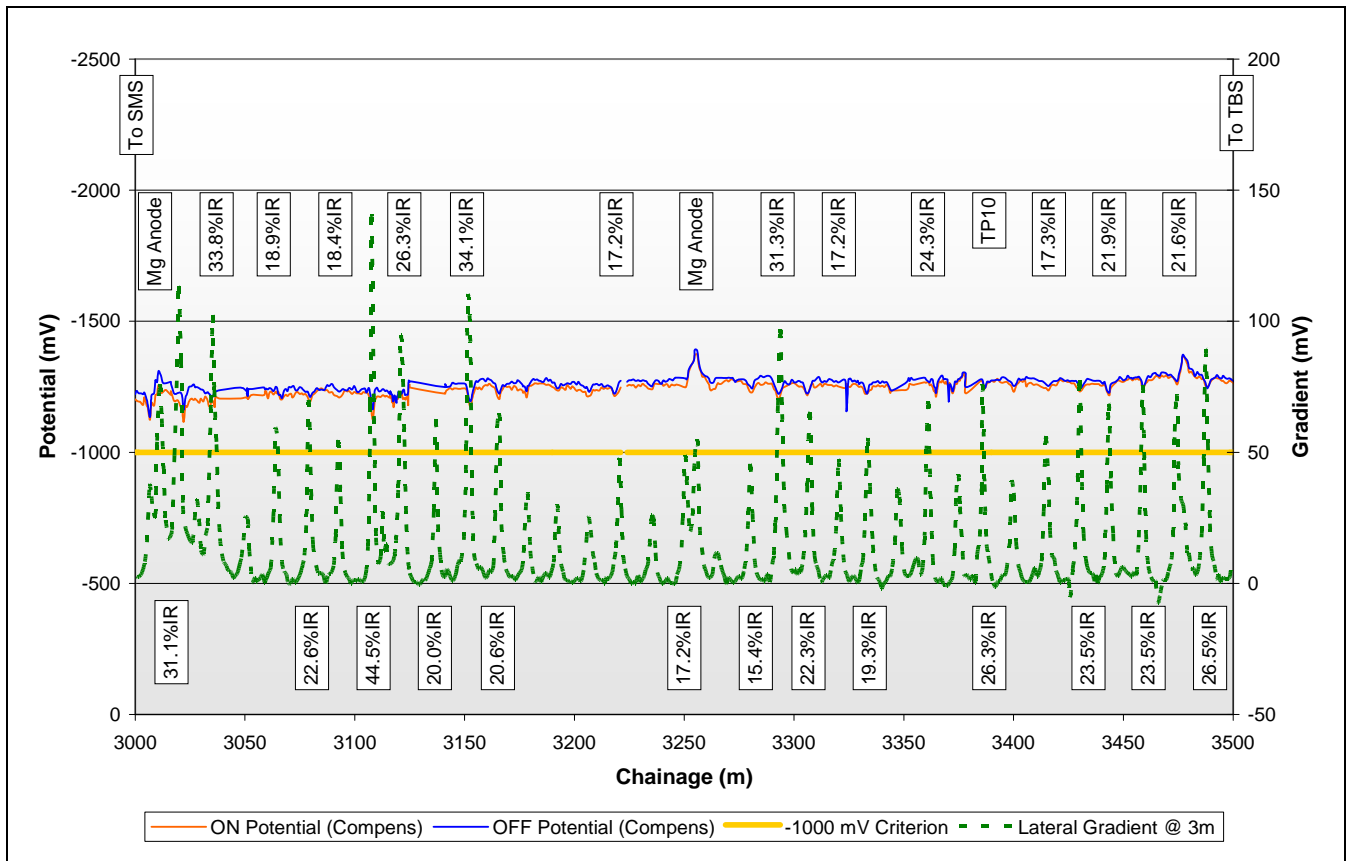
The line displayed a significant number of DCVG indications between chainage 2100 m and chainage 3800 m, which were uniformly distributed along the line, creating an unusual “Saw Tooth” gradient pattern (see Figures 12 and 13).

The indications were attributed either to depleted distributed anodes or to poor coating at welds. Since the line was fully protected, all the indications were prioritized as "Suitable for Monitoring".

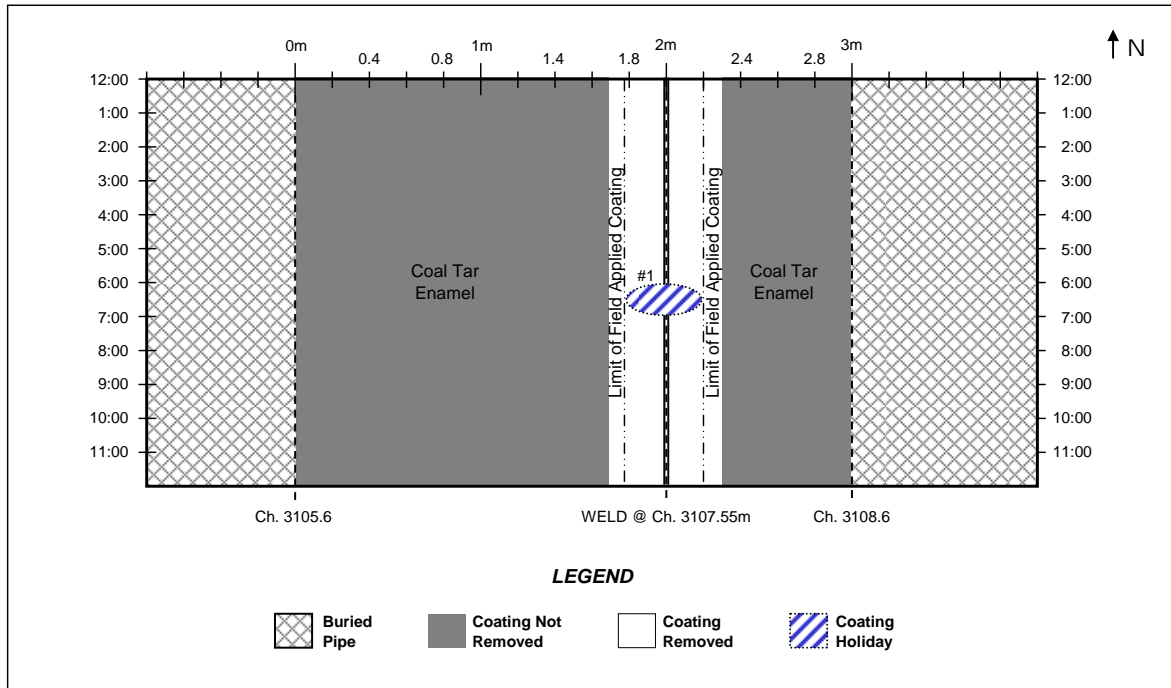
FIGURE 14 • Coating Inspection Map #3

The direct examinations were conducted in September 2007. At DE#1, a 20cm x 5cm holiday was found at the weld, as shown in Coating Inspection Map #3 (Figure 14) and in Figure 15.

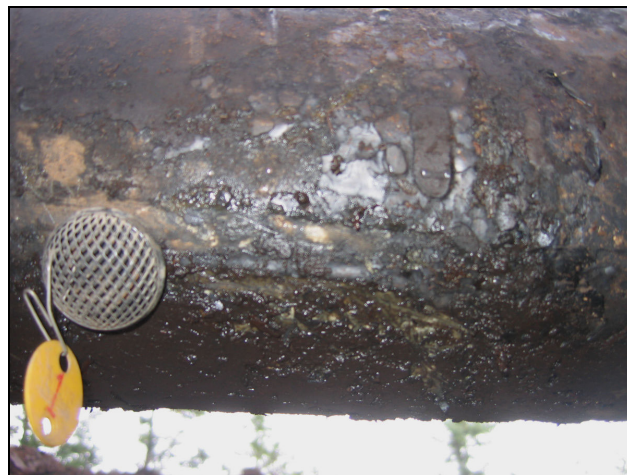
FIGURE 15 • DE #1. Coating Damage.
20 cm x 5 cm Holiday #1.

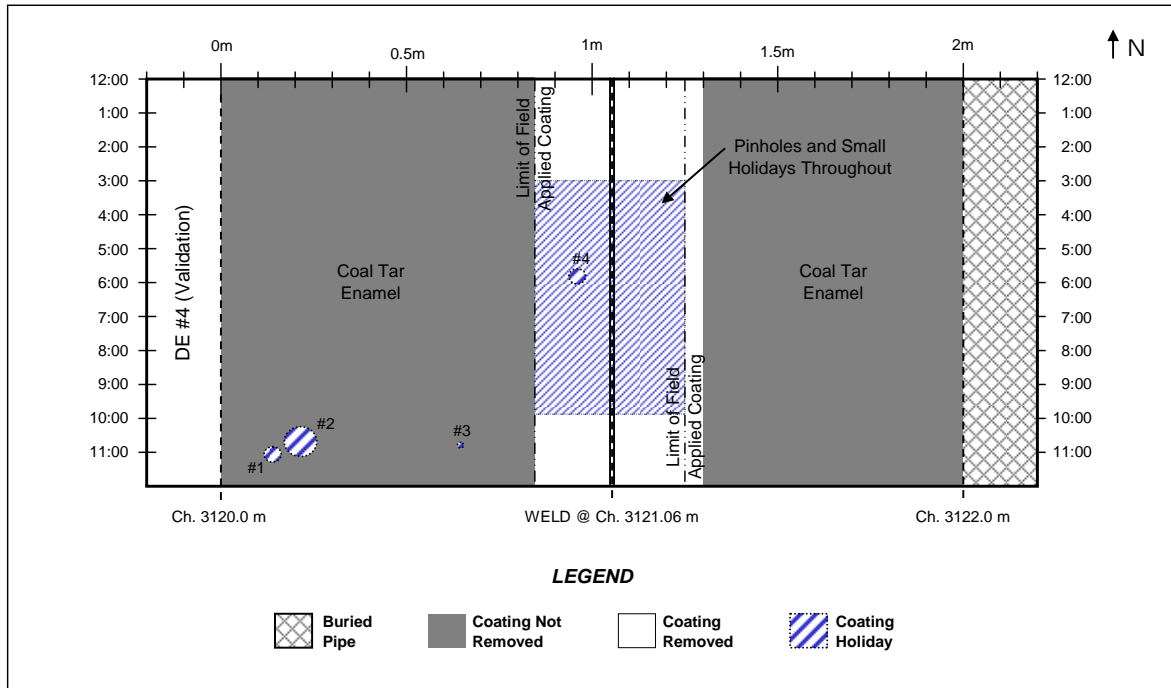
FIGURE 16 • Coating Inspection Map #4

At DE#2, four holidays were found, with holiday #4 and additional small holidays located in the weld area, as shown in Coating Inspection Map #4 (Figure 16) and Figure 17.

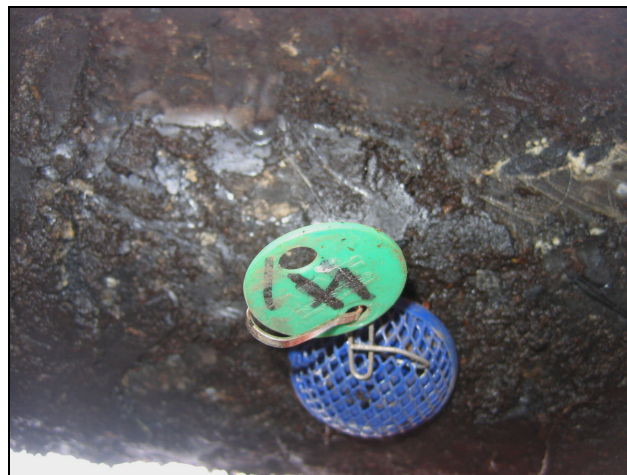
FIGURE 17 • DE #2. Coating Damage.
5 cm Dia. Holiday #4.

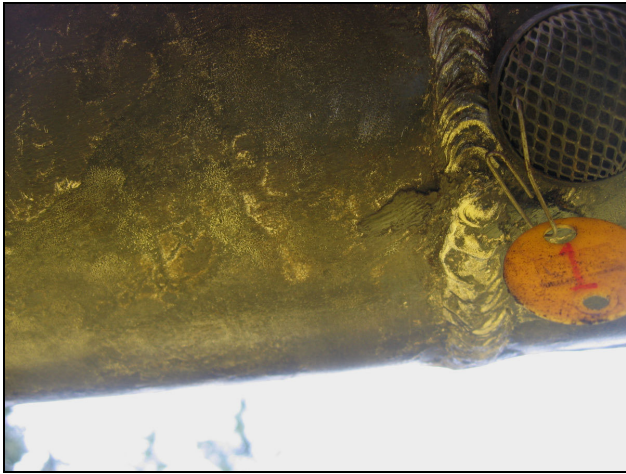
After removing the coating, the pipe was found in good condition, with no metal loss, as shown in Figures 18 and 19.

FIGURE 18 • DE #1. Pipe Exposed at 20 cm x 5 cm Holiday #1.

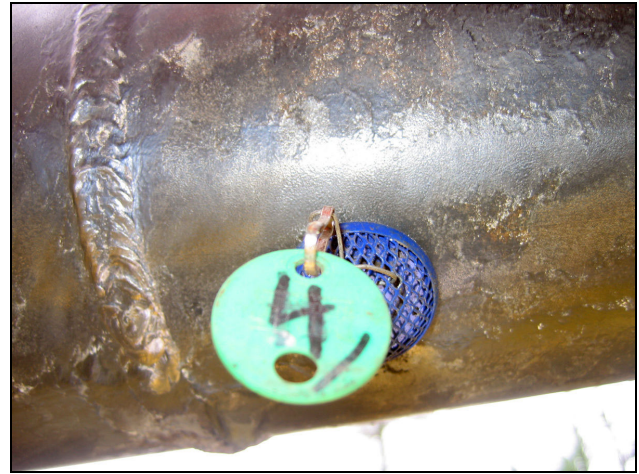
FIGURE 19 • DE #2 Pipe Exposed at Holiday #4. Close View.
