RESULTS FROM AN ECDA PLAN

R.G. Reid, P.Eng.
Union Gas Limited
A Duke Energy Company
50 Keil Drive North
Chatham, ON, Canada N7M 5M1

S.M. Segall, P.Eng.
R.A. Gummow, P.Eng.
Corrosion Service Company Limited
205 Riviera Drive
Markham, ON, Canada L3R 5J8

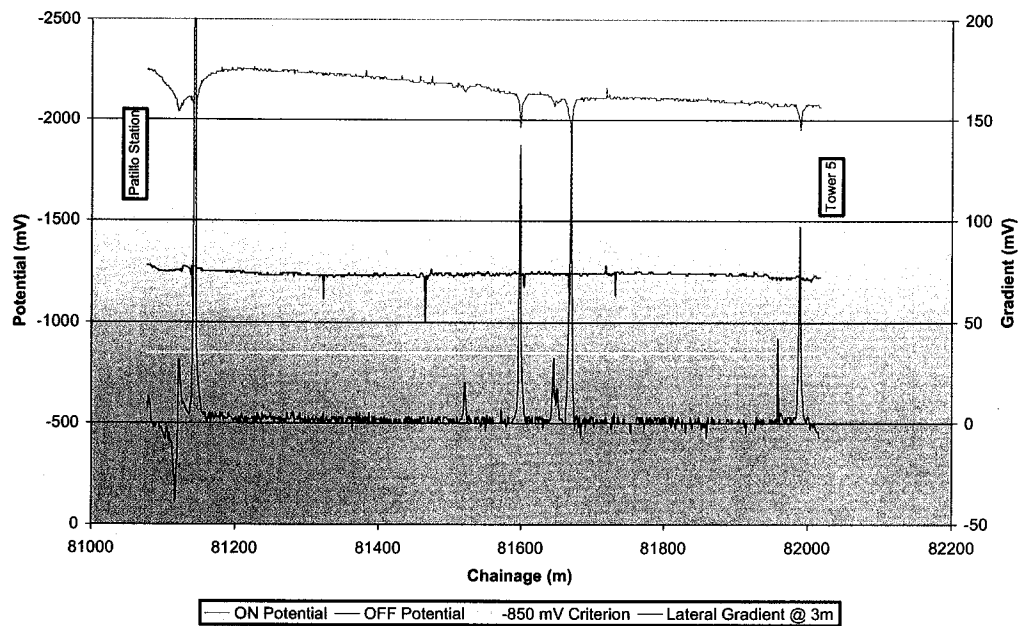
Figure 6. 16" Panhandle Line. CIPS/DCVG Survey (1.1 Km Sample)

Typical results of the integrated CIPS/DCVG survey on the Panhandle line are plotted in Figure 6. Pipe-to-soil potentials are plotted on the left-hand ordinate axis and the lateral gradient voltages are plotted on the right-hand ordinate axis.

The $-850 \text{ mV}_{\text{CSE}}$ criterion is also shown in the chart to identify CIPS indications. The line was fully protected along the entire section under assessment, since the proximity of the rectifier ensured that sufficient current was available to protect moderate or even large holidays.

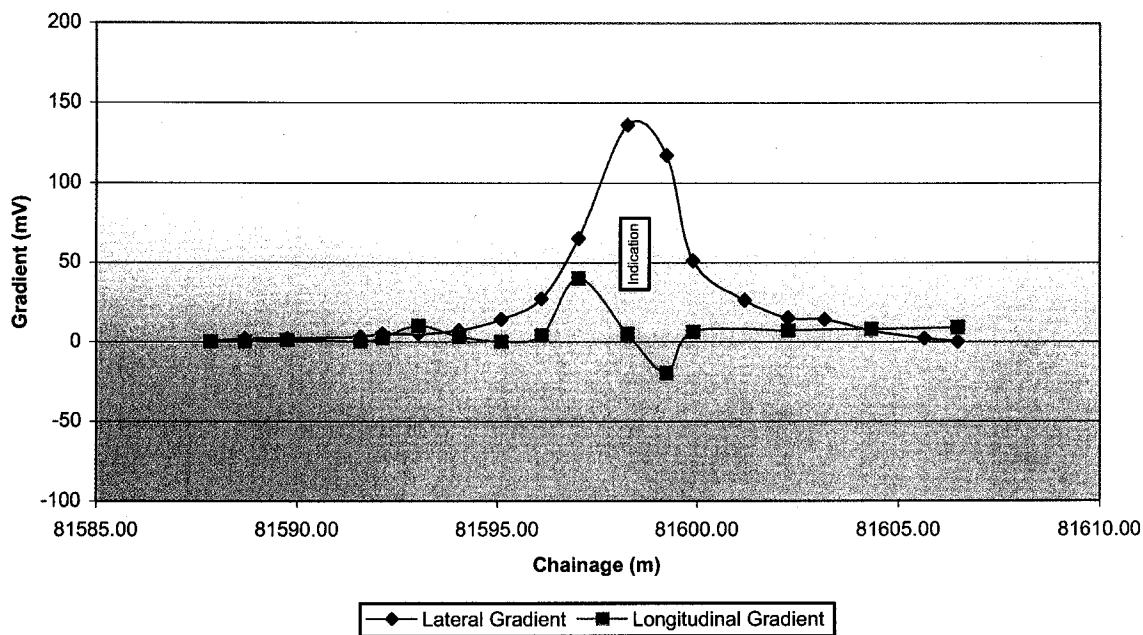
Figure 7. 16" Panhandle Line. Chainage 81598m. Voltage Gradients at DCVG Indication

DCVG indications were identified by the characteristic shape of the lateral gradient (i.e. increasing, reaching a maximum value at the epicenter of the holiday and then decreasing), as shown in Figure 7.

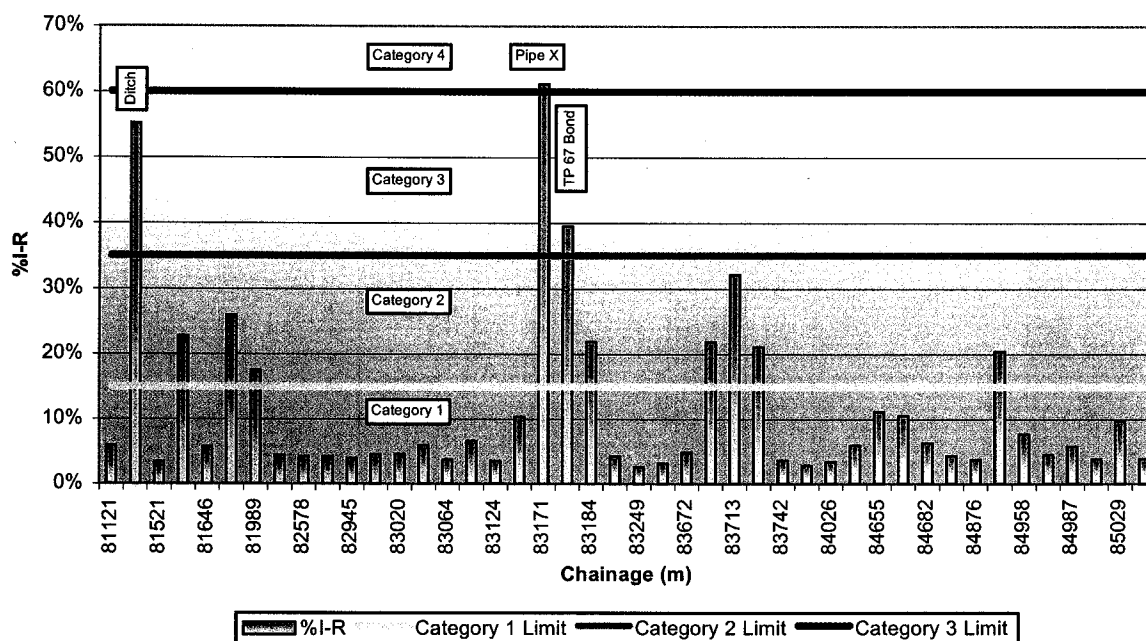
Figure 8. 16" Panhandle Line. Summary of DCVG Indications

A Category 3 indication was found at the ditch crossing, west of Patillo Road (chainage 81143.25m). This severity index (55.2%) can be attributed in part to the gradient distortion produced by the reduced soil cover. Considering the difficulties associated with excavating the pipe versus the probability of mechanical damage and the risk of corrosion due to the possible presence of de-icing salt in the case of a rectifier outage, it was essential to re-assess the severity of the coating damage indication under reduced cover.

The severe and moderate indications at chainage 83171.29m and 83171.43m respectively appeared to be related to the gradient produced by the special configuration of Elmstead Gate Station piping. The previous station take off riser was capped off 0.6 m from the new take-off connection. The new 5cm (2") dia. take-off pipe runs for 12.4 m in parallel with the main line and displays three 90° bends before rising above grade inside the station. The cathodically protected 7.5cm (3") dia. branch is bonded at TP67 to the Panhandle line. Considering all these gradient distortions and the fact that the line is fully protected at this location (i.e. $V_{OFF} = -1250 \text{ mV}_{CSE}$), no threat to pipeline integrity was anticipated. Furthermore, should a failure shut down the Patillo rectifier, partial protection would be provided from the branch via the bond at TP 67.

Of the 44 indications found on the Panhandle line, 41 were classified as minor, 1 as moderate, and 2 indications were attributed to gradient distortion.

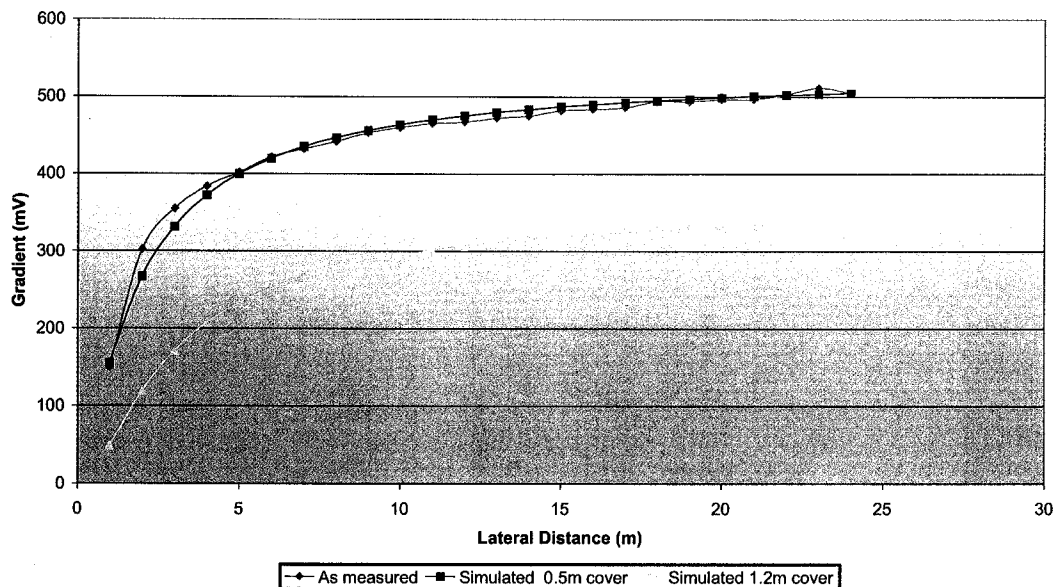
Figure 9. Influence of Reduced Cover on the Severity of Coating Defect

The measured gradient to remote earth (orange line) was matched to a simulated gradient produced by a 50 cm² holiday with a 0.5m cover (blue line), as shown in Figure 9.

The gradient produced by the sized holiday but with 1.2 m cover was then calculated and plotted (gold line). The reduction in cover results in an increase of approximately 48% (160 mV) in the lateral gradient at 3m. As such, the calculations indicate that the %I-R index at chainage 81143.25m under normal cover conditions would be approximately 40%, instead of 55.2%, still leaving the site as a Category 3 indication.

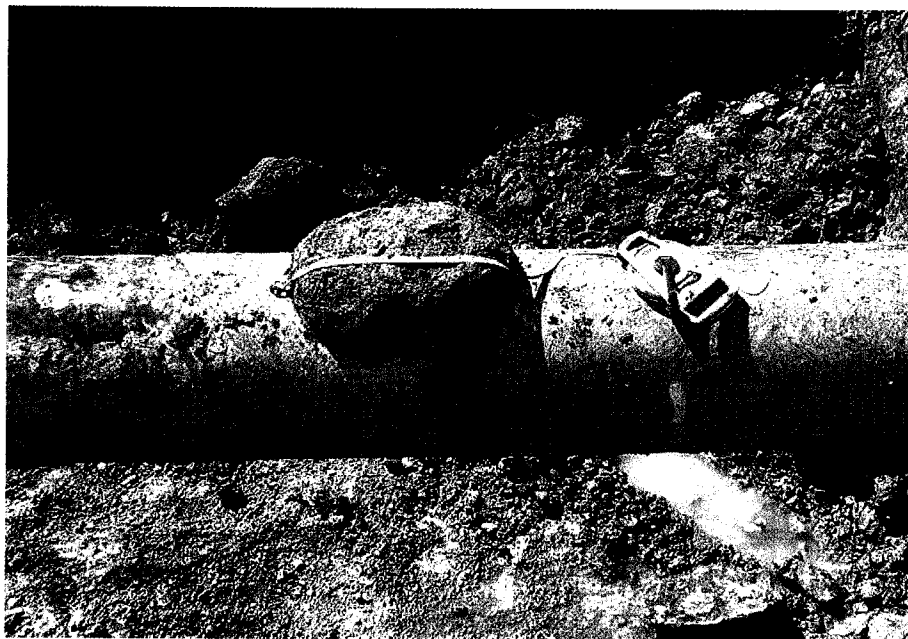
Figure 10. 16" Panhandle Line. Clay-Calcareous Deposit Lump at Site A (chainage 83712m)

Coating damage was found at all the four excavated locations. The holidays were covered by hard lumps made of a mix of clay and calcareous deposit as shown in Figure 10. (site A at chainage 83712m). No corrosion pits were found after removing the deposit and the pH of the trapped water was between 10 and 12. The exact size of the holiday could not be exactly measured, as the wax coating cracked during the removal of the hard calcareous deposit – clay mix. The coating inspection map for this site is shown in Figure 11.

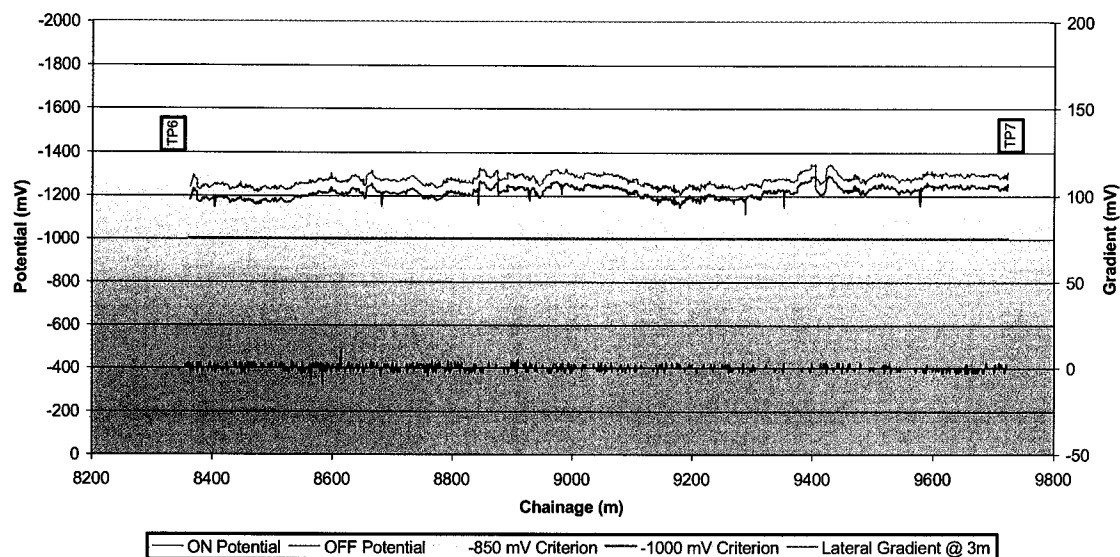
Figure 12. 8" Leamington North Line. CIPS/DCVG Survey Sample (As Measured)

The results of the integrated CIPS/DCVG survey conducted on July 12, 2004 were telluric compensated. The "As Measured" and compensated data are plotted in Figures 12 and 13.

The extreme soil dryness made the survey very difficult, as poor contact resulted in anomalous gradient readings. At some locations, the gradient was re-measured several times, until the crew was satisfied that the recorded potentials were accurate.

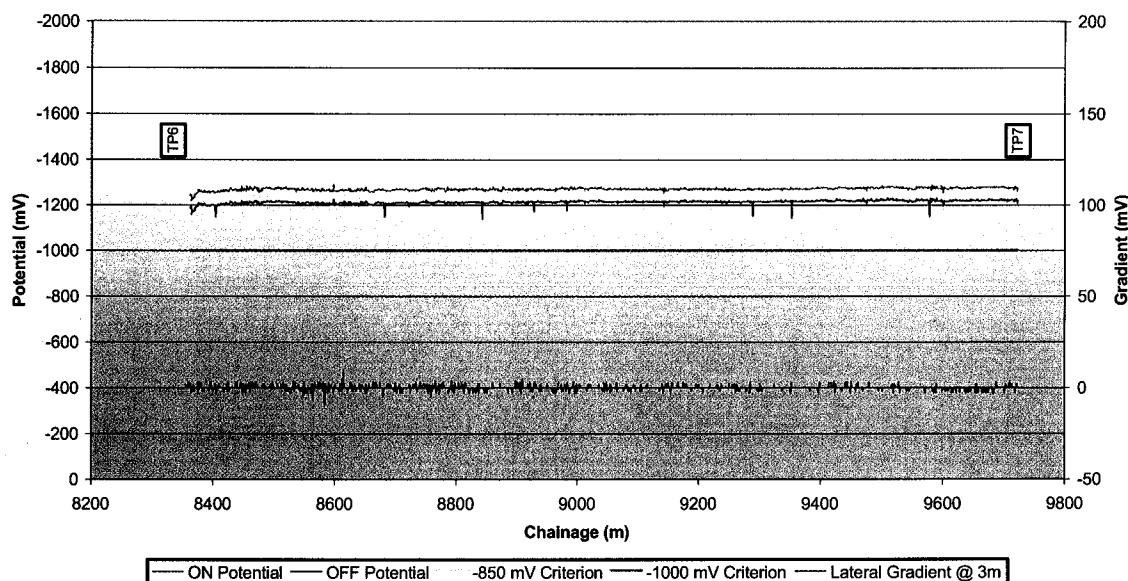
Figure 13. 8" Leamington North Line. CIPS/DCVG Survey Sample (Compensated)

The results of the CIPS survey indicated that the line was fully protected along its entire length.

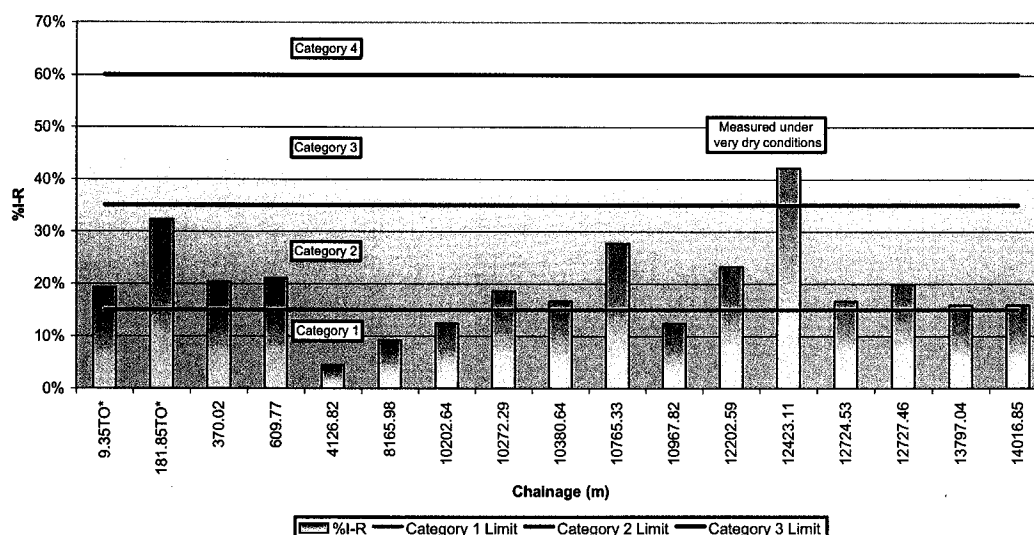
Figure 14. 8"/10" Leamington North Lines. Summary of DCVG Indications

Seventeen DCVG indications were found along the line, as shown in Figure 14.

All the coating defects were classified as minor, except for one moderate (42.2% Category 3) indication at chainage 12423.11m, which was attributed to the extremely dry soil conditions.

All the locations were prioritized as "Suitable for Monitoring". Two areas were specifically recommended for excavation. The first location at chainage 181.85m on Leamington North – Windsor Line tie-over pipeline displayed 32.2% %I-R, measured under ideal conditions and the second one at chainage 8165.98m on Leamington North line displayed a small holiday (i.e. 9.2% I-R) in conjunction with a minor risk of AC induced corrosion.

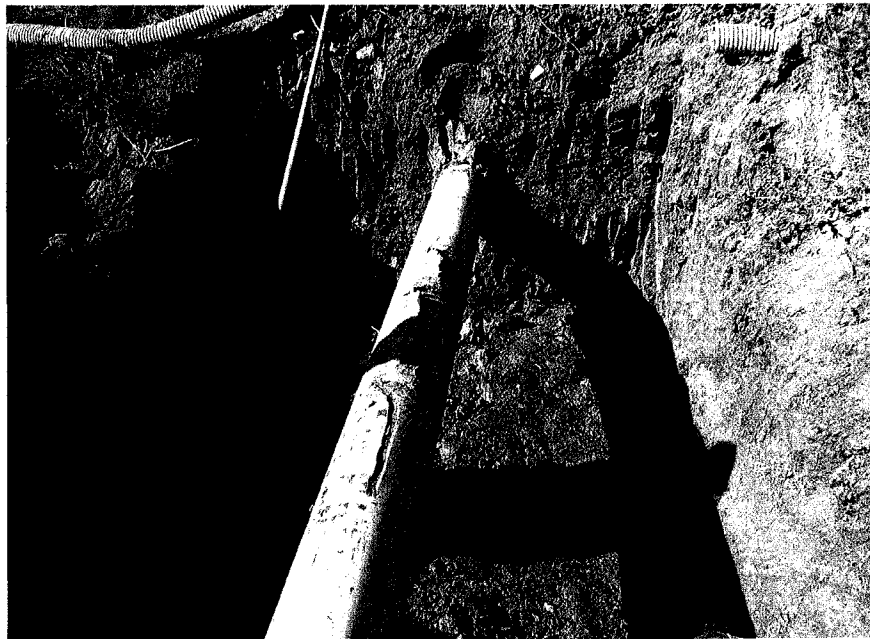
Figure 15. Leamington North Tie Over. Coating Damage at Chainage 181.85m

At chainage 181.85m on Leamington North – Windsor Line tie-over, three large scratches attributed to third party damage were found in the coating (see Figure 15). The pipe was slightly gouged to depths up to 0.36mm. No active corrosion was observed. The gouges were buffed out after being evaluated and considered no threat to pipe integrity.

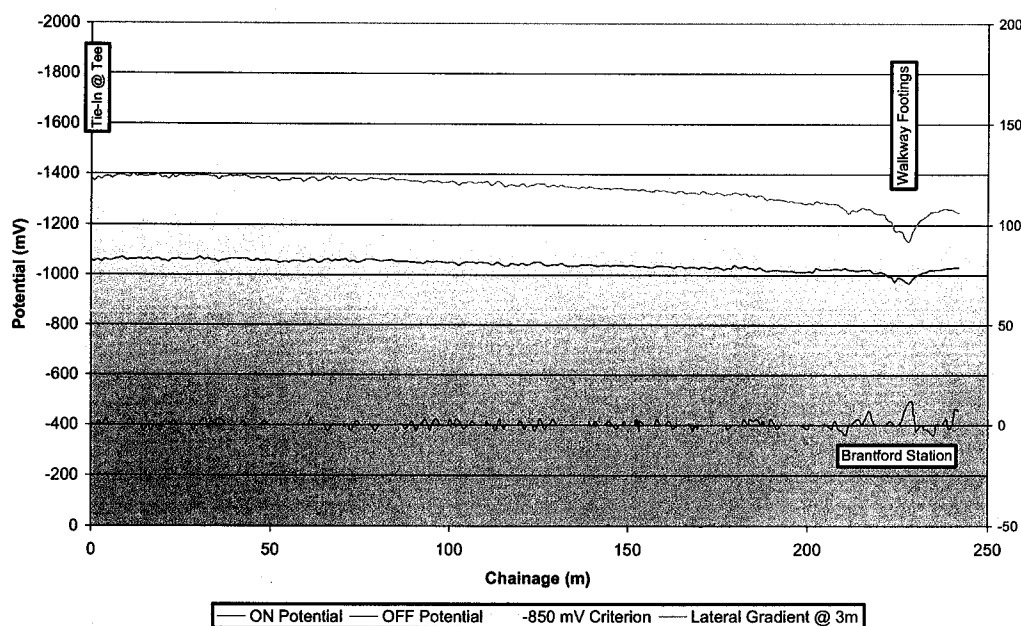
Figure 16. Brantford Transmission Station Take-Off. CIPS/DCVG Survey

The pipeline is fully protected along its entire length. A minor DC interference indication was found at chainage 228.92m, near the walkway footings. A possible minor DCVG indication (1.9% I-R C-C) was identified at the same location, however since the line is shorted to the station ground it is possible that the walkway footings are the source of the gradient distortion. The area was defined as "Suitable for Monitoring" and a direct examination will be conducted at this location.
