New and Old Challenges in Analyzing ECDA Indirect Inspections Data

S.M Segall, P. Eng.
R.A. Gummow, P. Eng.
D. Fingas; P. Eng.
Corrosion Service Company Limited
9-280 Hillmount Rd.
Markham, ON, Canada L6C 3A1

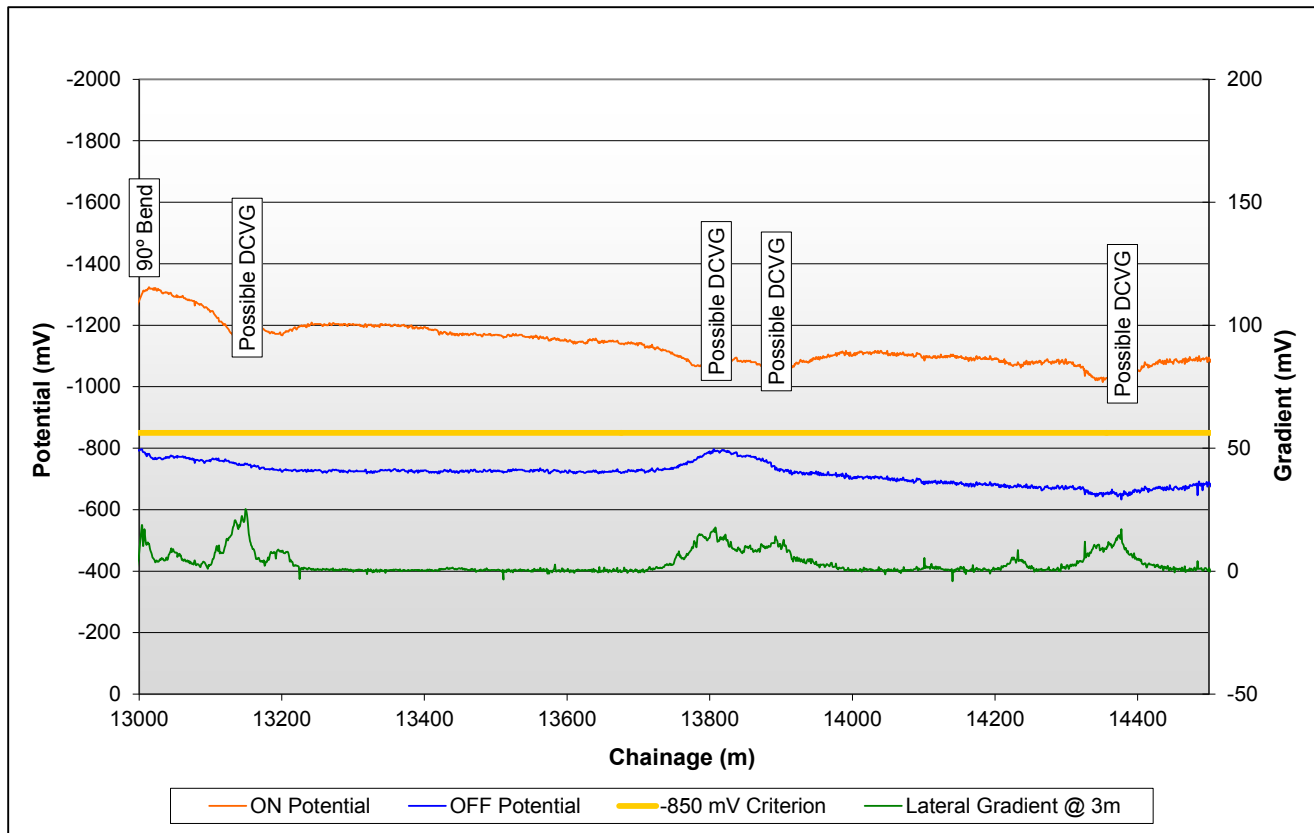
Figure 1: NPS 30 Mainline Loop. Integrated CIPS/DCVG Data. Preliminary Graph

The first survey was conducted along the NPS 30 Mainline Loop (pipeline under assessment) using the integrated CIPS/DCVG technique¹. The pipe-to-soil potential and the lateral gradient at 3m were measured simultaneously using a two-channel data logger. The lateral gradients were measured on the east side, far from the NPS 30 Mainline. A sample of the results, as recorded from Ch. 13000 m to Ch. 14500 m is shown in Figure 1. The lateral gradients indicate four possible DCVG indications at Ch. 13149 m, Ch. 13808 m, Ch. 13892 m and Ch. 14377 m.

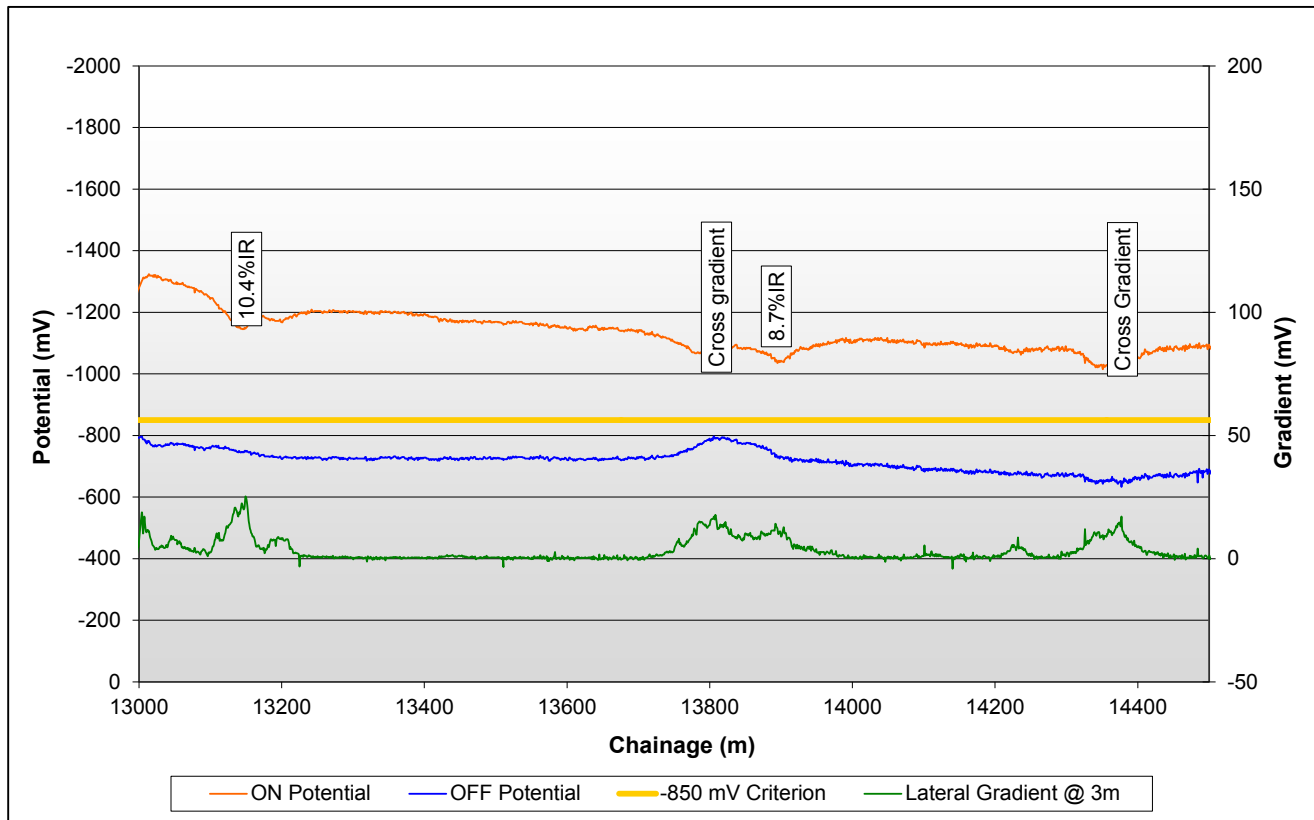
Figure 2: NPS 30 Mainline Loop. Integrated CIPS/DCVG Data. Final Graph

The data indicates that only two holidays may be attributed to the line under assessment (i.e., at Ch. 13149 m and Ch.13892 m), as shown in the final graph of the survey – see Figure 2. The other two locations are marked on the graph as “cross gradient”.

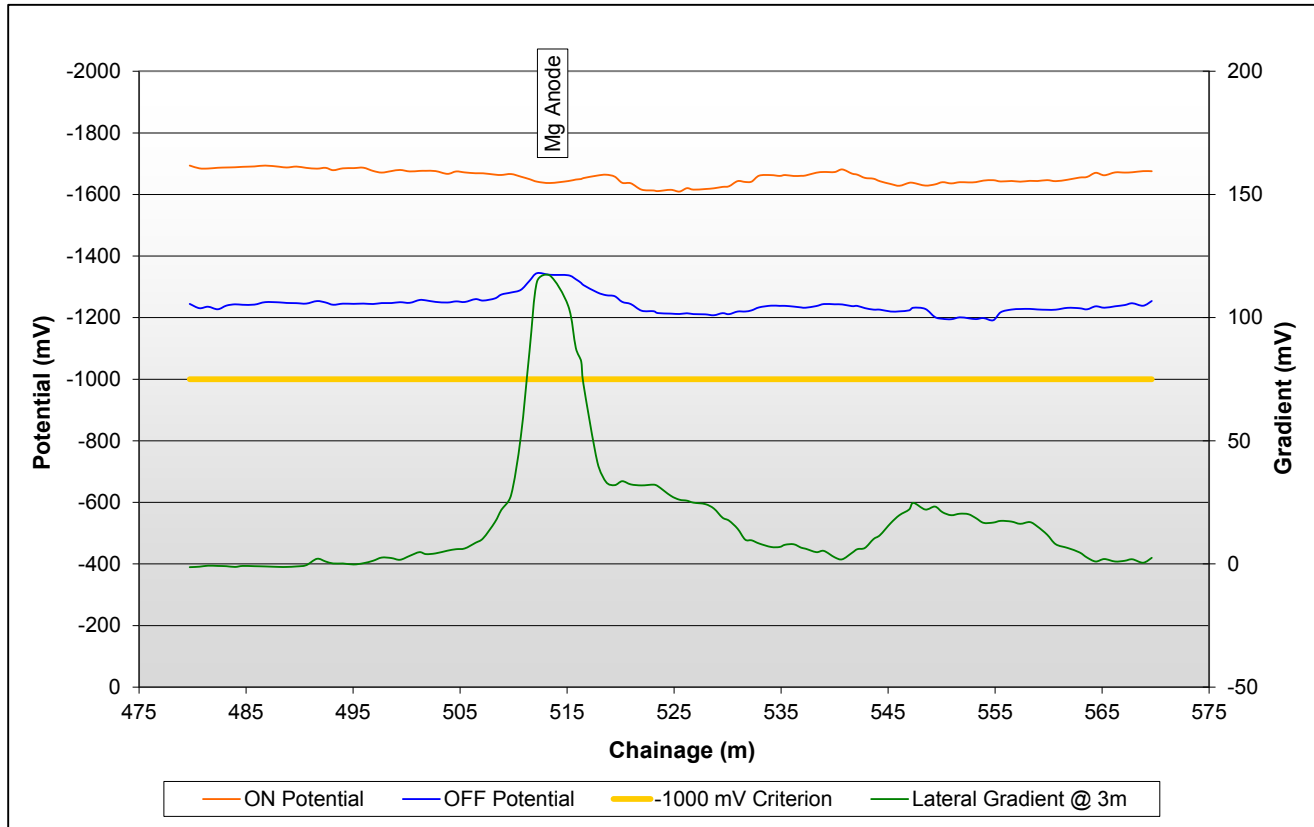
Figure 3: Typical Profile of an Active Magnesium Anode

The typical profile of a magnesium anode in a CIPS/DCVG graph shows an increase in the OFF potential in conjunction with a significant lateral gradient, as shown in Figure 3.

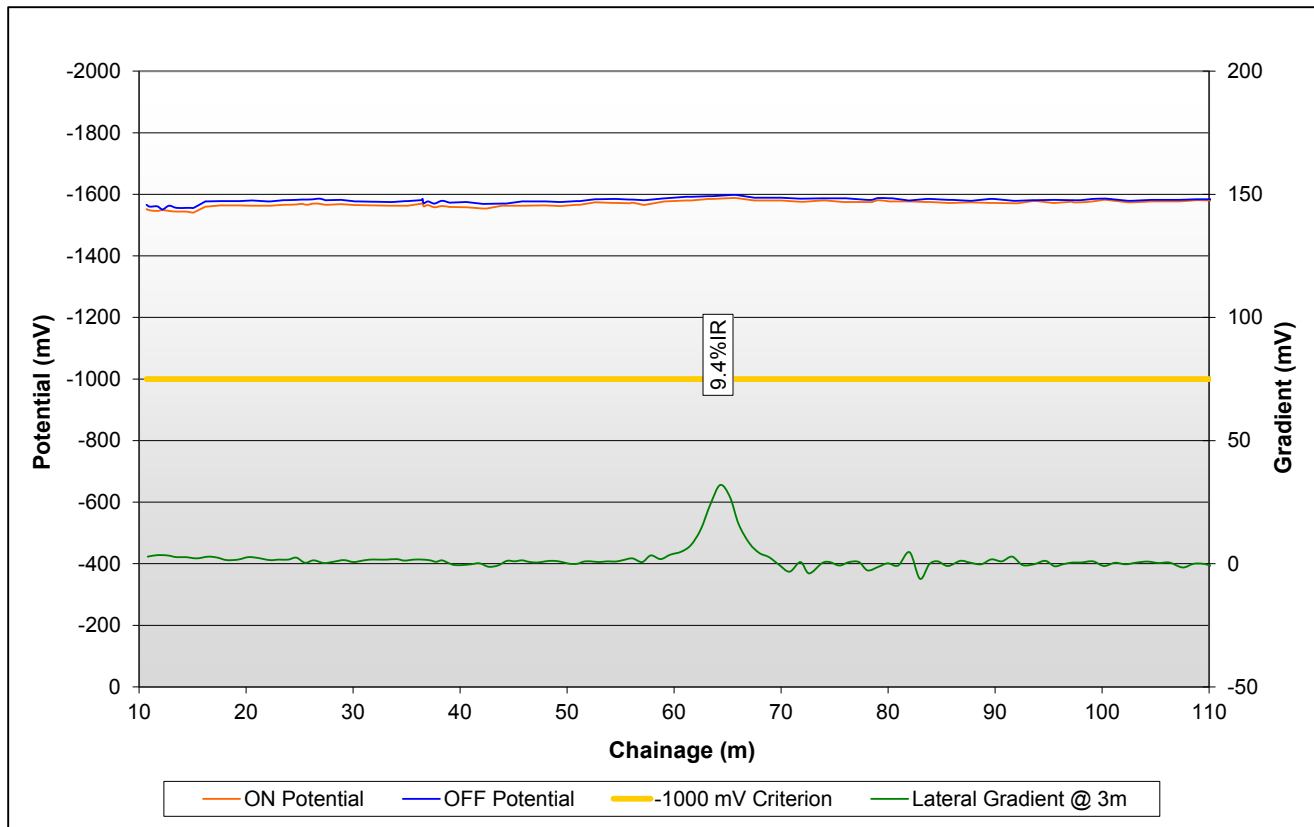
Figure 4: NPS 4 Pipeline. Ch. 10 m to Ch. 110 m. CIPS/DCVG Aligned Data

The increase in the lateral gradient at Ch. 64.30 m was identified as a “below threshold” DCVG indication¹ and with no more severe indications, it was selected for direct examination.

The coating was found in good condition, with no identifiable holidays. An old magnesium anode connection was found at this location as shown in Figure 5.

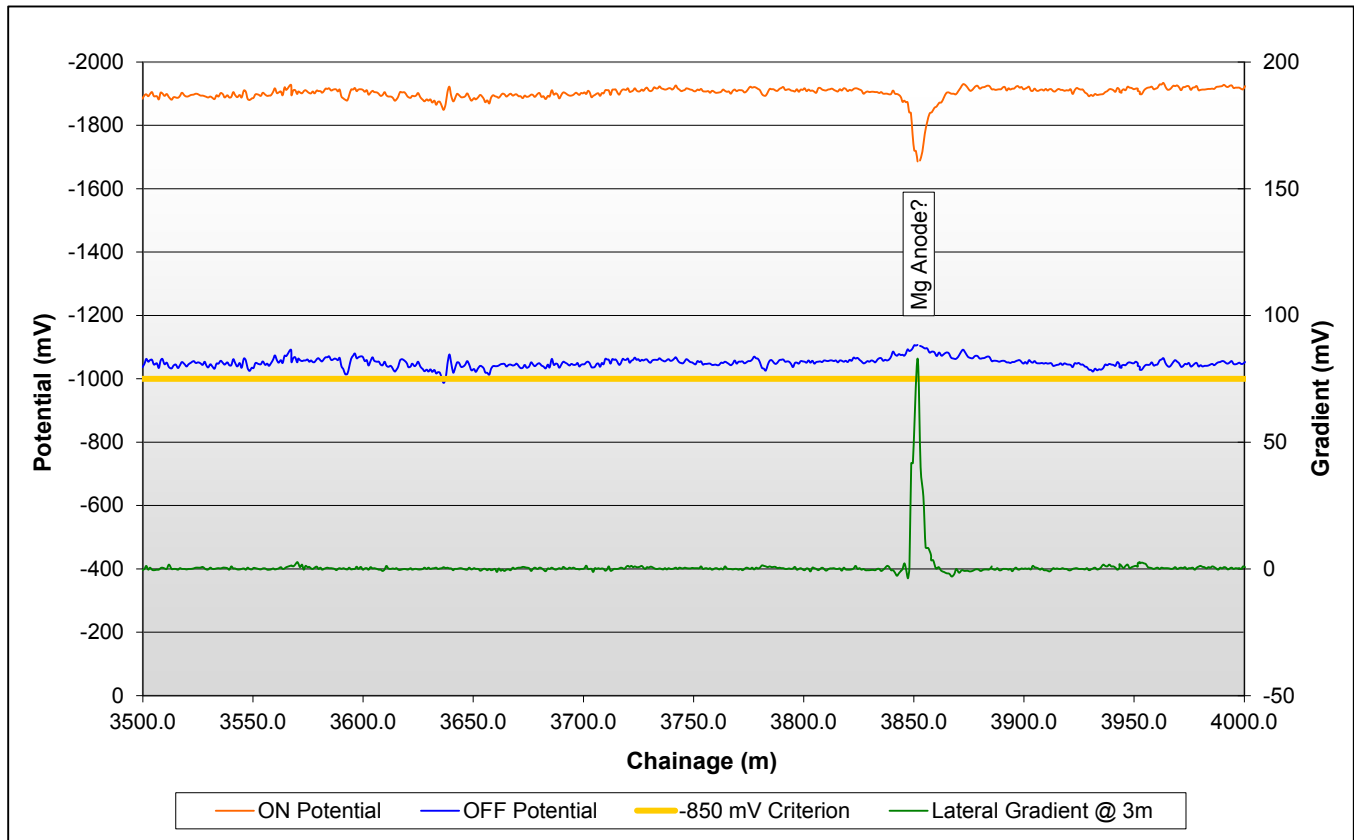
Figure 6: NPS 36 Pipeline. Ch. 3500 m to Ch. 4000 m. Integrated CIPS/DCVG Data

The lateral gradient shift ΔG in Table 2 increases, reaches a maximum at Ch. 3851.7 m (i.e., 83 mV), and then decreases. The calculated %IR is 23.2%, which would correspond to a minor DCVG indication, if the gradient shift is attributed to a coating holiday.

The OFF potential increases to -1107 mV, compared to -1070 to -1090 mV levels adjacent to the peak, pointing to a magnesium anode.

At Ch. 3851.7 m, the gradient ON is 66.1 mV, indicating significant current pick-up, while the gradient OFF is -16.9 mV indicating significantly lower current discharge.

With a high ON gradient and a significantly lower OFF potential, and considering that no anodes were installed according to the pre-assessment data, the gradient shift at Ch. 3851.7 m was attributed to an “anode shaped” holiday.

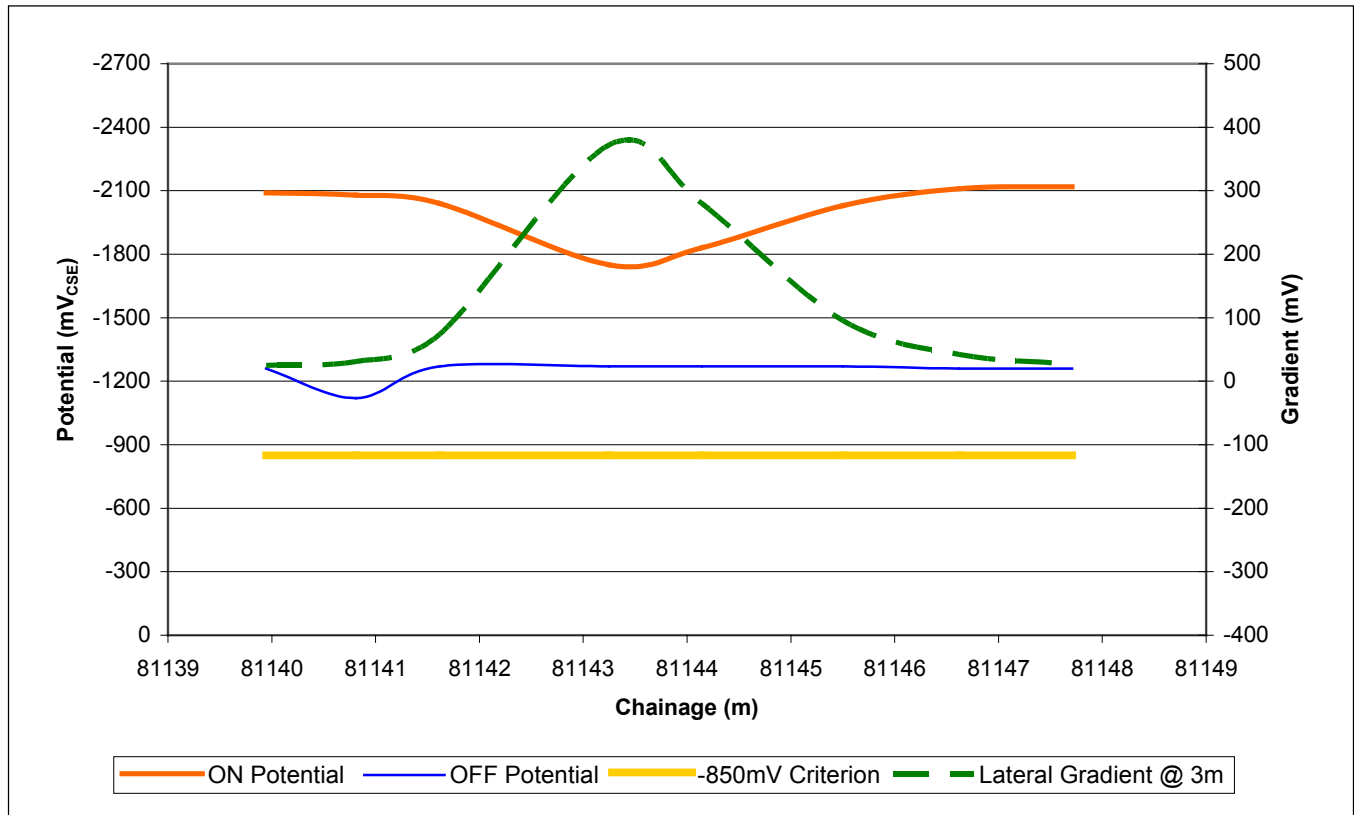
Figure 7: NPS 16 Pipeline. Ch. 81139 m to Ch. 81149 m. CIPS/DCVG Data

Figure 7 shows the results from an integrated CIPS/DCVG survey in southern Ontario.

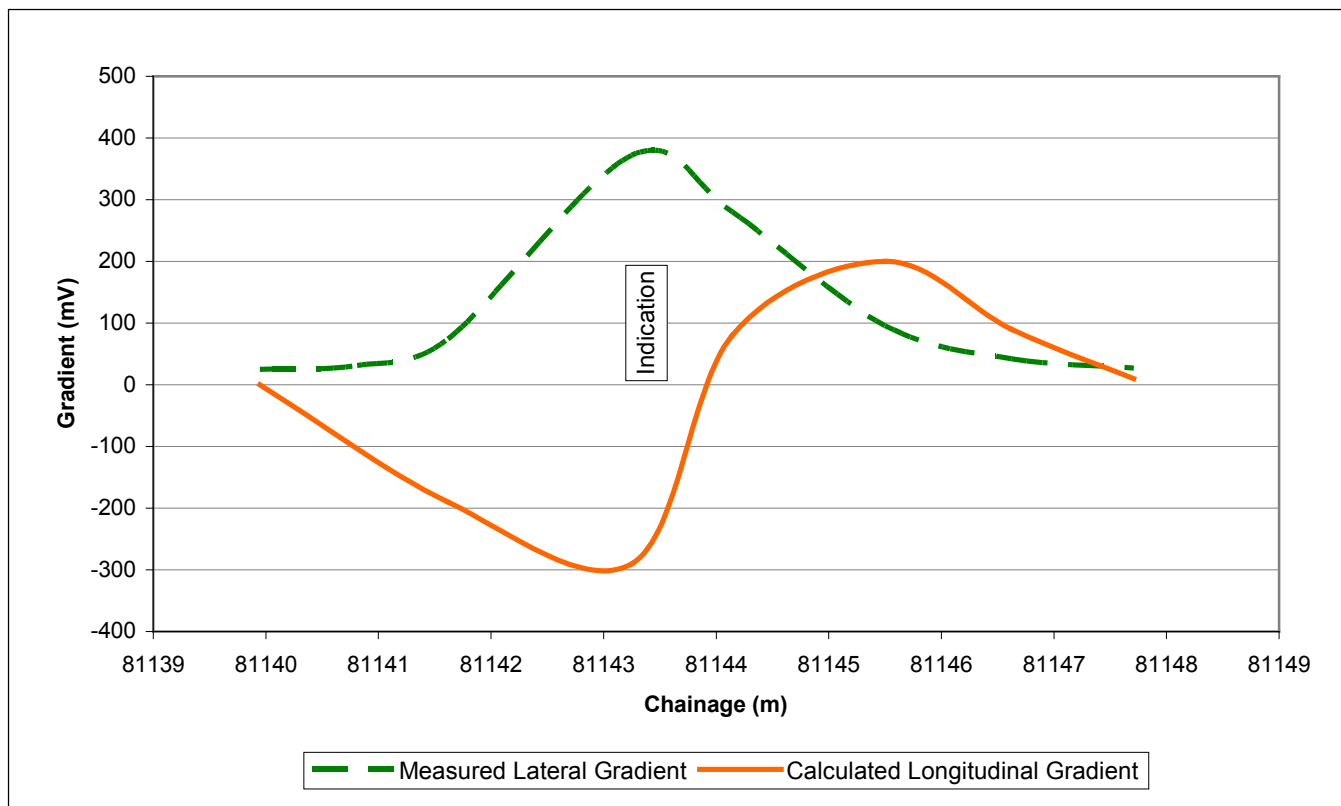
Figure 8: NPS 16 Pipeline. DCVG Indication Identified from CIPS Data

Figure 8 shows the same measured lateral DCVG profile versus the calculated DCVG longitudinal profile. The DCVG longitudinal profile was obtained from the pipe-to-soil potential data plotted in Figure 7, by assuming that the longitudinal gradient between two points on the pipeline equals the difference between the two pipe-to-soil potentials.

Both profiles identify the same holiday.

To avoid this type of “double dipping” only the DCVG indication should be prioritized. The drop in potential displayed in the CIPS profile should be seen as a confirmation of the presence of a holiday and not an independent CIPS indication.
