Improving the Quality of ECDA Indirect Inspection Data

S.M. Segall, P. Eng.
Corrosion Service Company Limited
9-280 Hillmount Rd.
Markham, ON, L6C 3A1
Canada

John Shore P. Eng.
Union Gas Limited, A Spectra Energy Company
50 Keil Drive North
Chatham, ON, N7M 5M1
Canada

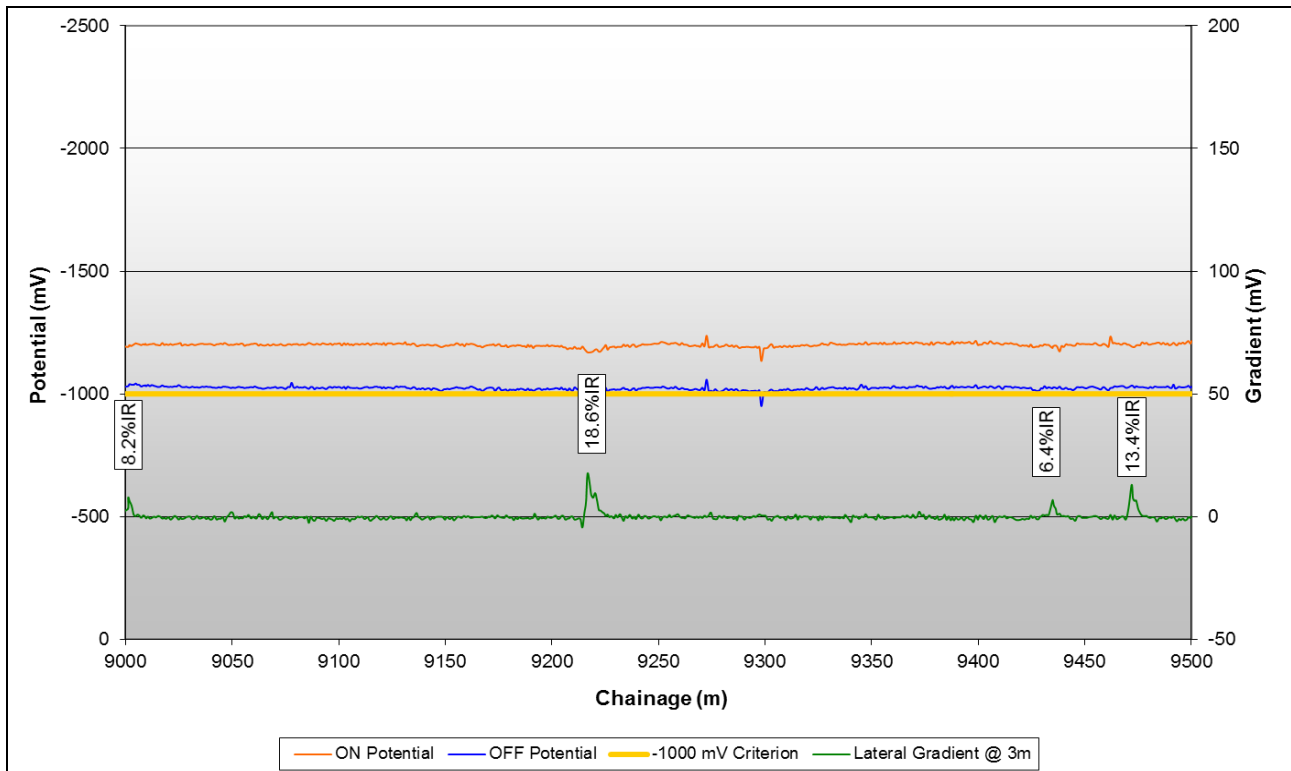
Figure 1: Ch. 8769 0 m to 9000 0 m. CIPS/DCVG Survey Results

The line displayed only one DCVG indication at chainage 9216.8 m (18.6%IR), as shown in Figure 1.

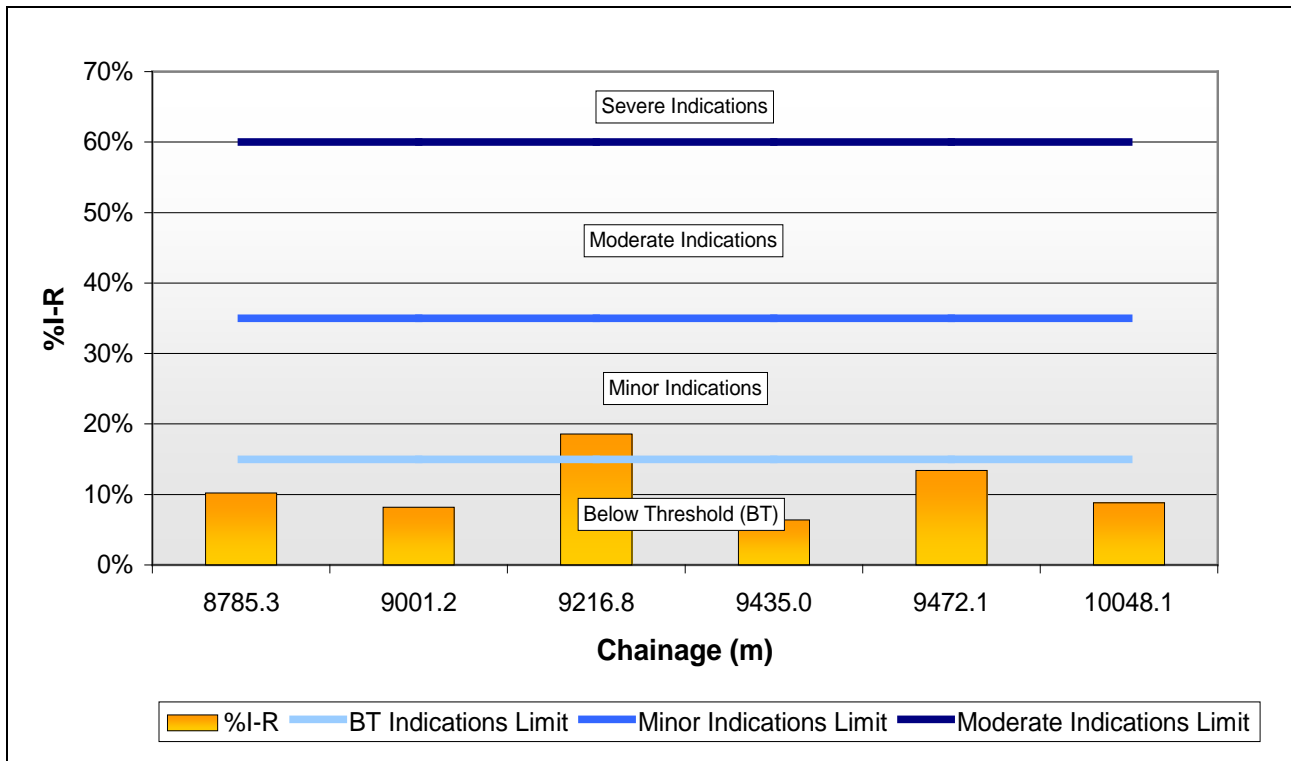
Figure 2: %IR Severity Index for Coating Defects

Five more DCVG indications were classified as below-threshold and reported in conjunction with minor ACC indications. All coating defects are plotted in terms of %IR and severity limits in Figure 2.

All the indications were prioritized as “Suitable for Monitoring” and with no indications prioritized as “Immediate Action Required” or “Scheduled Action Required”, a minimum of four direct examinations (DE) were selected, according to Paragraphs 5.3.1.1 and 6.7.2.1 of NACE Standard SP0502-2010².

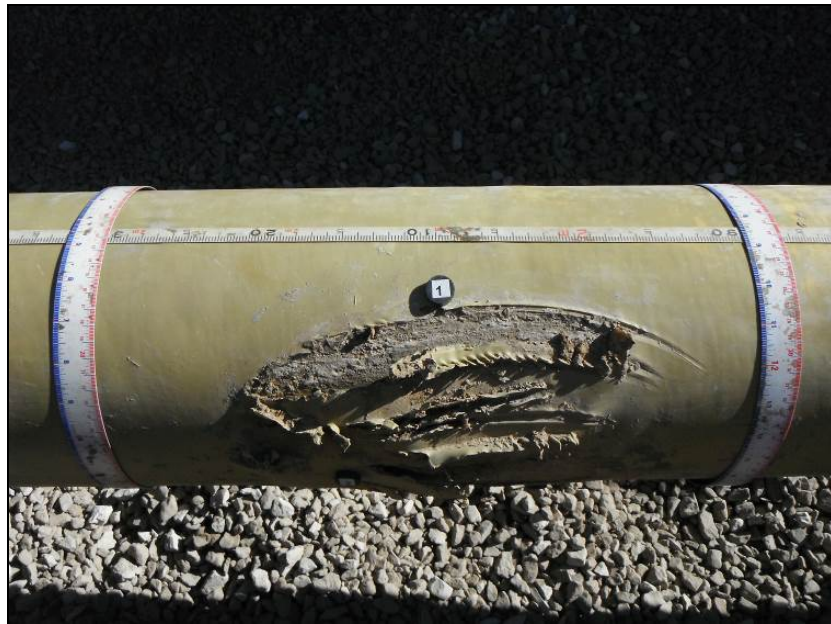
Third-party damage was found at the location of the direct examination site #3 (chainage 10048.1 m). The factory applied coating had been damaged by an auger during the installation of the hydro pole, causing severe abrasion extending to the metal surface and resulting in three extensive holidays, as shown in Figures 3 to 5.

Figure 3: DE#3. Third-Party Coating Damage. Holiday #1

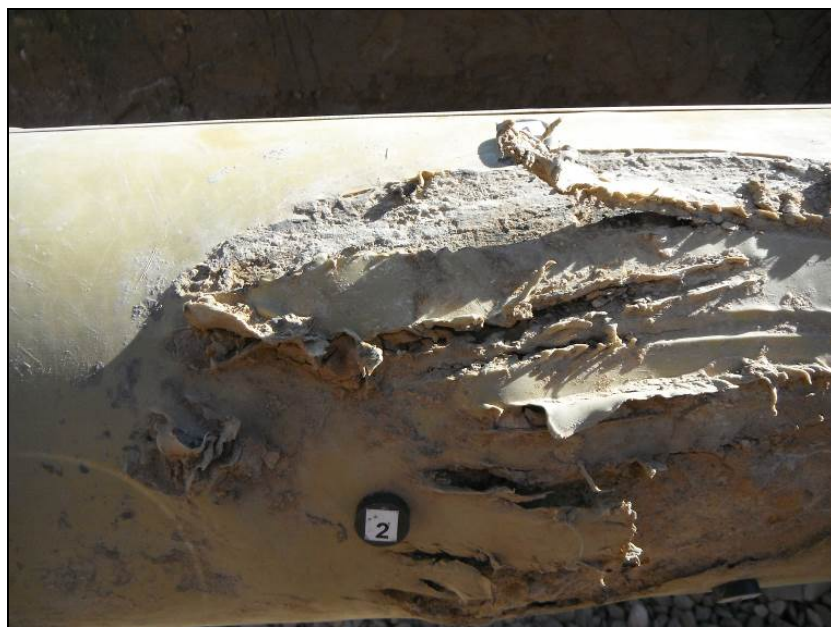
Figure 4: DE#3. Third-Party Coating Damage. Holiday #2

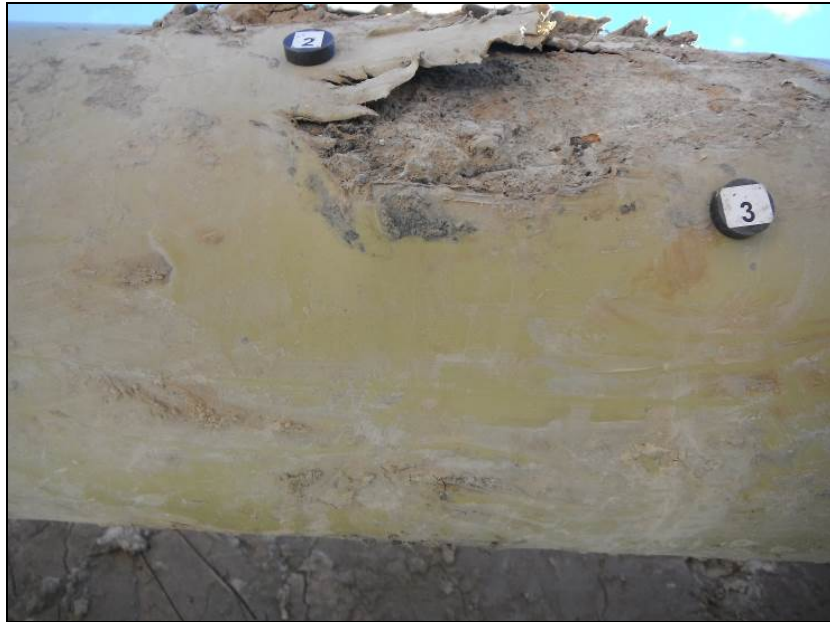
Figure 5: DE#3. Third-Party Coating Damage. Holiday #3

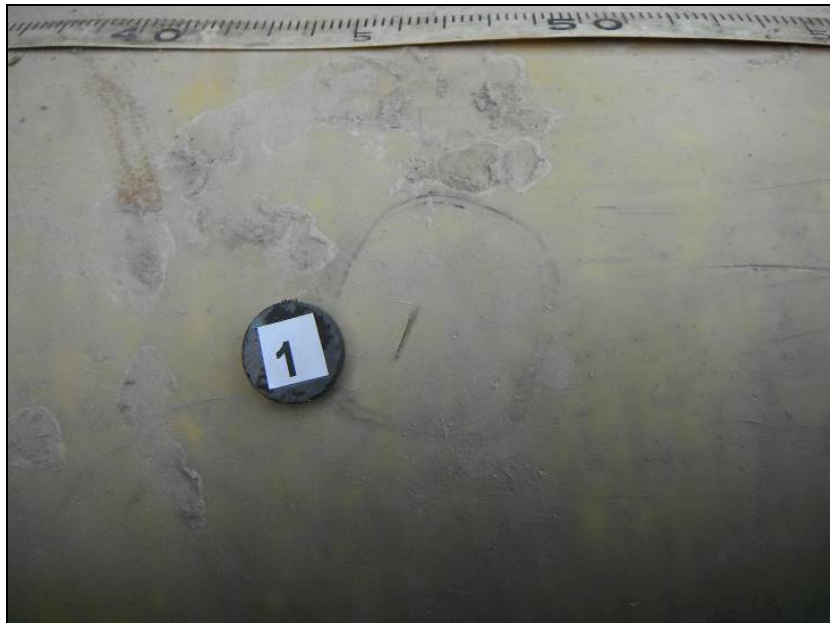
Except for the third-party damage, the coating at all dig sites was found in good condition, with superficial defects and no bare metal exposed to soil, as shown in Figure 6.

Figure 6: Sample of Superficial Defect at DE#2

However, the lateral gradient profiles at DE#1 and DE#2 clearly indicate holidays with 18.6%IR and 8.8%IR, respectively.

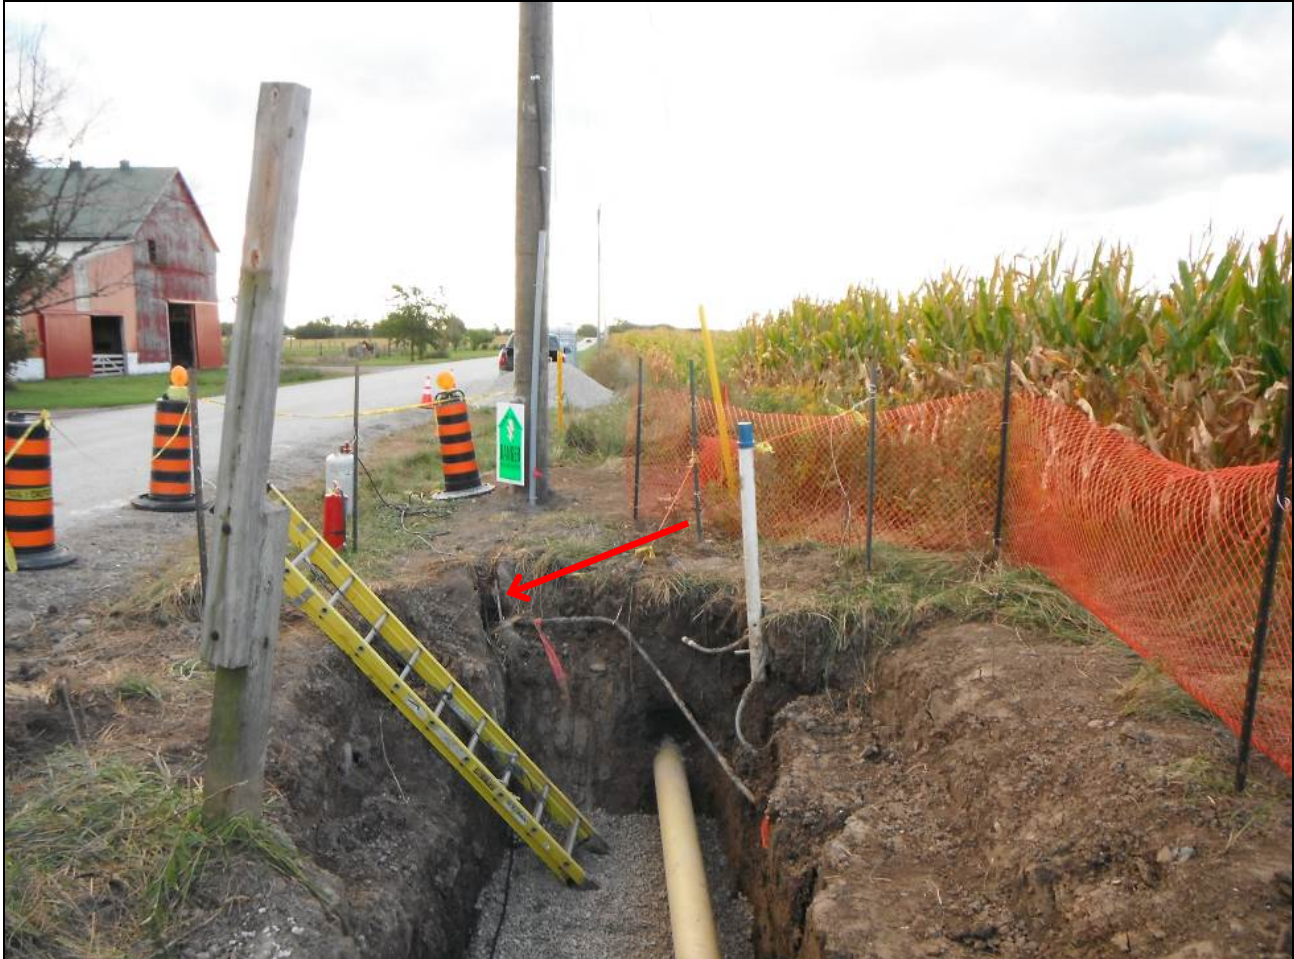
A buried grounding rod at a hydro pole was identified in one of the photographs showing the open excavation, as shown in Figure 7. Note that this hydro pole had been relocated prior to this excavation.

Figure 7: DE#2 Open Trench. Looking South. Buried Grounding Rod

Based on this additional information, the “apparent” DCVG indications were attributed to DC interference on the grounding rods. Cathodic protection currents were picked up by grounding rods close to the groundbeds, travelled via the ground conductors and were discharged at grounded poles located in the immediate proximity of the pipeline. This interpretation was confirmed by the fact that all the hydro poles with grounding (e.g. at transformers), and no other hydro poles, exhibited this behavior.

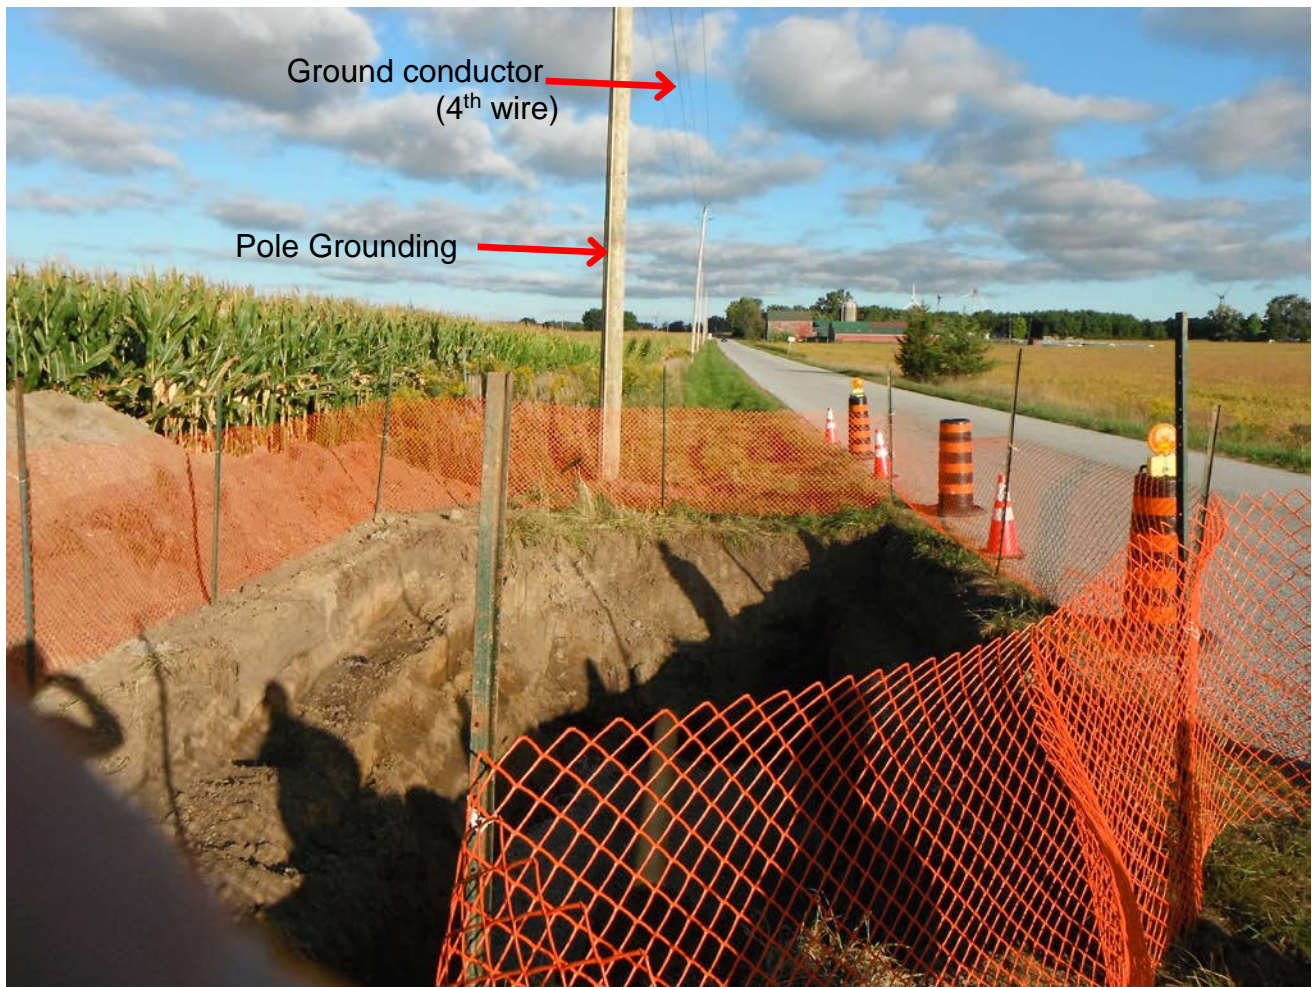
The grounding rods were interconnected via the fourth wire of the hydro line, as seen in Figure 8.

Figure 8: DE#1 Open Trench. Looking North. Powerline Ground Conductor and Pole Grounding

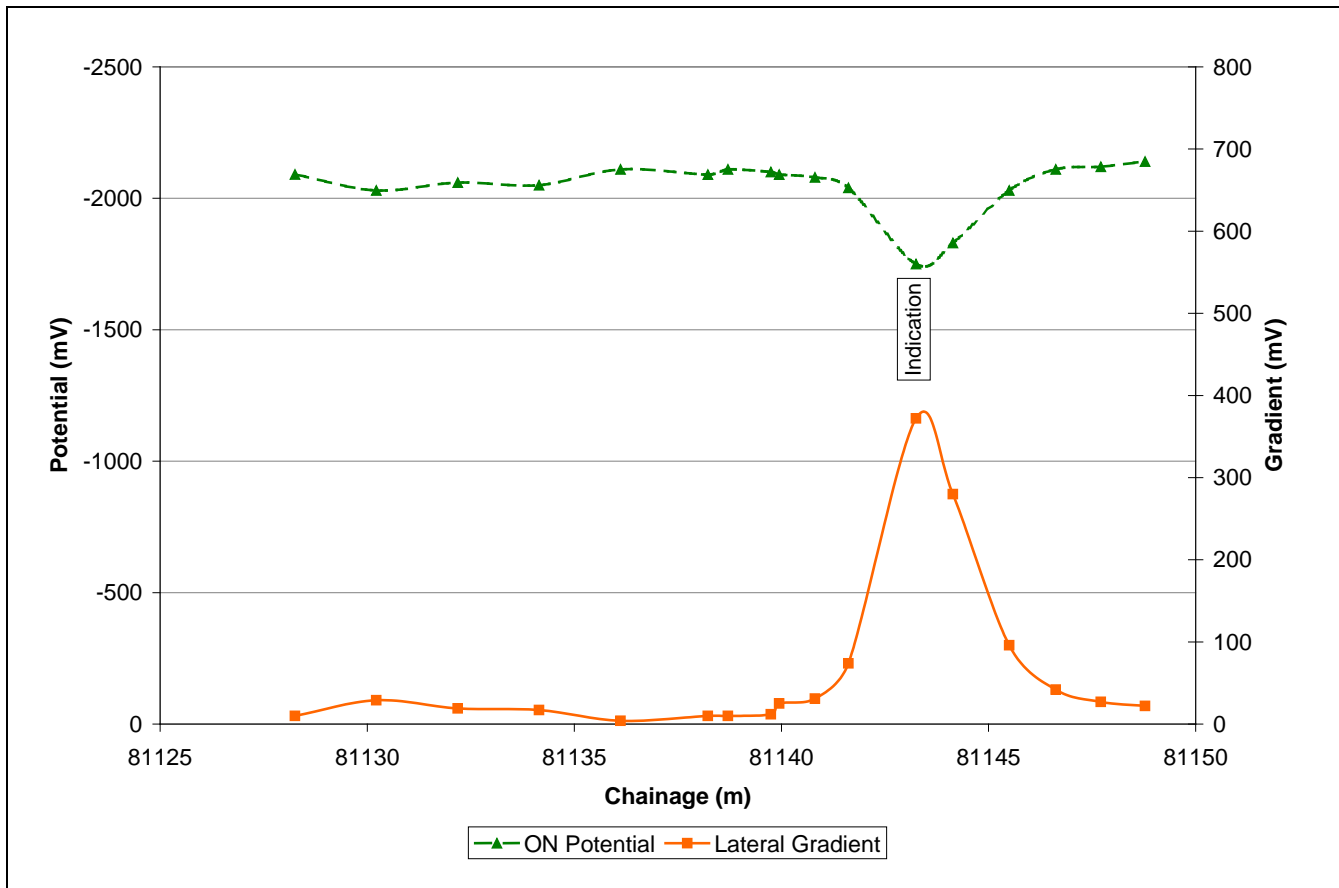
Figure 9: NPS16 Pipeline. 2004 CIPS/DCVG Integrated Survey Data

Just plotting the aligned CIPS and DCVG data on the same graph helps identifying and validating indications. For example, a drop in the ON potential in conjunction with an increase in the lateral gradient would always point to a coating holiday, as shown in Figure 9, reproduced from a previous presentation³.

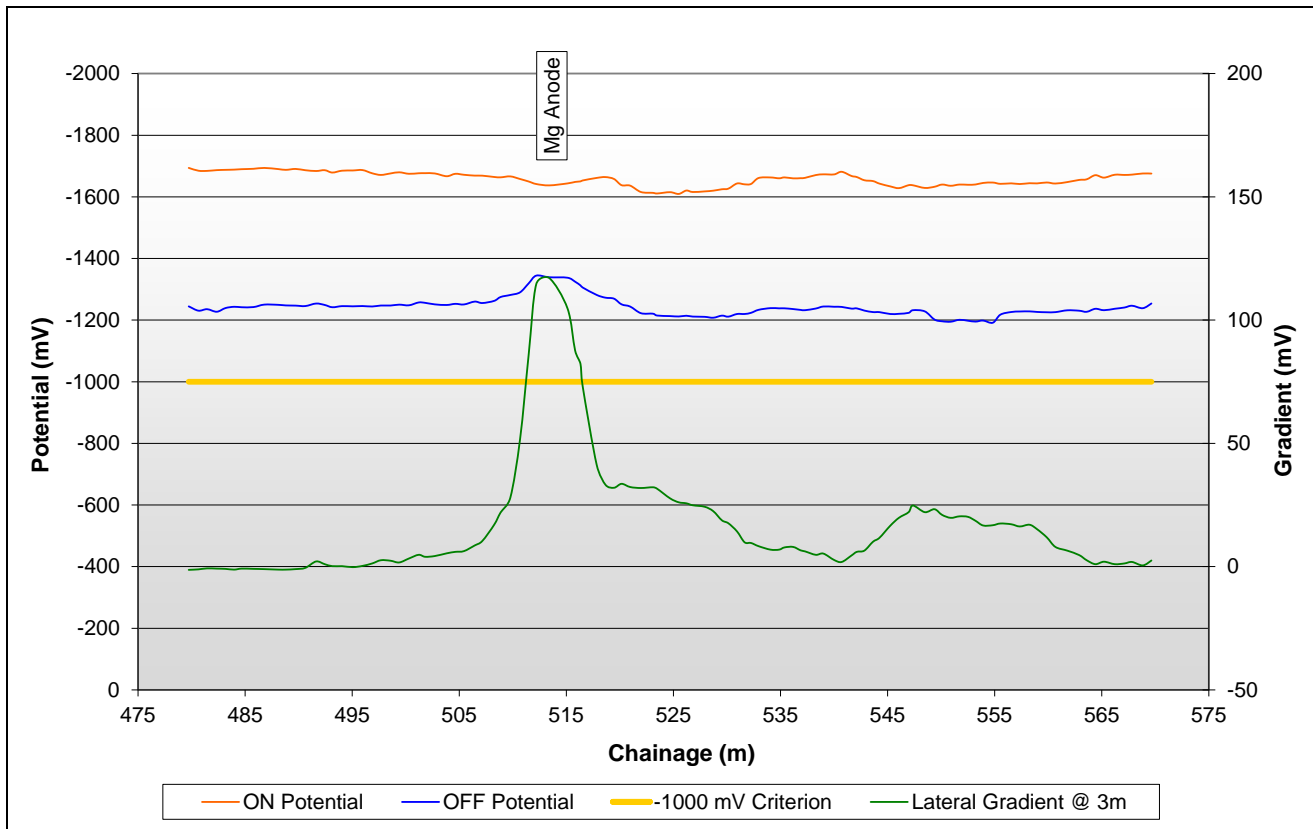
Similarly, an increase in the OFF potential in conjunction with an increase in the lateral gradient (see Figure 10) typically indicates a magnesium anode, but it also may be result of a holiday discharging equalization current, as discussed in a previous paper⁴.

Figure 10: Typical Profile of an Active Magnesium Anode

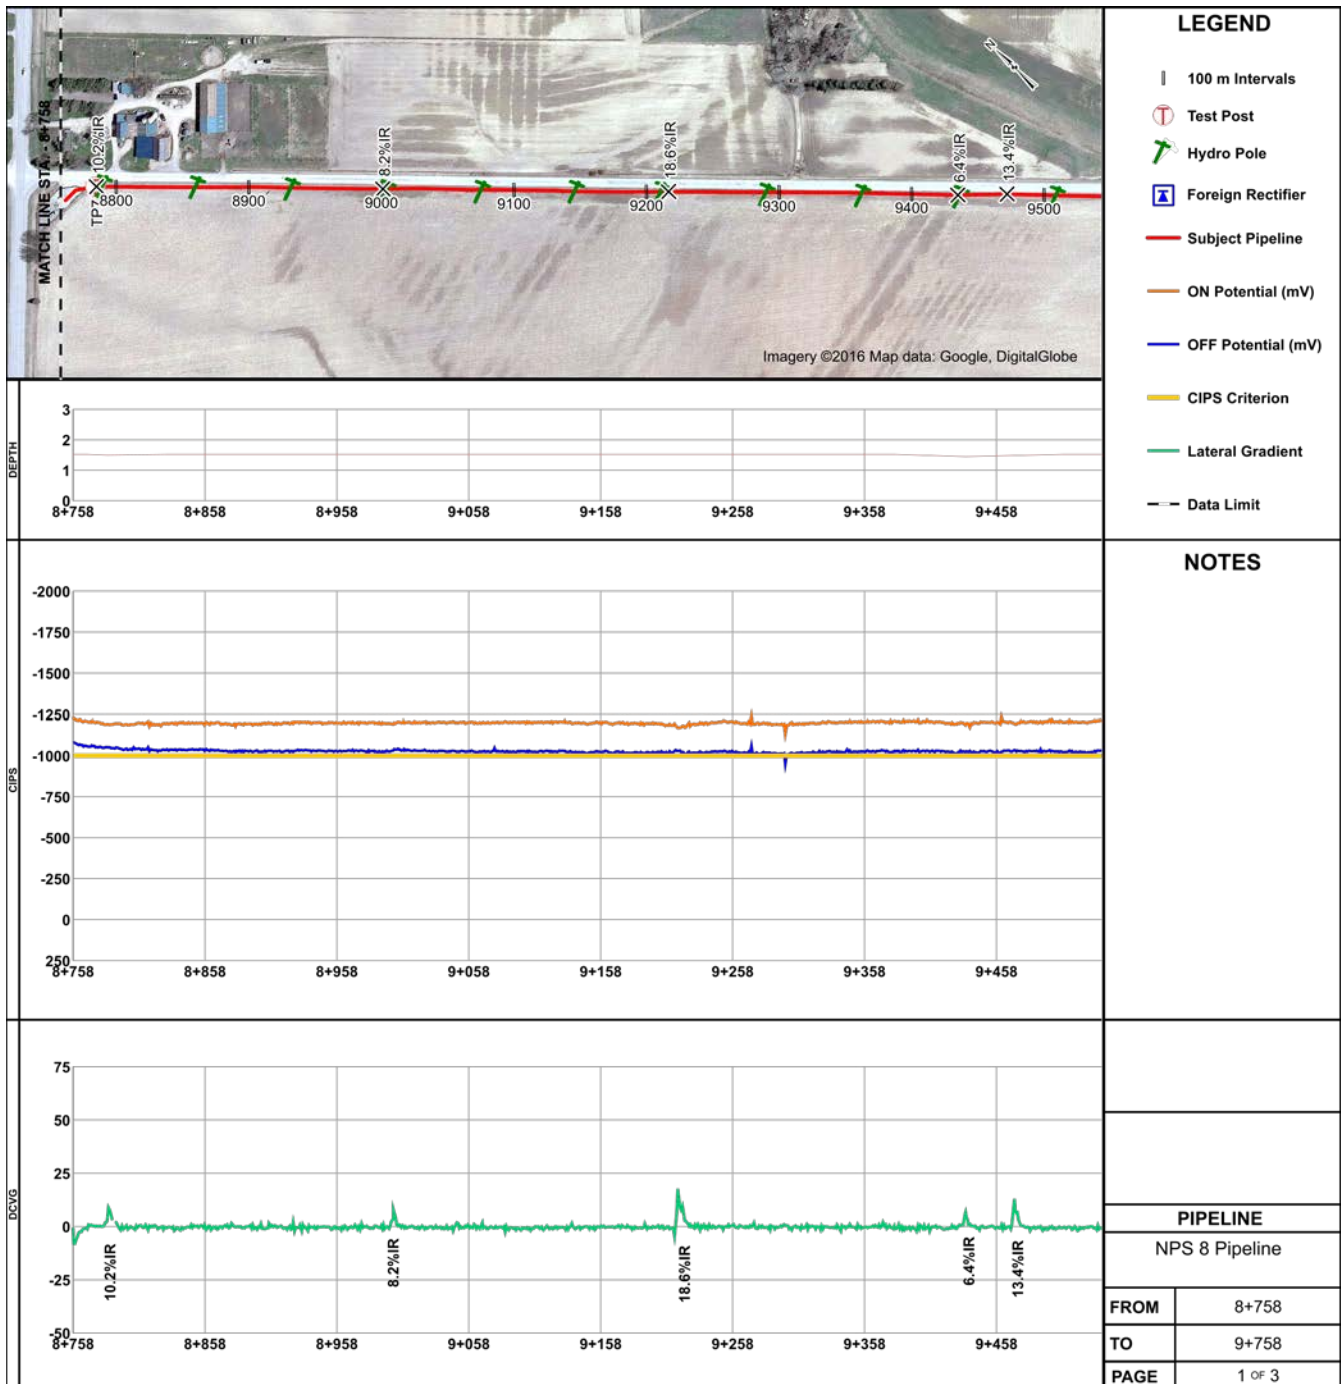
Figure 11: Ch. 8758 0 m to 9758 0 m. CIPS/DCVG Survey Results (New Format)

For comparison, Figure 11 displays the same survey data resulting in “apparent” DCVG indications as Figure 1. However, now the Hydro poles may be easily identified at the indication locations, as well as the road crossings, the type of terrain, the elevation, and the risks associated with excavating at the poles for direct examinations. The impressed current foreign rectifier responsible for the DC interference on the powerline grounding rods appears in the last graph (see Figure 12).
