# Improvements in the Use of Indirect Inspection Tools and Data Interpretation

S.M Segall, P. Eng. Corrosion Service Company Limited 9-280 Hillmount Rd. Markham, ON, Canada L6C 3A1

Cory Bradshaw, P. Eng. TransCanada Pipelines Limited 450 – 1st Street SW, Calgary, AB, Canada T2P 5H1

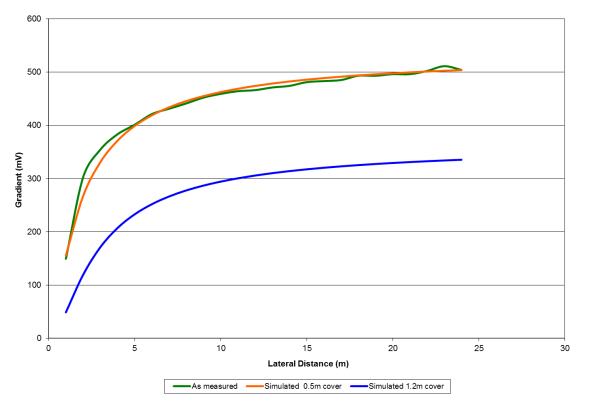
The gradient potential was measured at the holiday every meter until it stabilized and the results were plotted as shown in Figure 1 (green line).

Figure 1: Influence of Reduced Cover on Severity of a Coating Defect.

The measured gradient was then matched to a simulated gradient produced by a 50 cm<sup>2</sup> holiday with a 0.5 m cover (orange line). The gradient produced by the same sized holiday, but with the 1.2 m cover, was then calculated and plotted (blue line). The reduction in cover resulted in an increase of approximately 48% (160 mV) in the lateral gradient at 3 m. The %IR was adjusted accordingly, dropping to 40%.

The process was work intensive and using it at each holiday was not an option. As such, the proprietary formula was further developed to account for the pipe depth.

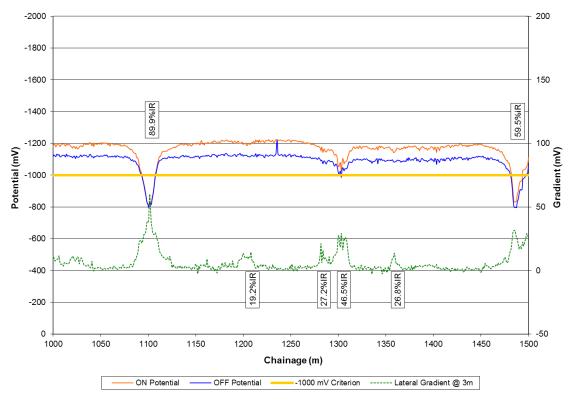
As the survey progressed in a rocky area, the pipe-to-soil potential ON/OFF shifts dropped below 20 mV and the calculated %IR reached values close to 90% (see chainage 1100m on Figure 2).

## Figure 2: CIPS/DCVG Profile in High Resistivity Area.

Although the calculation method had previously been tested in the field during several years of ECDA applications and had been found to give excellent results, it was never used where such small potential shifts were encountered. Installing a temporary groundbed to increase the shifts was not an option, since the high anodic gradients would have obscured the detection of the smaller gradients produced by the coating holidays. Subsequently, it was decided to validate the calculation method by actually measuring the lateral gradient and the total potential shift with respect to remote earth at two DCVG indications (i.e. chainage 1101.6 m and chainage 1485.7 m).

Using the regular practice of interpolating pipe-to-soil potentials measured to remote earth at adjacent test posts would have resulted in completely erroneous values, since the closest test posts were located in relatively low resistivity areas where the pipe-to-soil potential shifts were 230 mV up-stream and 136 mV down-stream.

To avoid errors in interpolating pipe-to-soil potentials measured to remote earth at test posts installed in areas with different soil conditions, it is recommended to either measure the value locally or use a calculation method which accounts for the local conditions.

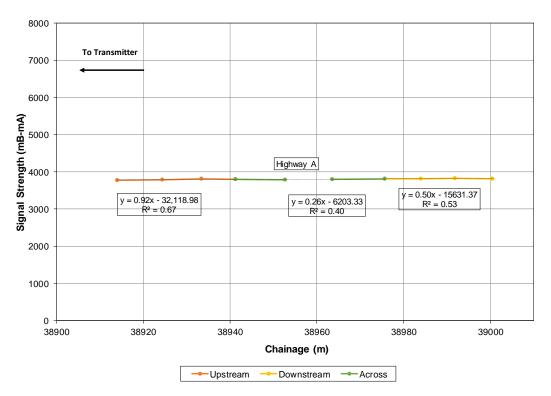
#### Figure 3: Highway A. AC Current Attenuation Data.

In this survey profile, the attenuation per meter is relatively constant along each section and does not exceed 1 mB/m. This is a typical result and indicates that the coating quality across the inaccessible highway section is similar to the coating quality along the upstream and downstream sections, where no DCVG indications were observed.

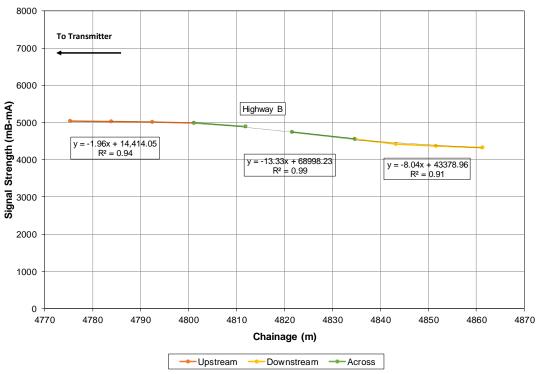
Figure 4: Highway B. AC Current Attenuation Data.

The survey profile at Highway B, however, has significantly higher attenuation across the highway than along the upstream and downstream sections. Notice also that although no coating defects were observed during the DCVG survey in the accessible regions adjacent to the highway, that the ACCA shows some variation in the attenuation even outside the actual inaccessible area. This is consistent with the ACCA being a macro tool and with the manufacturer's data interpretation guidelines.

The survey profile at Highway B is similar, indicating the existence of coating damage, along the inaccessible highway section.

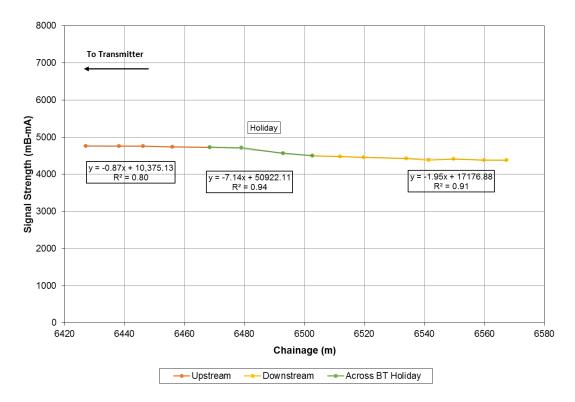
To evaluate the higher attenuation in terms of severity of indication, a profile was recorded at a known, accessible below threshold (BT) DCVG indication (i.e., 13.3%IR), as shown in Figure 5.

## Figure 5: Profile at 13.3%IR BT DCVG Indication for Comparison with ACCA profile.
