# Electrochemical Corrosion Control of AL-6XN<sup>®</sup> Super-Austenitic Stainless Steel Flue Gas Desulfurization Scrubbers

**Winston W. Shim, P. Eng.**  
Corrosion Service Company Limited  
2-498 Markland St.  
Markham, Ontario L6C 1Z6  
CANADA

**Tom Henderson, PE**  
Santee Cooper  
Moncks Corner, SC 29461  
U.S.A.

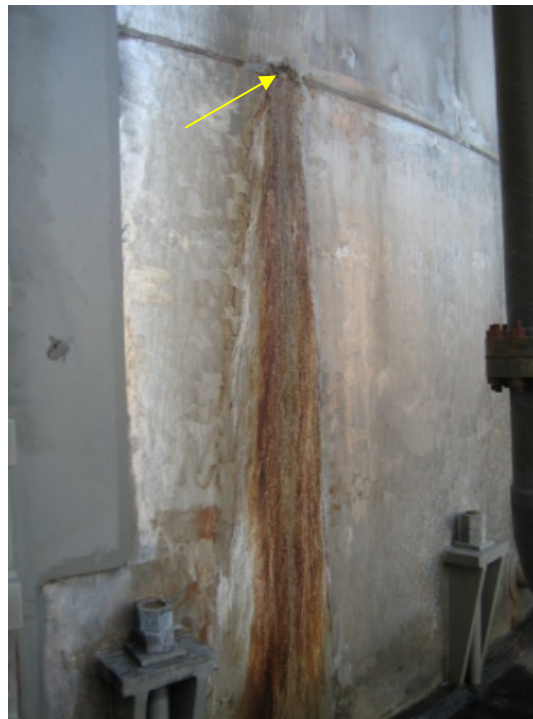
**Observations:** Within 18 months of putting the new scrubbers into operation, a through-wall penetration occurred in Unit #2 (Figure 1). The breach was close to the weld seam between the 1<sup>st</sup> and 2<sup>nd</sup> course from ground elevation and resulted in slurry leakage. Subsequent investigation pointed to pitting corrosion damage as being the cause. With an original 0.5625 inch wall thickness at that location, the corrosion rate is equivalent to 375 mils per year (mpy).

**Figure 1:** Through-wall corrosion damage after 18 months of putting a new scrubber into operation. Note brown staining below the damage.

Since the cause of damage could not specifically be linked to construction or operational issues but perhaps a combination of both, the logical solution was to incorporate a corrosion prevention system to prevent further damage. Following an exhaustive investigation, the management at Santee Cooper elected to use an electrochemical corrosion prevention system called PAP™ (also known as Potential Adjustment Protection™), supplied by Corrosion Service Company Limited (CSCL).

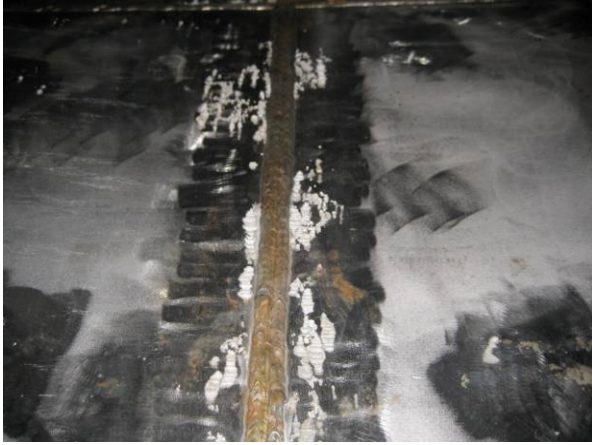
Subsequent internal vessel inspection of both units showed extensive pitting damage below the liquid level. Pitting above the liquid level was either not observed or very minimal. The pitting appeared to concentrate at the Heat Affected Zone (HAZ) but base metal corrosion was also observed (See Figures 2 and 3). These findings were unexpected given that the super-austenitic stainless steel was tested to be immune to corrosion damage within the operating specifications of the scrubbers.

**Figure 2:** Pitting damage on the side of a vertical weld seam after 18 months operation. Base metal pitting also visible at upper right area of photo.

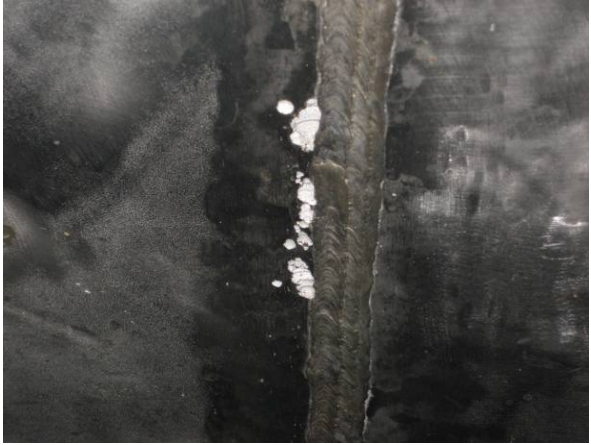
**Figure 3:** Closer view of pitting corrosion at Heat Affected Zone (HAZ) of weld.

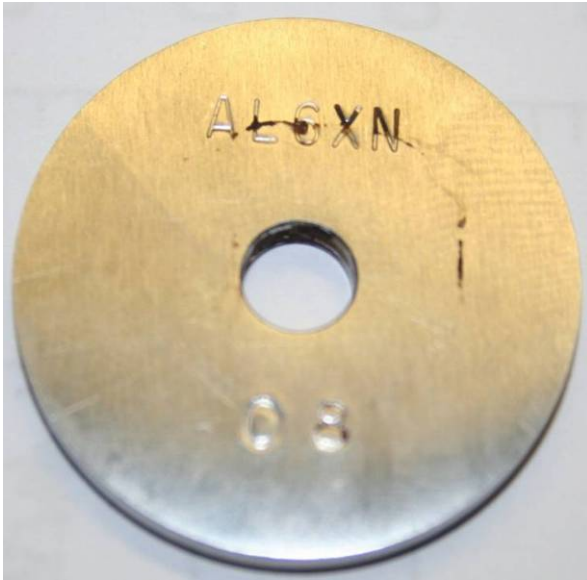
Figures 8a & 8b show the first set of coupons that were exposed for 15 days following installation of the corrosion prevention system. The coupons clearly indicated the benefits of PAP™. The unprotected (i.e. *control*) coupon showed deep pitting, while the protected coupon was pristine. The corrosion rate of the pit on the unprotected coupon, shown in Figure 8c, was approximately 240 mpy (i.e. 9.8 mils in 15 days). At this rate, the 0.5 inch thick scrubber wall would be penetrated in about 2 years, which is consistent with observations in Unit #2 which suffered penetration after 18 months.

**Figure 8a:** Protected AL-6XN coupon after 15 days exposure. No signs of corrosion. Brown lines are stains on coupon. Coupon dimensions: 1 ¼ inch dia.; 1/8 inch thick

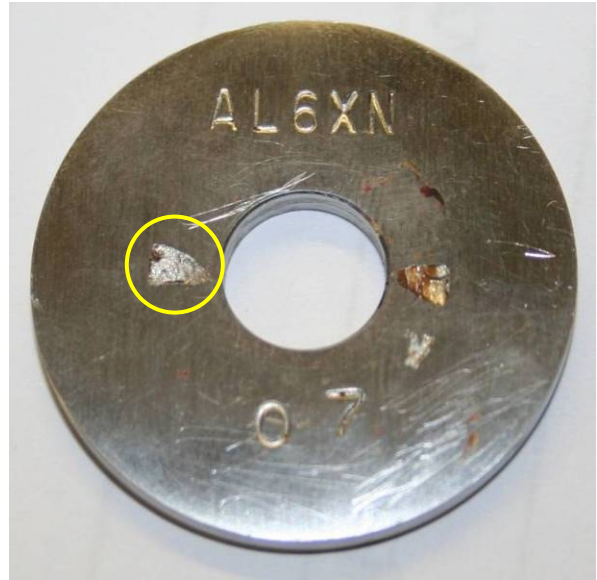
**Figure 8b:** Unprotected AL-6XN coupon after 15 days exposure. Three visible pits, with a maximum depth of 0.25 mm (250 mpy corrosion rate). Pit circled in yellow is magnified in Figure 8c.

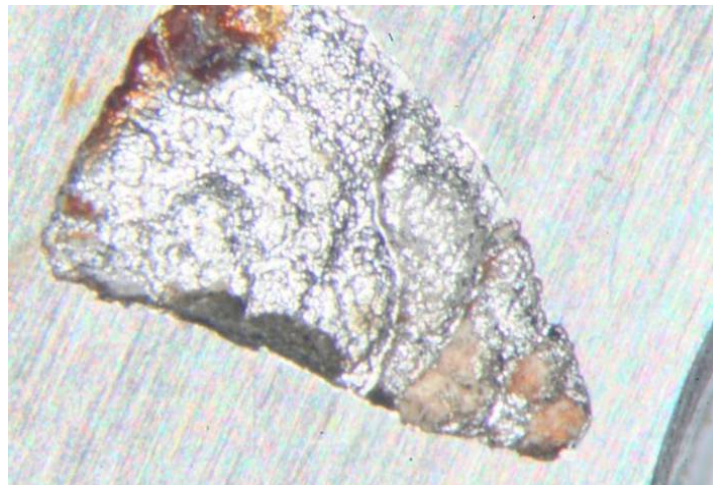
**Figure 8c:** Magnification of Pitting Damage encircled in Figure 8b.

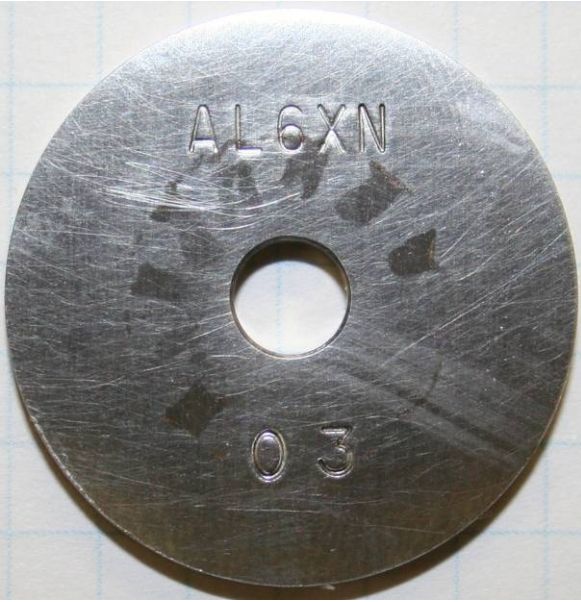
The coupons shown in Figures 9a, 9b and 9c were subjected to a 43-day exposure. These coupons, and multiple sets of other coupons utilized prior to the outage in 2010, exhibited similar results and led to the conclusion that the PAP™ system was indeed effectively protecting the scrubber as designed. Coupon monitoring is a very accurate and flexible method of determining the “protected” and “unprotected” corrosion rates of a vessel, in that exposure durations can be altered and an accurate corrosion rate still ascertained.

**Figure 9a:** Protected AL-6XN coupon after cleaning. Slight discoloration where staining and deposits were present; no crevices. 43 day exposure. Coupon dimensions: 1 ¼ inch dia.; 1/8 inch thick

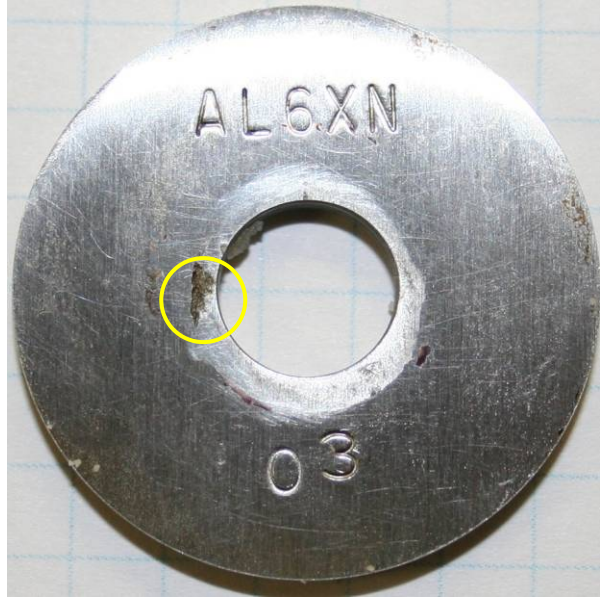
**Figure 9b:** Unprotected AL-6XN coupon cleaning. Stains largely eliminated, pits still visible. Pit circled in yellow is magnified in Figure 9c.

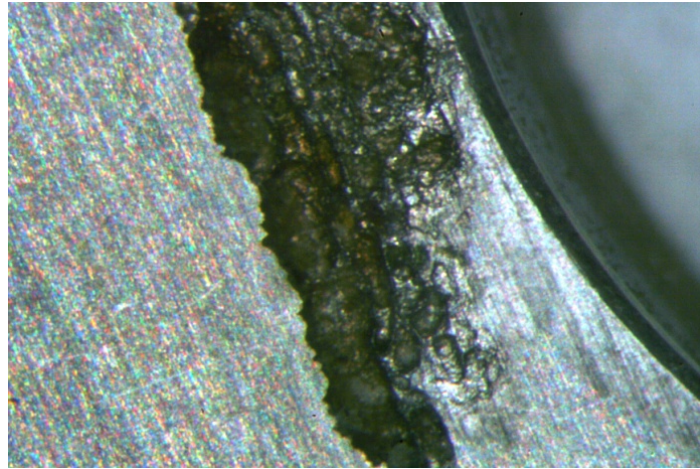
**Figure 9c:** Magnification of Pitting Damage encircled in Figure 9b.
