Remedial Testing and Cathodic Protection Design on a Deep Trenchless Crossing

Daniel Fingas
Corrosion Service Company Limited
9-280 Hillmount Road
Markham, Ontario L6C 3A1
Canada

Len J. Krissa
Enbridge Pipelines Incorporated
Enbridge Centre
10175 101 Street NW
Edmonton Alberta T5J 0H3
Canada

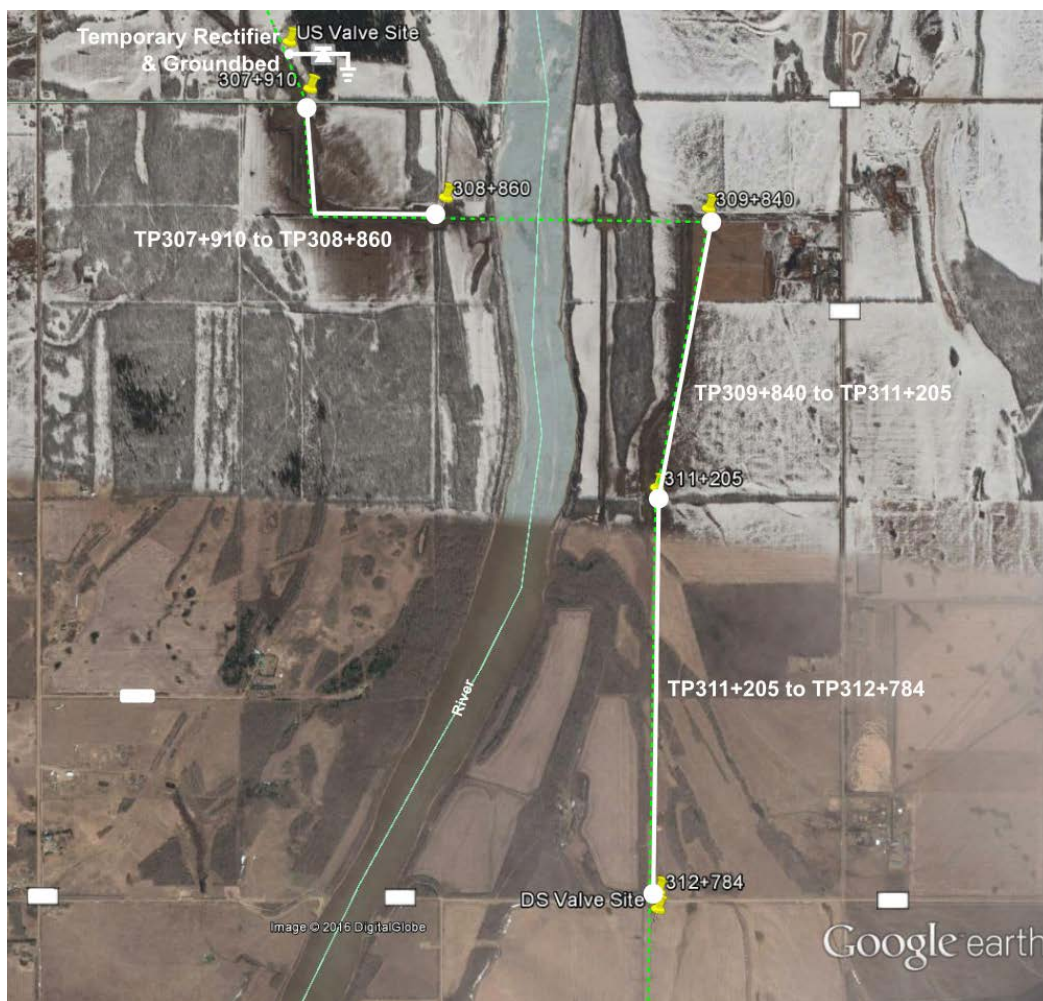
Figure 1: Test post and pipe configuration

The subject pipeline is a 2014 NPS 36 pipeline with the section of interest at a river crossing. The HDD span at the river crossing is 972 m long and the coating conductance test (based on the PRCI methodology) indicated the coating quality was very poor, with approximately 1.76% bare area. For comparison, testing performed on many trenchless crossings indicates less than 0.001% bare area.

A schematic of the pipeline is shown in **Figure 1**. The pipe itself is shown as a green dashed line, while the test posts are marked as chainages (in metres) and upstream (US) and downstream (DS) valves are also marked. After installation, the pipeline was protected by a remote impressed current cathodic protection (CP) system plus remedial magnesium anodes installed upstream and downstream of the HDD. The location of the temporary rectifier and groundbed at the US valve site is also shown.

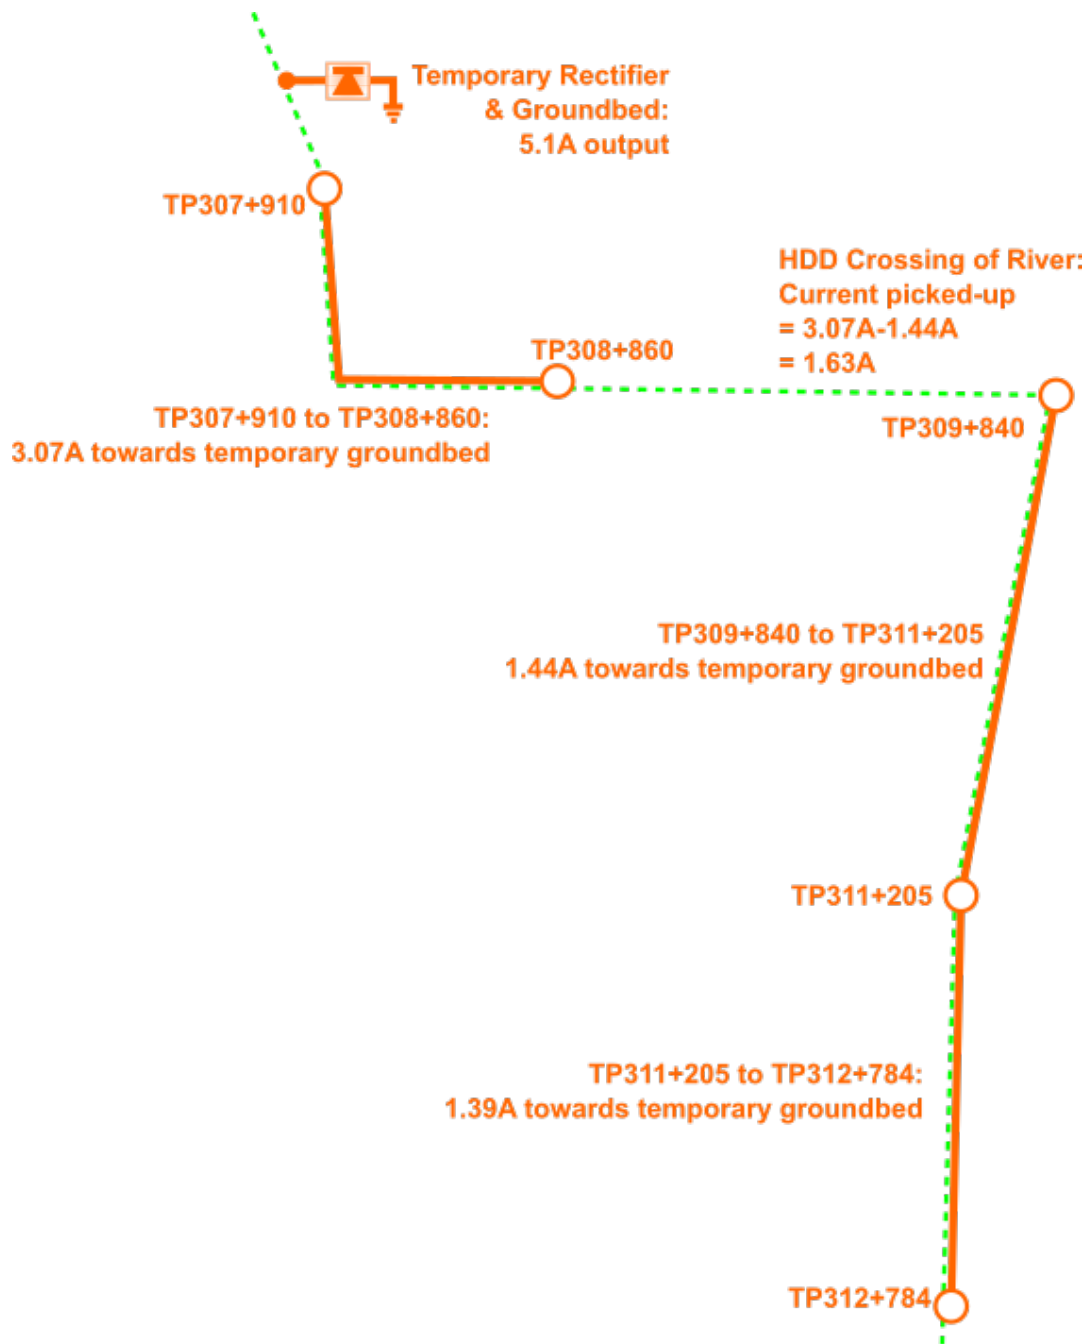
Figure 2: Explanation of Determining Current Pick-Up Along HDD

By subtracting the current in the section upstream of the crossing from the current in the section downstream of the crossing, the current picked-up along the HDD section can be estimated. This process is shown in **Figure 2** for the temporary rectifier case from **Table 2**.

Although the measurement from TP311+205 to TP312+784 is not required for calculation of the HDD current pick-up, it is included for verification purposes. As expected, it confirms that the change in current along a well-coated section is low.

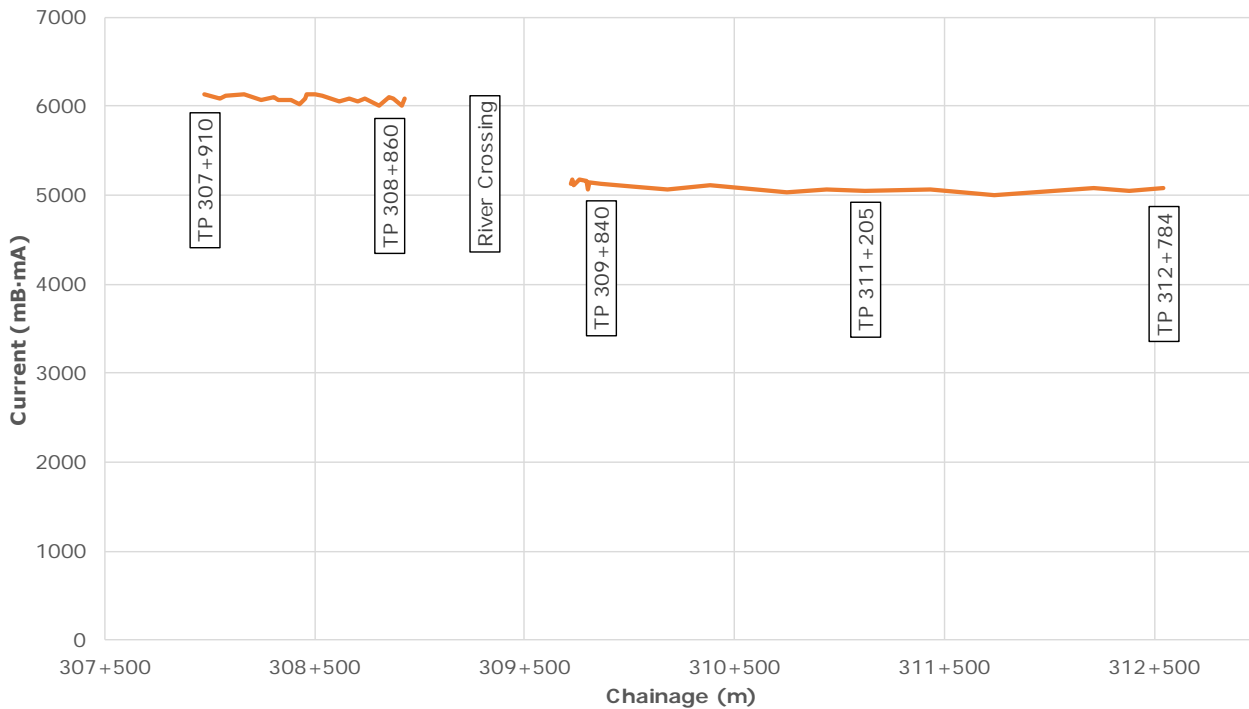
Figure 3: AC Current Attenuation Results

To confirm the assumption about good coating quality along these test sections, and to provide additional confirmation of the poor coating quality on the river crossing, an AC Current Attenuation (ACCA) test was performed.

As expected, the current upstream and downstream of the crossing was very stable, but the attenuation at the crossing was high. The actual attenuations are given in **Table 2** and the results are consistent with the expected poor coating quality based on the conductance test.

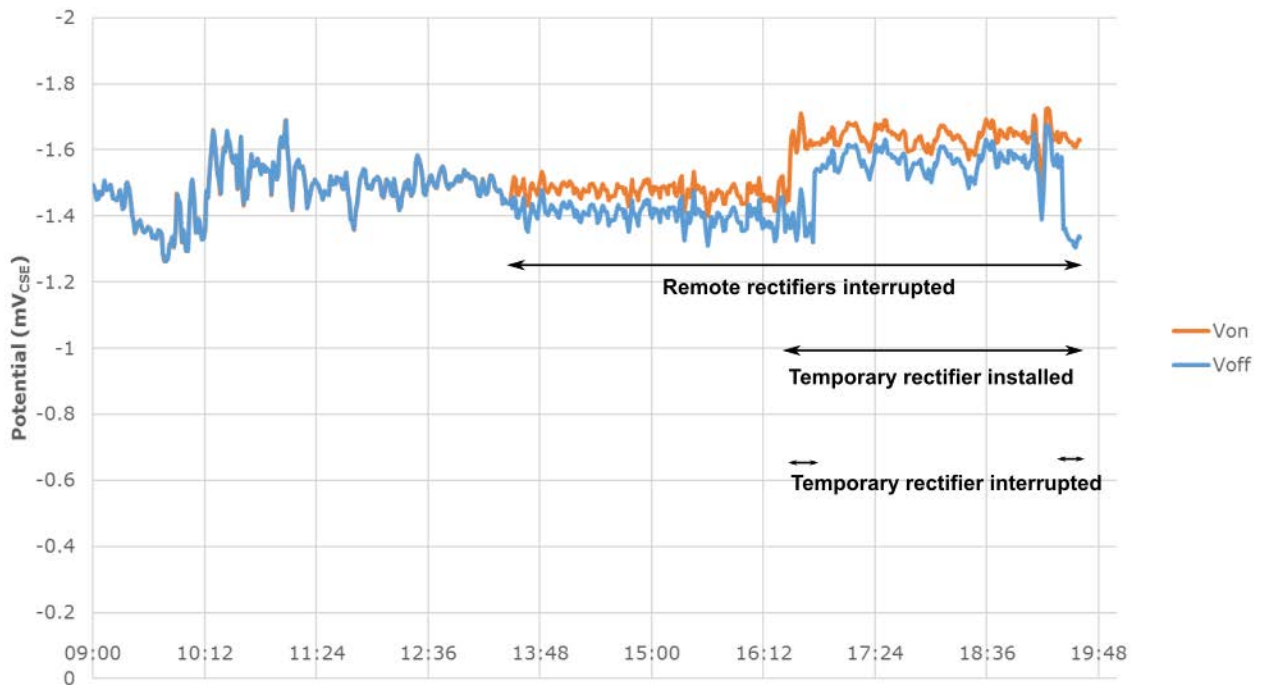
Figure 4: Telluric Activity During Polarization Testing (Recorded at TP 309+840)

A current requirement test was performed by recording the potentials on both sides of the river while energizing the temporary rectifier at 5.1 A. Unfortunately, due to long-term telluric activity (see **Figure 3**), it was not possible to determine the resulting polarization.

Note that the current requirement portion of the test, even if it had been successful, may not have been a reliable measure of the ability to polarize the pipe at depth in rock since a reference electrode at grade at the test post is most sensitive to protection levels at 'close' coating defects.

Follow-up testing was also recommended at a time when telluric activity was less significant to validate the current distribution findings and to determine whether the current distribution from a surface groundbed differs from the current distribution from a deep groundbed.
