THE EFFECT OF COPPER ON THE CORROSION OF IRON WATERMAINS

**Robert G. Wakelin and Robert A. Gummow
Corrosion Service Company Limited
369 Rimrock Road
Downsview, Ontario, Canada**

The data obtained from several municipal watermain corrosion studies in the Province of Ontario is presented. This data corroborates the findings of a previous study indicating that the galvanic couple formed by the connection of copper service piping to iron watermain is a principal factor controlling the watermain corrosion rates.¹ Soil electrical resistivity is found to be of major importance only where this galvanic couple exists. A simple means of estimating the integrity of a watermain based on soil resistivity and service type is also presented.

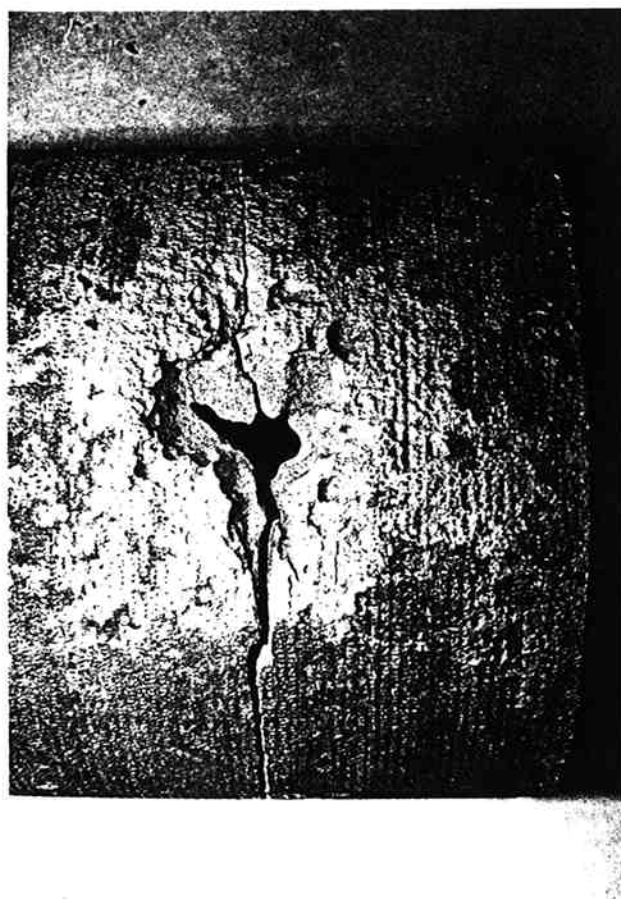
Figure 2 - Grey Cast Iron
Watermain Failure (After Sandblasting)

Although early studies had shown corrosion to be the principal cause of failures on iron watermain,^{2,3} this fact was not widely recognized by the waterworks industry until recently. The major reason is that in the case of grey cast iron piping, the iron corrodes leaving behind a hard but weak matrix of graphite flakes which retain the shape and appearance of the original pipe casting, thereby concealing the true extent of the corrosion damage. Figure 1 shows a failure on a 6" diameter cast iron pipe that was described in the repair records as being simply a circumferential break (ie. brittle fracture). After sandblasting the pipe to remove the graphitic corrosion product, the cause of this break is actually seen to be a corrosion perforation, from which the crack subsequently propagated (Figure 2).

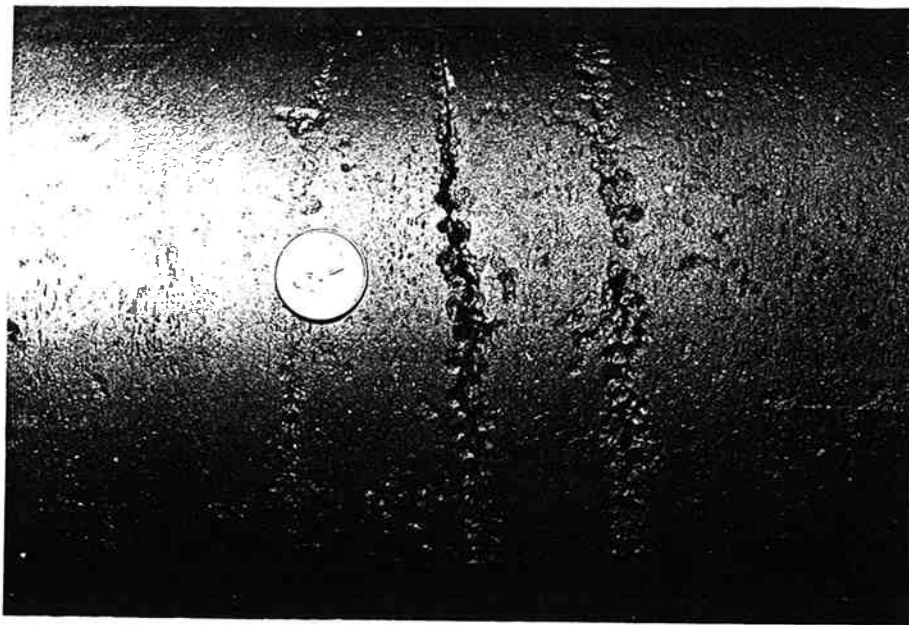
Figure 5 - Grey Cast Iron Watermain Break at Row of Concentrated Pits
