Using Electrochemical Protection to Prolong Service Life of Scrubbers and Associated Equipment

Presented at the NACE CORROSION/98 Conference (Paper No. 477)
San Diego, California, March 1998

This paper discusses an EP system that was recently supplied to an electric power utility company to protect a 316L thin metallic lined (wallpapered) FGD scrubber reaction tank. Acidic effluent from the absorber section of the scrubber is piped into this reaction tank for limestone neutralization and hence formation of calcium sulfate. Inspection of the protected reaction tank after one year of operation as well as in-situ coupon test results indicated that the EP system was very effective in mitigating localized corrosion of the scrubber reaction tank. The results are presented in this paper.

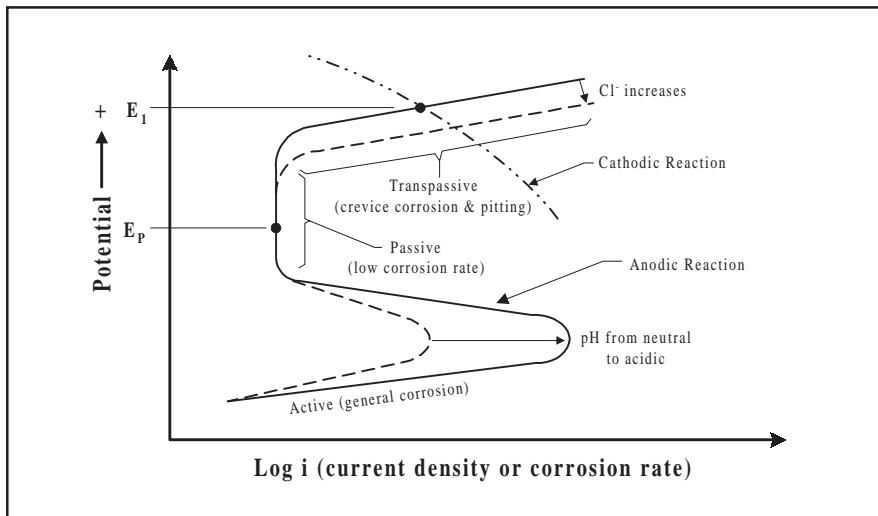
FIGURE 1 • Typical polarization curve showing the effects of pH and chloride. E_p is the protected potential and E_i is the potential where crevice corrosion and pitting occur.¹

protective layer on stainless steel may be determined by potentiodynamic polarization testing. The passive zone on the polarization curve represents the electrochemical conditions where neither localized corrosion nor active dissolution will occur (Figure 1). The

In oxidizing acid chloride environments, the polarization curve of stainless steel changes as follows (Figure 1):

- i) as chloride concentration increases, the width of the passive zone decreases and
- ii) as pH decreases from neutral to acidic, the active-passive transition becomes more pronounced.

Stainless steel in oxidizing acid-chloride environments will normally develop a solution potential (E_i) as depicted in Figure 1. By using a DC power supply, the potential of the metal can be moved electronegatively from its naturally occurring potential (E_i) to the passive region (E_p), repairing the passive layer and resulting in a reduction in localized corrosion.

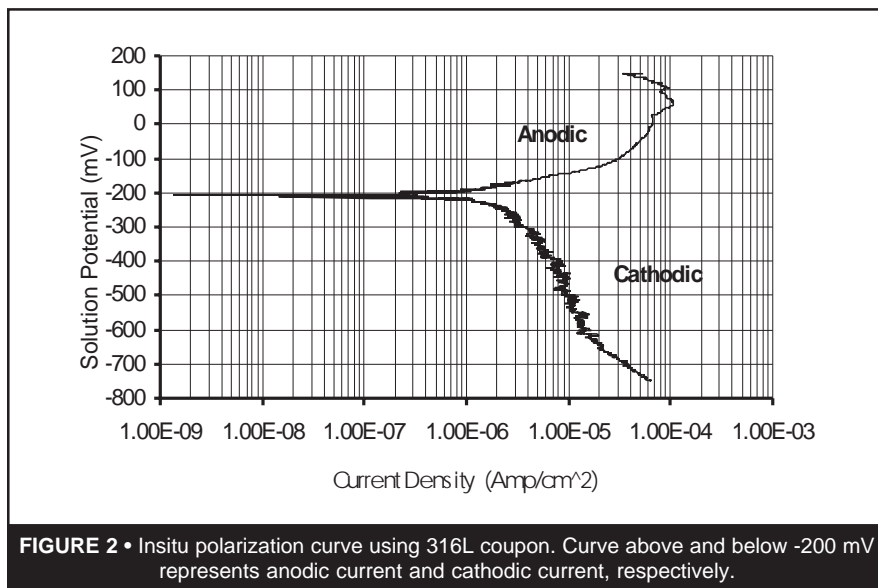
Polarization curves were performed insitu to characterize the operating electrochemical conditions. A typical curve is shown in Figure 2. As previously discussed, application of a cathodic current to the reaction tank will shift the potential in the electronegative direction from the transpassive to the passive region. The curve shown

is a composite of the anodic and cathodic polarization curves. The anodic portion of the curve represents metal oxidation. The oxidation reaction may be represented by the dissolution of iron (steel) as:

The cathodic portion of the curve represents the reduction reaction which is dependent on potential and electrolyte conditions. A possible cathodic reaction would be the reduction of dissolved oxygen (O₂) to hydroxyl (OH⁻) ion.

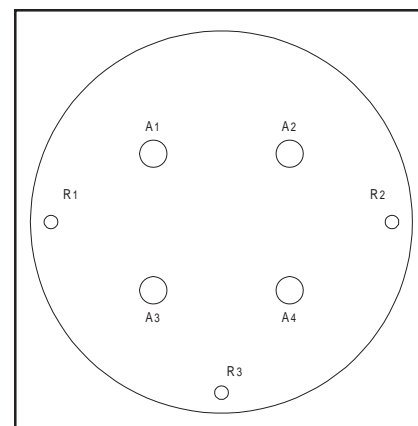
FIGURE 3 • Plan view of EP system anode and reference electrode arrangement on tank roof. This particular system depicts four anodes, A1 to A4, and three reference electrodes, R1 to R3.

minimize DC cable lengths and keep the unit in a low traffic area, it was mounted on the reaction tank roof (Figure 3).

Anodes and reference electrodes were inserted from the tank roof in a symmetrical design. The vertical anode configuration provides more uniform current distribution to the vessel walls (Figures 3 to 6).

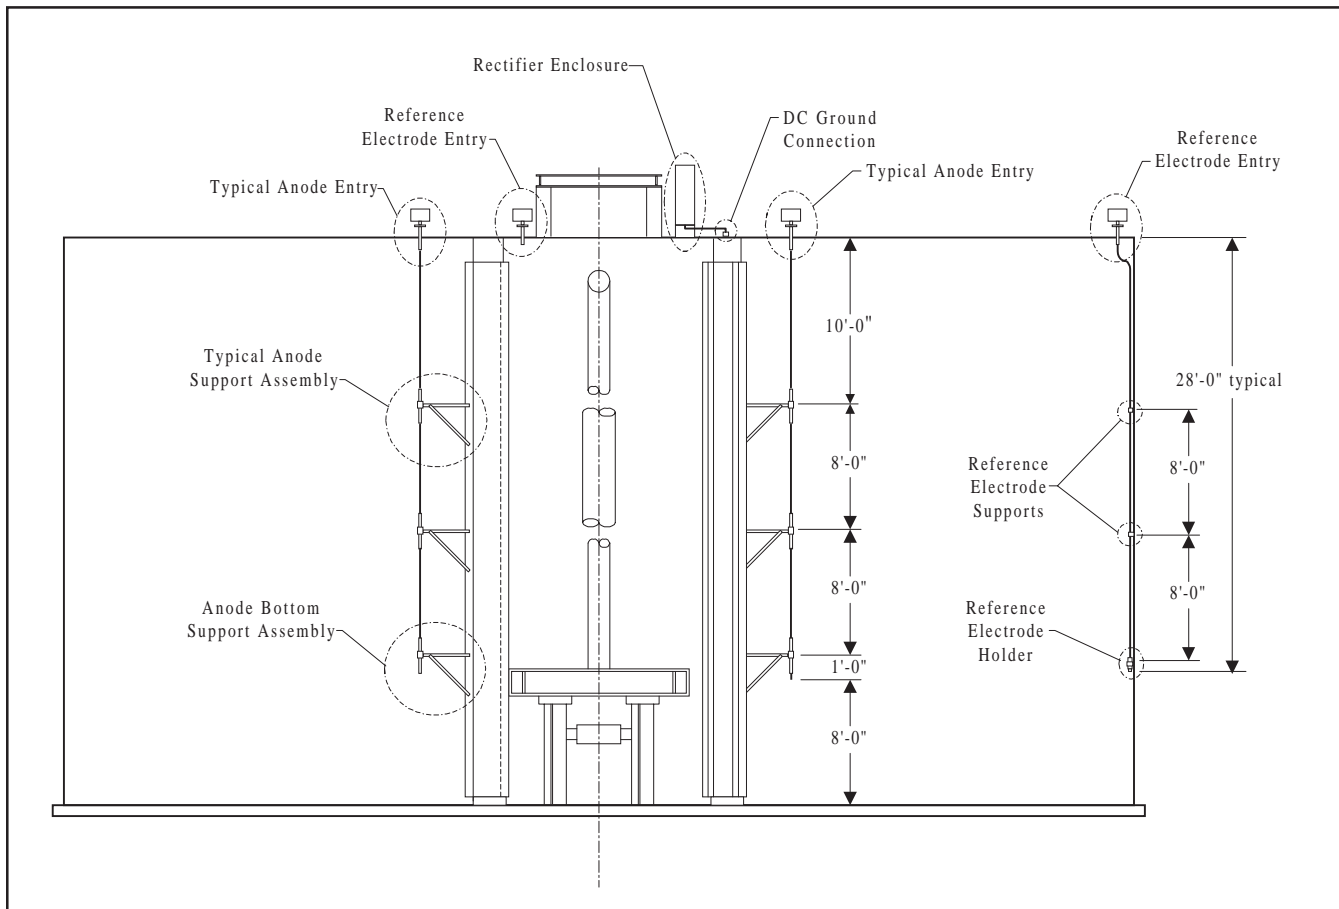
FIGURE 4 • General (EP) System Anode and Reference Electrode Arrangement in Reaction Tank

The positive output of the current source is connected to the anodes while the negative output is connected to the tank. One of the reference electrodes supplies a feedback potential to the current source. The current source operates in potential controlled mode. When the target potential is reached, the current source will automatically reduce current output to maintain the target potential in the passive zone of the metal. The additional reference electrodes are used as a cross-check and backup to the feedback probe.

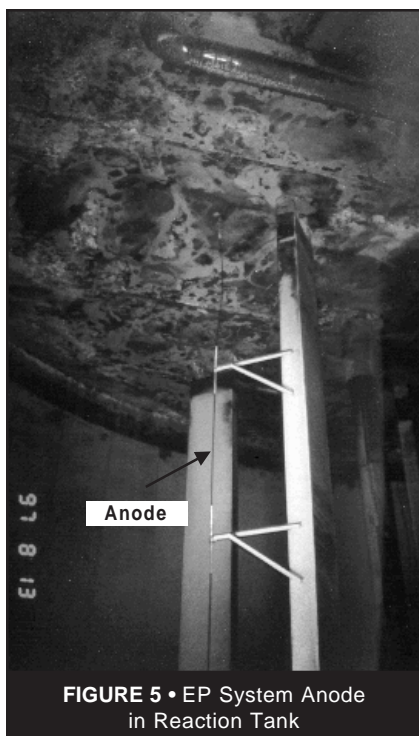
FIGURE 5 • EP System Anode in Reaction Tank

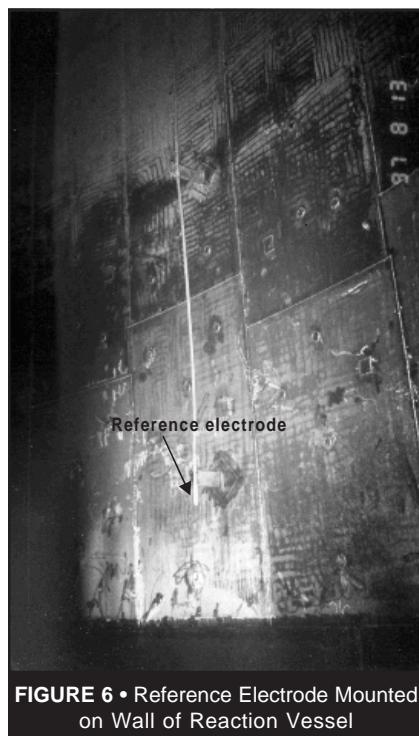
FIGURE 6 • Reference Electrode Mounted on Wall of Reaction Vessel

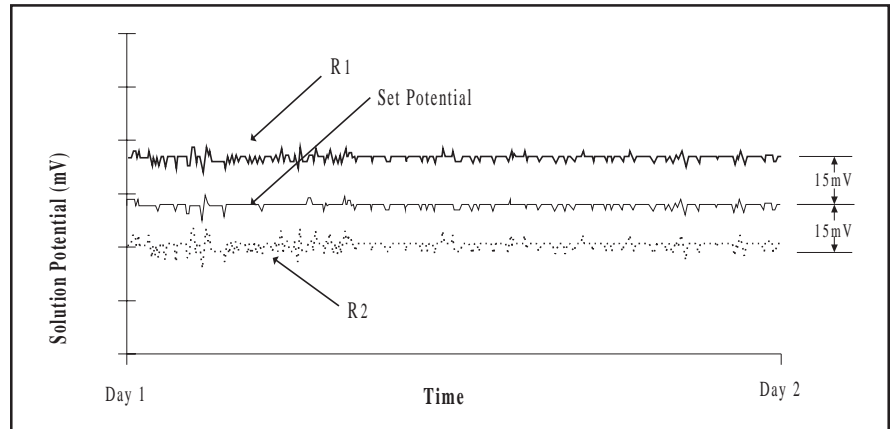
FIGURE 7 • Remote Monitoring Output Trending EP System Current and Voltage Over a Two Day Period

The RMU2 is housed inside the same cabinet as the current source and is supplied with state-of-the-art customized firmware that is programmed to the individual client's needs. Via a standard telephone line connected to the RMU2, the supplier monitors critical operating parameters of the system and immediately notifies the customer in the event of malfunction. Information from the RMU2 may also be accessed by customers using a PC operating Microsoft Windows®, a modem, and a custom software package. Figure 7 depicts a typical monitoring report.

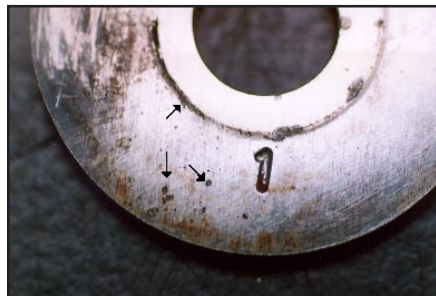
FIGURE 8 • Isolated 316L coupon (control) shows signs of crevice corrosion at the edge where a non-metallic washer was located. The crevice corrosion resulted in a ring above the stamped number “1” as indicated by uppermost arrow. Scattered pitting is shown by the two lower arrows.

Another coupon set with a new holder was installed in January, 1997. In April, 1997 the coupons were retrieved and the customer reported that a black film was visible on the protected coupon. After cleaning off the black film, no sign of pitting was visible at 30 X magnification. A small amount of crevice corrosion was detected on the protected coupon. The isolated coupon showed severe crevice corrosion under the isolation

washer and scattered pitting on the surface. The coupons were reinstalled and retrieved again in July, 1997. No noticeable difference was apparent from the exposure from April to July, 1997 (Figures 8 and 9.)

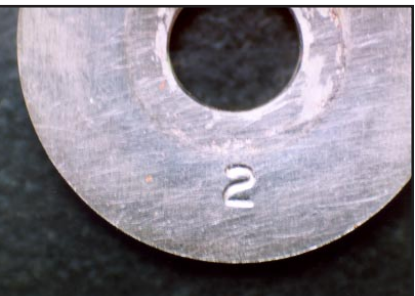
FIGURE 9 • 316L coupon protected by EP system shows no signs of pitting corrosion after exposure in scrubber neutralization tank from January to July, 1997. Small amount of crevice corrosion was visible at the location where isolation washer was situated.

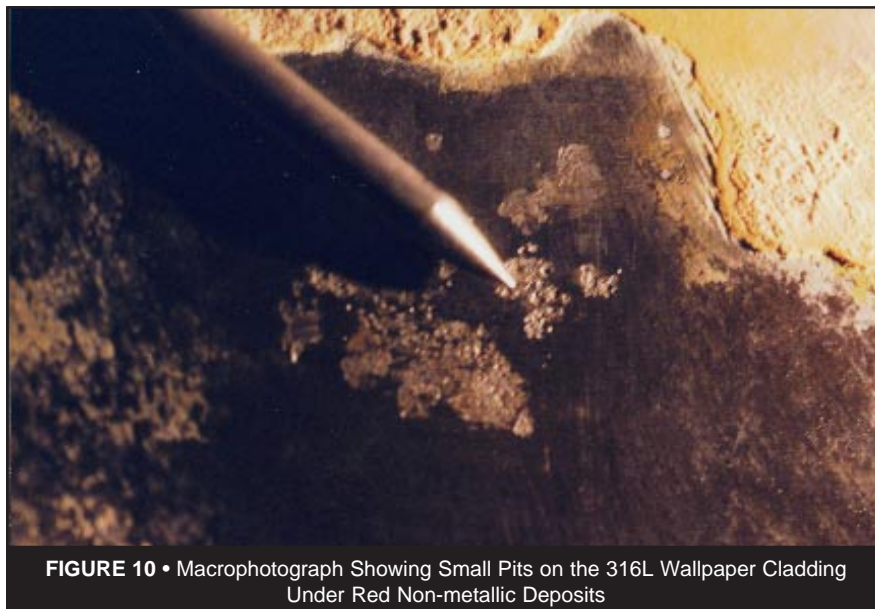
FIGURE 10 • Macrophotograph Showing Small Pits on the 316L Wallpaper Cladding Under Red Non-metallic Deposits

As no high chloride containing liquid was detected, the internal thin metallic wallpaper was known to be intact. The tank was shutdown for inspection during August, 1997. Information received from the plant personnel indicated that very little repair was required, however, there were some areas on the stainless steel lining with reddish non-metallic deposits. Shallow pits were found beneath these deposits (Figure 10.)

Although the amount of red deposits, and resulting pitting, was relatively small, it was still a concern. Plant personnel assumed the source of red deposits to be steel filings from steel balls used to crush the limestone. The steel filings and the limestone are screened to -350 mesh and fed into the reaction tank. The suspension is mixed with the acidic scrubber effluent and neutralized in the tank. During this mixing with the agitator, the surface of the stainless steel wallpaper operates under very abrasive conditions. This abrasion also enhances pitting because it destroys the passive layer on the stainless steel and allows pitting to proceed.

A literature search^{7,8} indicated the possibility of thiosulfate ($S_2O_3^{2-}$) interaction causing pitting of stainless steel. The source of the thiosulfate may be a number of reactions of the sulfur compounds present. The general consensus from the literature is that by moving the potential another 150 mV in the electronegative direction, the pitting will be eliminated. The success of this change should be known sometime in 1998.
