## **Equalization Currents and Metallic IR Drop: Impediments to True Potential Measurements**

Daniel Fingas  
Corrosion Service Company Limited  
9-280 Hillmount Road  
Markham, ON, L6C 3A1  
Canada

### **ABSTRACT**

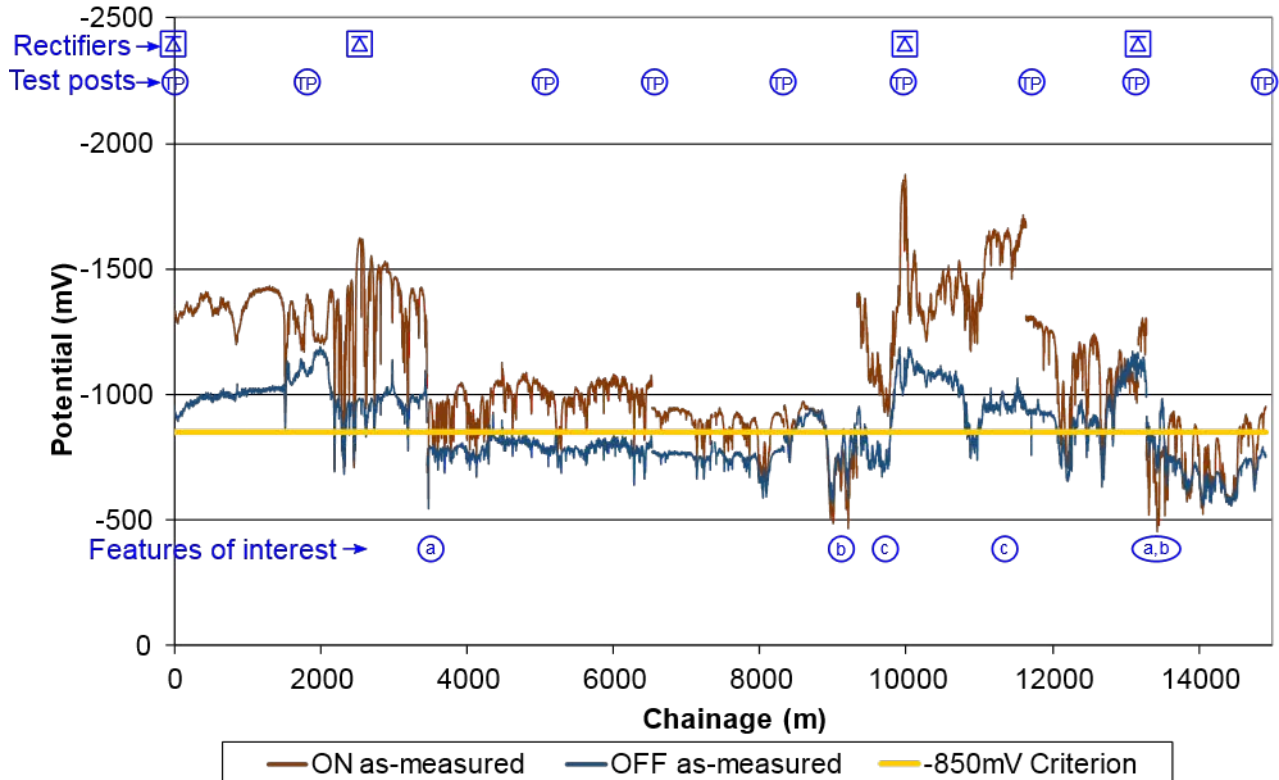
**Figure 1: As-measured close-interval potentials on an NPS 12 pipeline.**

Figure 1 shows an example of a dataset collected on a 15-km section of a pipeline where these effects were found to be significant. Along most of this section, this 1950's era NPS 12 pipeline runs alone in the right-of-way and all influencing rectifiers that could be identified were interrupted. Rectifiers and test posts are shown for reference.

- Discontinuities (i.e. sudden changes) in both on-potentials and off-potentials at changes in connection points (generally tests posts), such as chainage 3.5 km and chainage 13 km: (a)
- Off-potentials more electronegative than on-potentials near chainage 9 km and chainage 13 km, which is typically indicative of DC interference: (b)
- Without changing connection point, on-potentials initially decreased then showed a noticeable increase again as the surveyors moved away from rectifiers, such as moving upstream and downstream from the rectifier at chainage 10 km: (c)

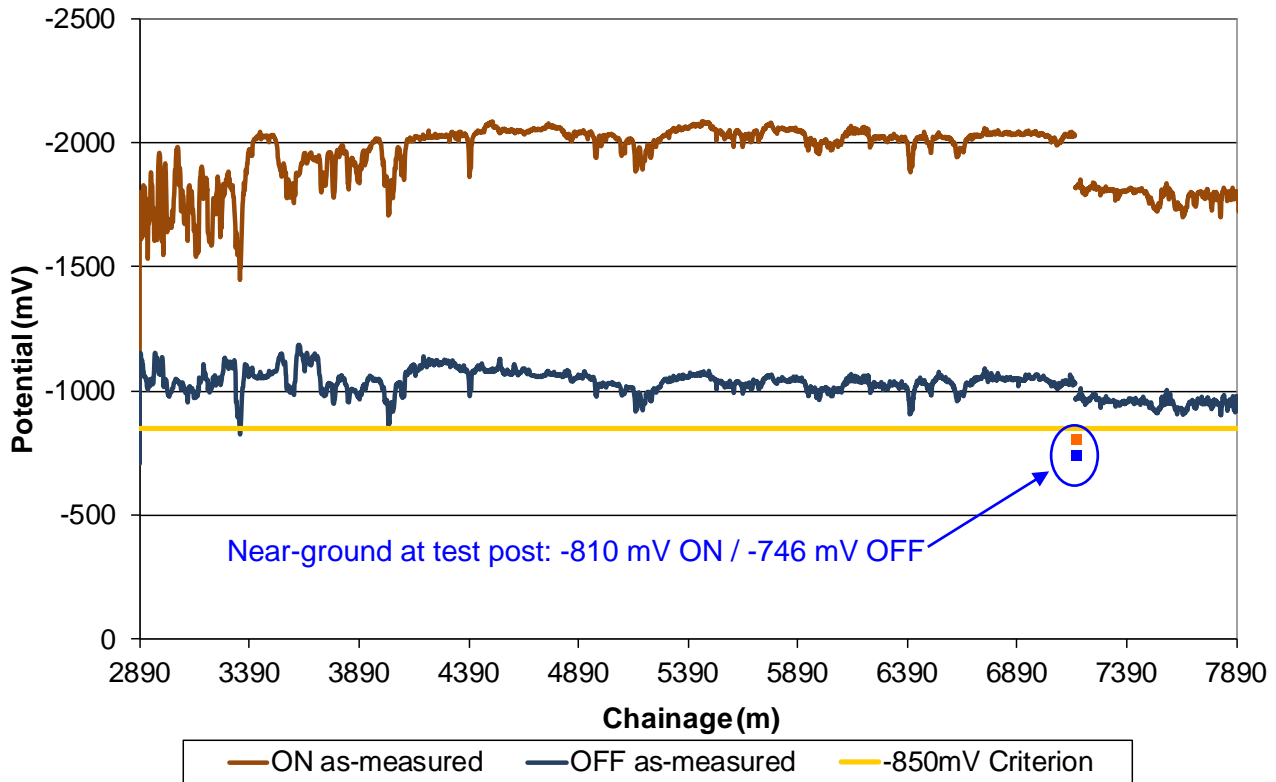
**Figure 2: As-measured close-interval potentials on an NPS 4 pipeline.**

A close-interval survey on an NPS 4 pipeline of similar vintage showed some of the same features, but in a less exaggerated way, as shown in Figure 2. In this case, the surveyor started surveying in the downstream direction and arrived at a test post at chainage 7.1 km. Upon measuring near-ground and far-ground potentials at the test post, the potential shift was observed to be very different (64 mV instead of 1000 mV) and both the on- and off-potentials differed by more than 200 mV, although the

alignment sheets indicated there was a test post located there. The surveyor made a field judgement that the test post was broken and went to the next downstream test post and surveyed back to this location, with the results shown on the same figure. In this case, the difference in the off-potentials was relatively small, and the difference in the on-potentials appeared much more reasonable, as shown.

However, when the data was reviewed in the office, the potentials on the test post could not be explained as there was no foreign crossing reported at this location. The pipeline owner mobilized quickly to correct the deficiency of only a single lead at this location, and it was found that the initial short lead reading was indeed the correct potential measurement at this location.

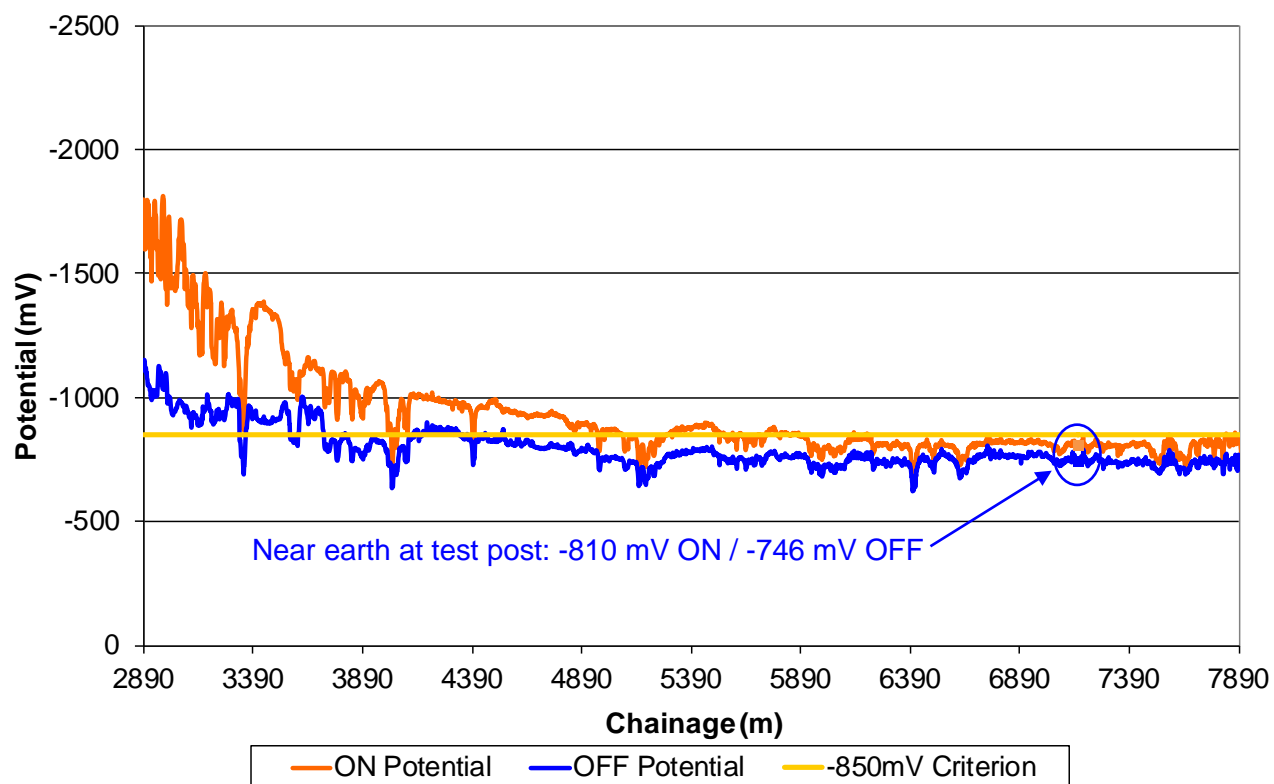
**Figure 5: Close-interval potentials from Figure 2 compensated for metallic IR-drop.**

Figure 5 shows the compensated data for the case introduced in Figure 2. The measured parameters are tabulated in Table 1 assuming a steel resistivity of  $18 \mu\Omega\cdot\text{cm}$ . As the pipe had widespread coating degradation, an exponential current attenuation was used to calculate the IR-drop rather than a constant/average current, but this average pipeline current was calculated and included in the table as a reference point.

Two notes of caution: first, because the compensation forces the potentials to match the values recorded at test posts, it is important not to automatically assume that matching potentials on the graph are equivalent to correct compensation; second, the linear approximation must not be applied when there is a rectifier connection but no accessible test lead between two test posts where a metallic IR-drop measurement is recorded.

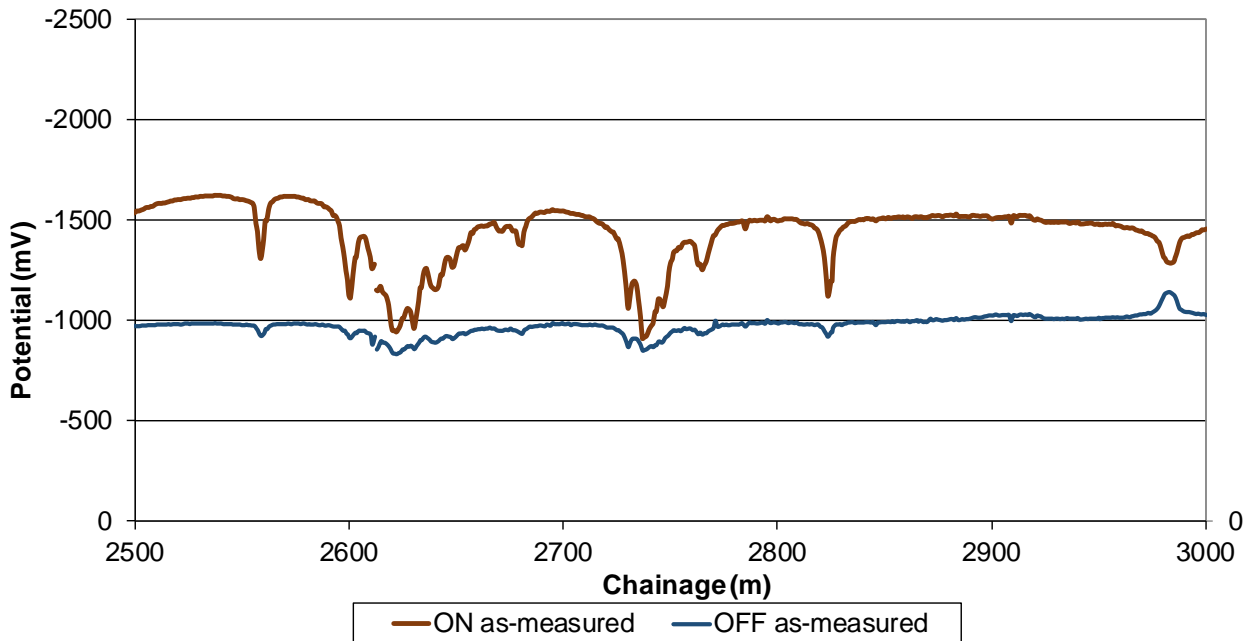
**Figure 7: CIPS data from NPS 12 pipeline on section impacted by equalization currents.**

Figure 7 shows a close-up of the CIPS data collected on the NPS 12 impacted by equalization currents.

The dips in on-potentials are typical for locations with coating defects. The characteristic dip shape results from the soil IR-drop being reduced as the surveyor approaches a coating defect, then being increased as the surveyor moves further from the coating defect. This type of IR-drop effect results from a coating defect picking up CP current.

The presence of a residual current during the off-potential measurements is confirmed for the coating defects between chainage 2550 and chainage 2850 by the presence of similar, but smaller, dips. In other words, during the off-potential measurements these coating defects continue to receive CP current and the true protection levels are more electropositive than the off-potential measurements.

At the indication near chainage 2980, however, the on-potential dips in the normal way, but the off-potential actually peaks at the indication. This electronegative peak shape is typical of magnesium anodes and results from current discharge.<sup>7</sup> The true protection level is between the off-potential measurement and the on-potential measurement. Note that although this isolated case could be attributed to a partially consumed magnesium anode, other locations with this characteristic have been excavated and confirmed to be coating defects.

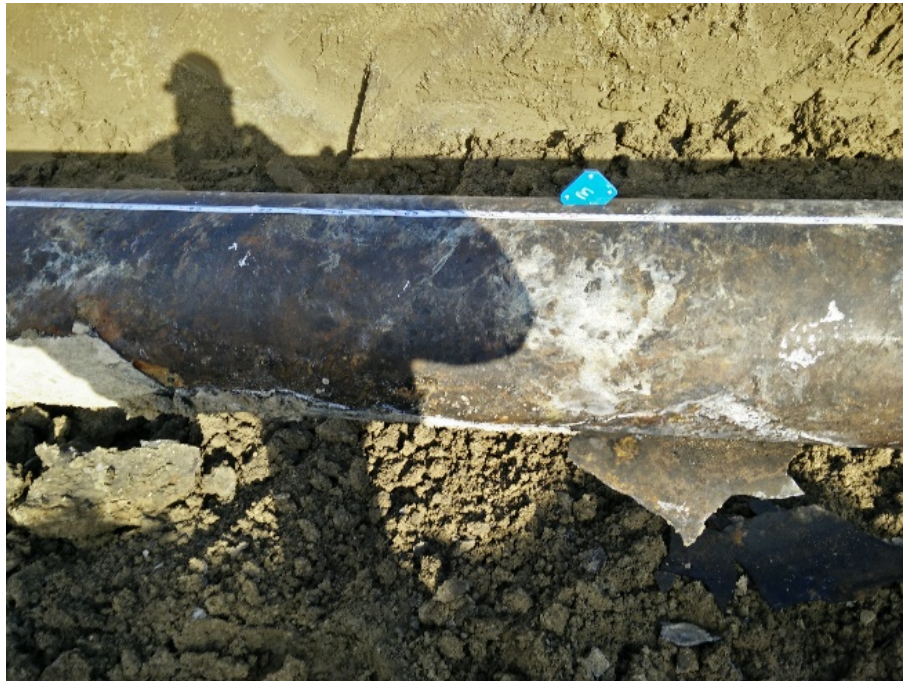
**Figure 8: Extremely poor coating and calcareous deposits were observed on the NPS 12 pipeline.**

This paper has described the impact of metallic IR-drops and equalization currents on potential measurements. These effects are most pronounced on bare or poorly-coated pipelines, which for the subject pipelines were 1950's era asphalt or coal-tar coatings. Two examples of the as-found coating quality are shown in Figure 8 and Figure 9. It is apparent that although some of the coating fell away during the excavation, the coating quality was very poor. It is under these conditions that the problems with metallic IR-drop and equalization currents will be most significant.

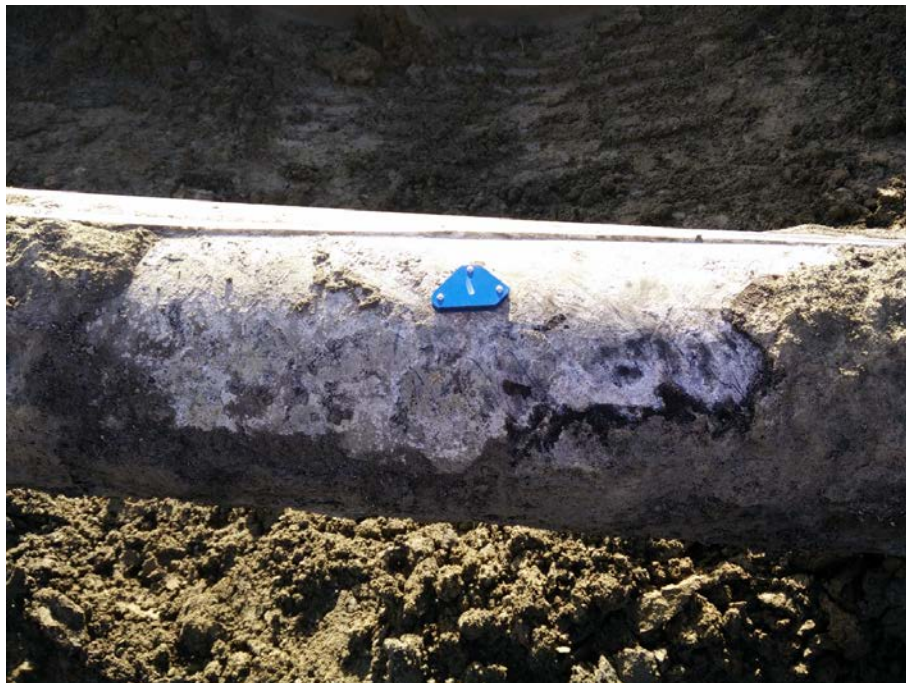
**Figure 10: Calcareous deposits on NPS 12 pipeline.**

The CP rectifiers were operating at very high currents in order to provide sufficient CP based on on-potential measurements at test posts and the coating deterioration was more pronounced near the rectifiers. The high currents also resulted in calcareous deposits at many locations, and at some of these locations calcareous deposits had developed on the outside of the coating. A section of pipeline with well-developed calcareous deposits is shown in Figure 10. To complicate the protection level assessments further, the operator has also observed significant seasonal variation in potentials on these pipelines, so the very low potentials measured in the summer are not necessarily representative of average protection levels on these pipelines.
