## **Control of External Corrosion On Iron and Steel Watermains**

R.A. Gummow, P.Eng.  
CORRENG Consulting Service Inc.  
369 Rimrock Road  
Downsview, ON, Canada M3J 3G2  
*bgummow@correng.com*

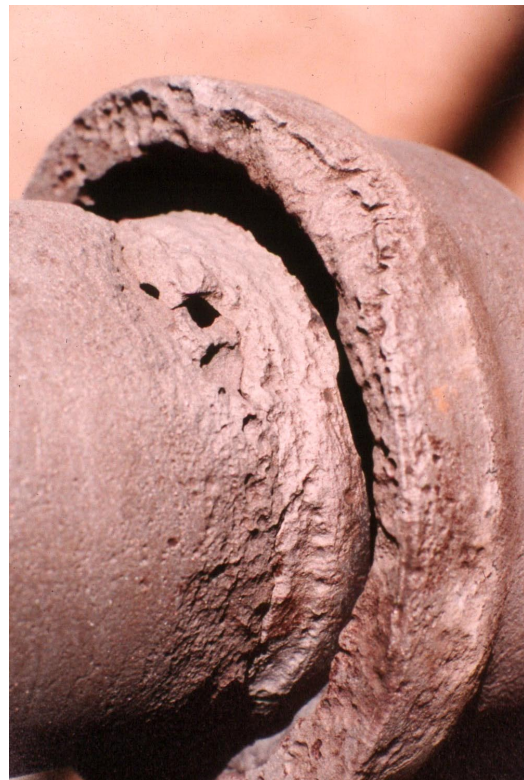
Figure 2 – Stray Current Corrosion  
 at a Bell & Spigot Joint

Because metallic water piping provides an alternative current path compared to the rails, current leakage ( $I_s$ ) from rails is picked-up near the locomotive and returns to the source along the watermain before discharging to the substation ground. When the current discharges to earth, corrosion occurs at a theoretical rate of about 10kg per ampere-year of current. The amount of stray current is directly proportional to the resistance of the running rails and inversely proportional to the running rail resistance to earth, the earth resistivity, the resistance of the watermain, the proximity of the watermain to the running rails and substation ground. Although significant corrosion damage occurs near the DC substation, attack will also occur at any electrically discontinuous joints, as current jumps around these discontinuities through the soil. Figure 2 shows corrosion attack at an electrically discontinuous bell and spigot joint.

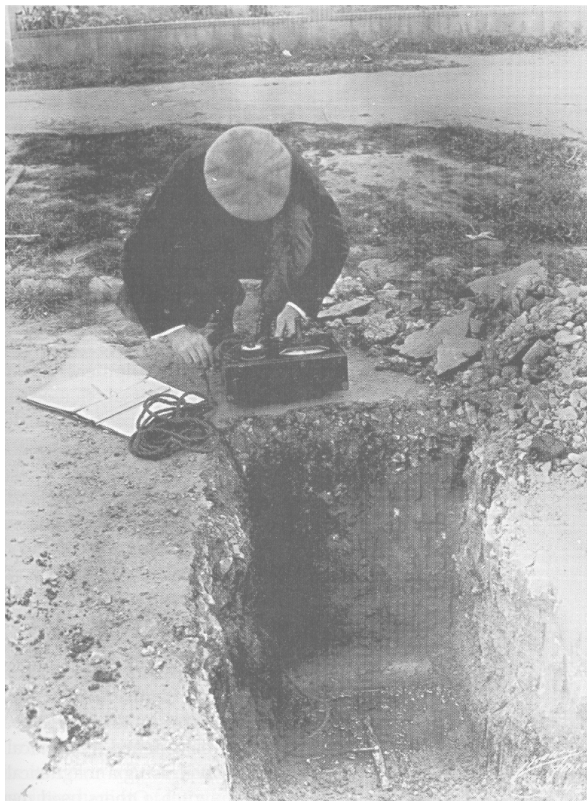
Figure 4 – Early Testing for Stray Current Activity  
(courtesy of East Bay Municipal  
Utility District, Oakland, CA)

As a result of these studies and other efforts by individual water utilities, the general approach to controlling stray current corrosion involved the establishment of electrolysis departments staffed by engineers who conducted extensive testing to identify problem areas and who installed and monitored drainage bonds between the watermains and the electrical railway (Figure 4).

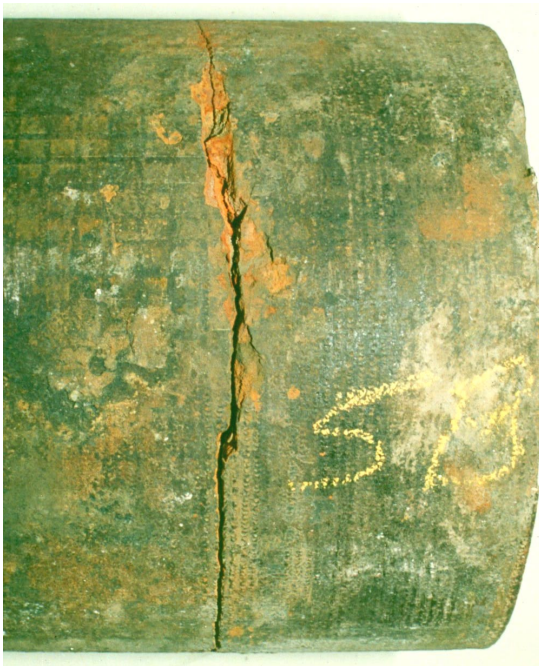
Figure 8 – Typical Beam Break on Grey Cast Iron

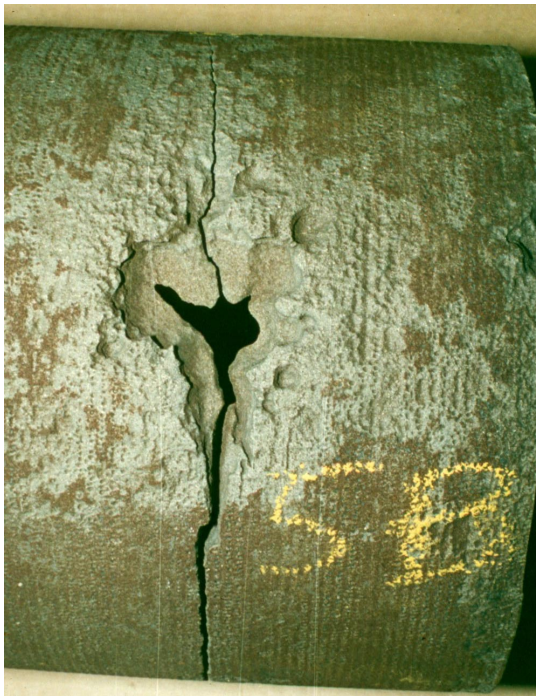
Figure 10 – Cast Iron Break in Figure 4 After Pipe Sample was Sandblasted to Remove the Graphite Corrosion Product

This relationship was typical of the pattern of corrosion caused leaks in steel piping systems. In addition, Fitzgerald<sup>[5]</sup>, in 1968, demonstrated that breaks on grey cast iron were principally due to the weakening of the pipes with time by graphitic corrosion. He recommended that pipe breaks be examined for signs of graphitization and that cathodic protection be considered for cast iron watermains exposed to soil having a resistivity of 5000 ohm-cm or less (Figure 10).

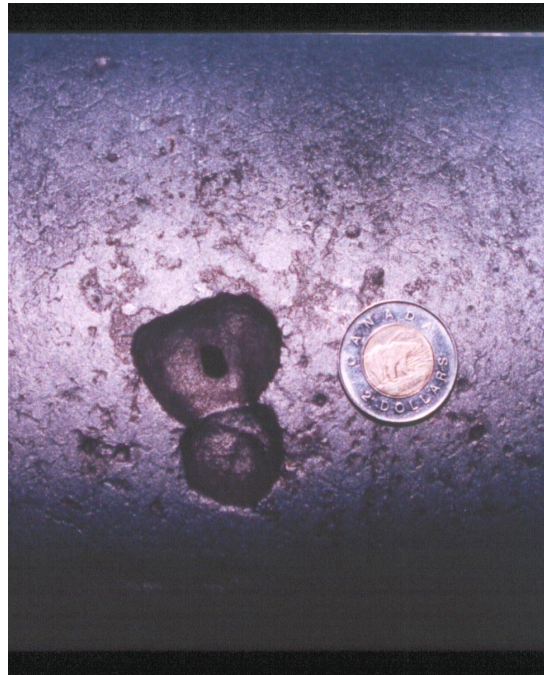
Figure 12 – Typical Corrosion Pit in Ductile Cast Iron

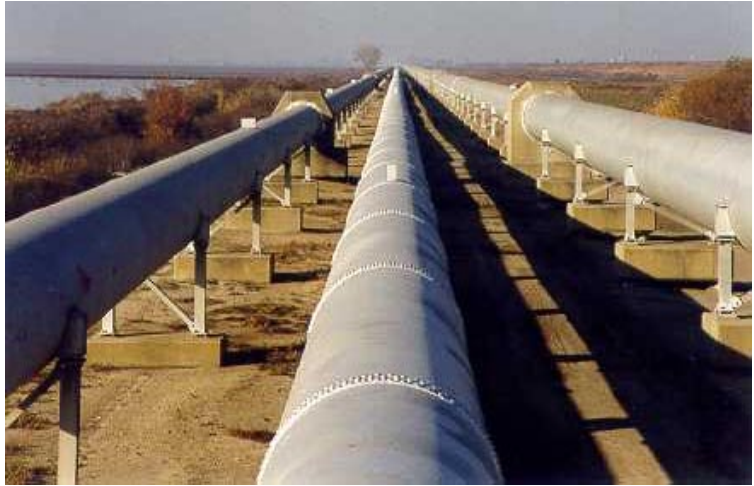
Figure 17 – View of the Mokelumne Aqueducts. Middle pipe is the original aqueduct installed in the early 1920's  
(photo courtesy of East Bay Municipal Utility District, Oakland, CA)

Interestingly, the oldest existing cathodic protection system on a water line is on steel not cast iron. A 95" diameter, 90-mile long, riveted steel aqueduct, installed near Oakland, California in the early 1920's, experienced corrosion failures in the early 1930's and received protection from an impressed current cathodic protection system in 1934-35. Figure 17 shows the above ground portion of this pipeline.

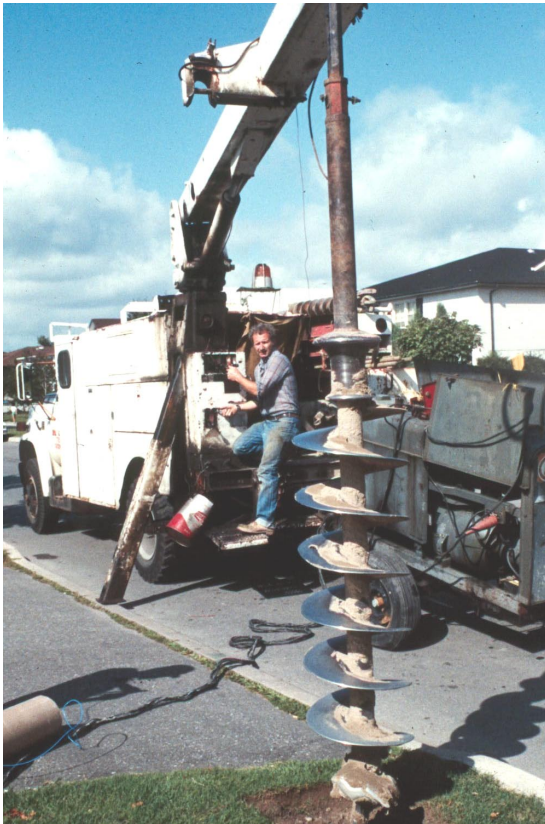
Figure 20 – Augering Hole Above the Watermain

This method involves augering a minimum 450mm diameter hole above the pipe until the pipe is exposed. After cleaning the pipe surface the anode lead wire of a 9kg packaged magnesium anode is attached to the cast iron pipe by stud welding and the anode is lowered into the augered hole as shown in Figures 20 and 21.

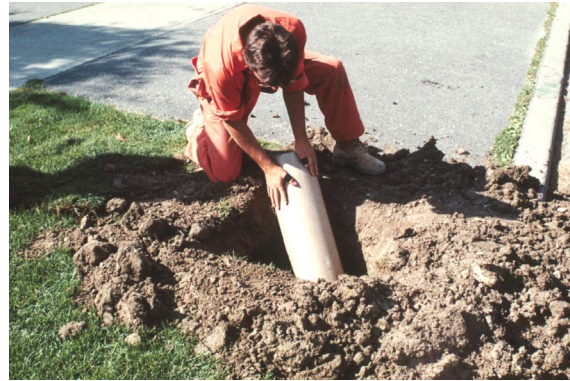
Figure 21 – Lowering Magnesium Anode into the Augered Hole

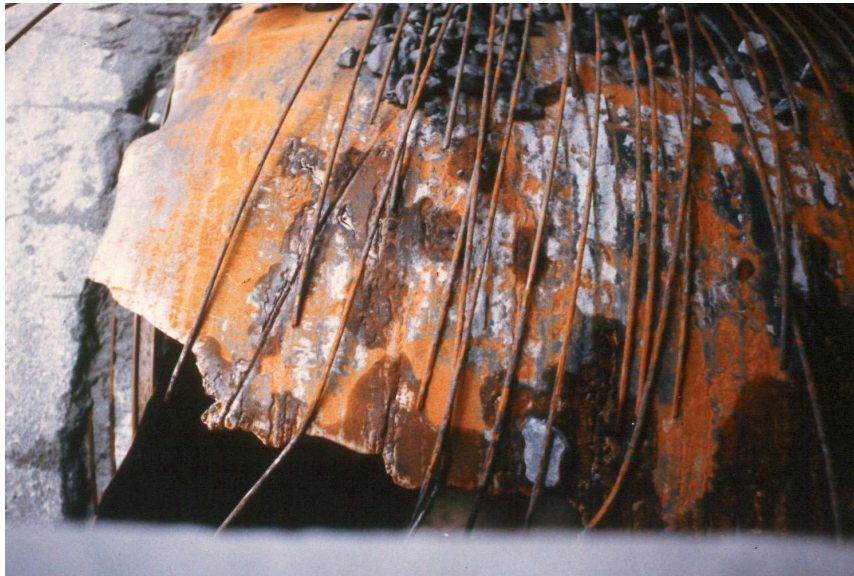
Figure 27 - Typical Corrosion Failure of a Prestressed Concrete Cylinder Pipe

A high soil concentration of chlorides is normally not required for chloride attack to occur. If the pipe is subjected to a variable water table that produces wet/dry cycles, whereby the pipe surface is wetted and dries by evaporation, then chlorides left behind on the concrete surface result in a concentration of chlorides sufficient to migrate through the mortar cover and attack the underlying steel. This has been the cause of numerous failures like that shown in Figure 27.
