Benefits of Anodic Protection and Remote Monitoring on Sulphuric Acid Tanks Contaminated by NOX

Winston W. Shim, P. Eng.
Corrosion Service Company Limited
205 Riviera Drive, Markham, ON, Canada L3R 5J8

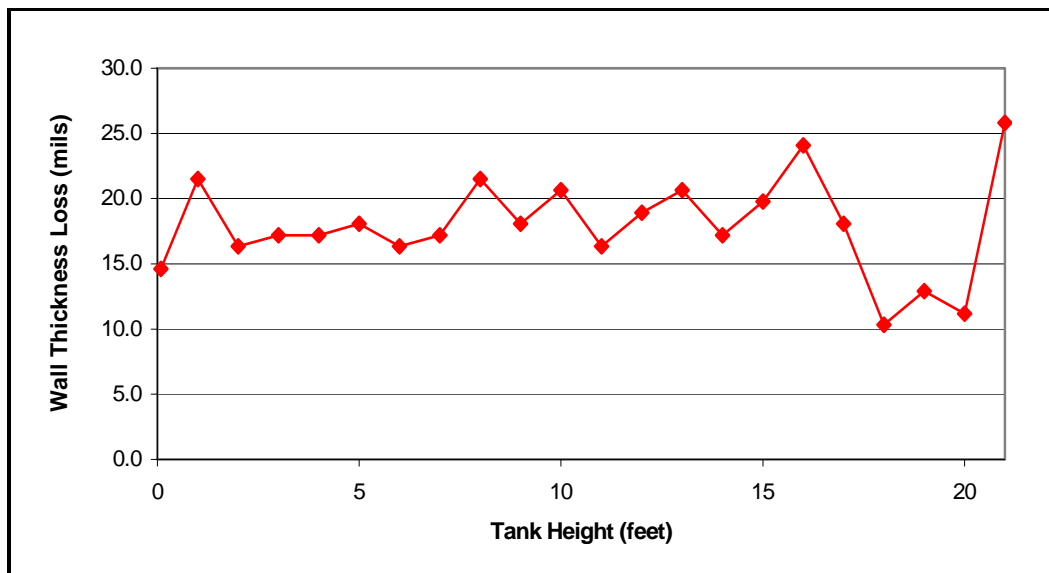
Figure 1. Average wall thickness loss over a period of 406 days derived from ultrasonic measurements taken on May 3, 2004 and August 17, 2005.

Field thickness data on the storage tank was recorded on May 3, 2004 and August 17, 2005. The thickness loss is presented in Figure 1. To compensate for the additional 66 days over which this degradation occurred, an average daily loss was calculated and multiplied by 406 days for comparison purposes. The average wall loss over this period was 18 mils (0.457 mm) or 16 mpy (0.406 mm/yr). The discrepancy between the calculated 40 mpy rate and the normalized actual rate of 16 mpy may be attributed to the 50 °C laboratory data and the ambient temperature field data. Nevertheless, the corrosion rates are in the right order of magnitude and Equation (1) may be considered as a good first approximation of actual corrosion rate. It should be emphasized, however, that Equation (1) was derived specifically for NO₃⁻ and acid can contain other nitrogen oxide species.

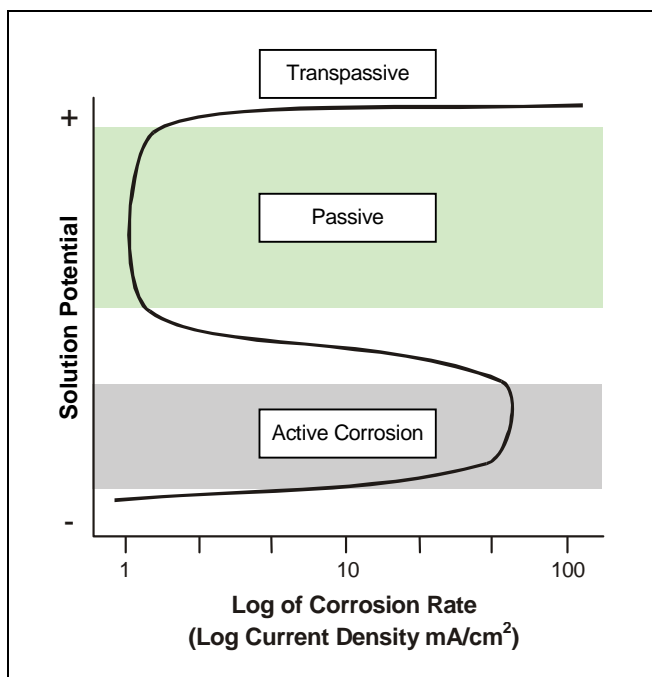
Figure 2. Polarization curve showing active/passive behaviour with corrosion zones identified.

The application of AP has been very successful in mitigating corrosion. This is accomplished by moving the electrochemical potential of the tank wall from the "Active Corrosion" zone to the "Passive" zone where corrosion rate is limited. See Figure 2.

While the current required to move the potential from the "active corrosion" to the "passive" zone is quite high, once passivity is achieved, the current required to sustain potential is very modest indeed. In fact, less than 5% of the current required to make the active/passive transition may only be necessary.

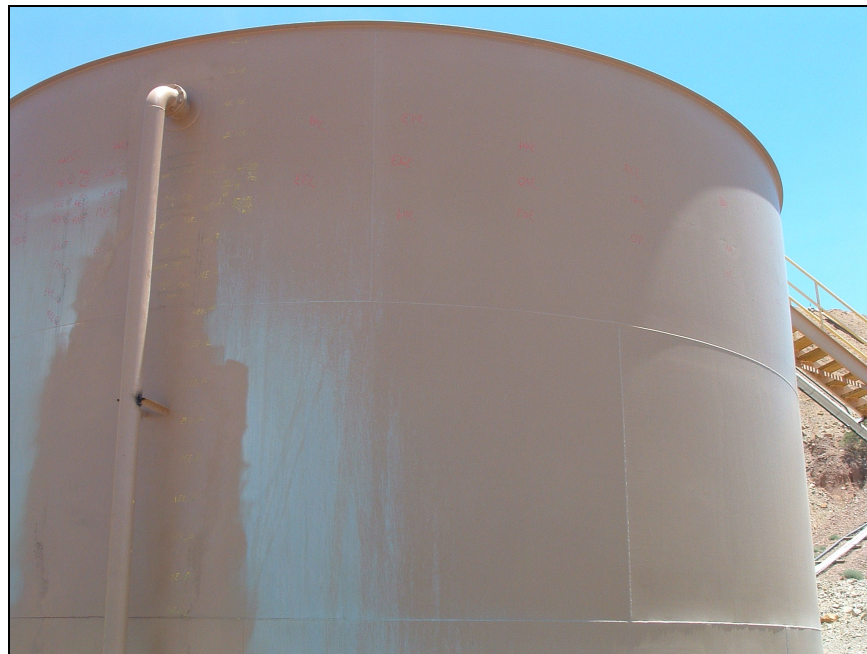
Photo 1. Sulphuric acid tank containing NOX contaminated acid.
Ultrasonic measurements revealed accelerated corrosion.

The acid tank being protected by anodic protection is constructed of A36 carbon steel and was commissioned in 2002. It is 33 feet (10.06 m) in diameter, 24 feet (7.32 m) high, and has a design maximum acid level of 20.5 feet (6.25 m). The nominal content acid strength is 95%.

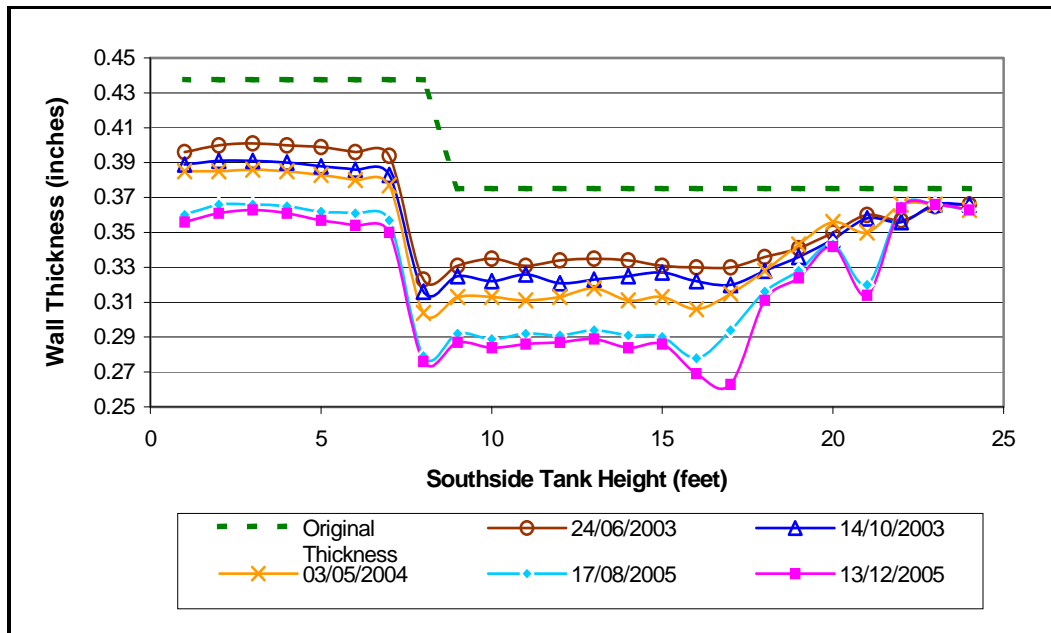
Figure 3. Summary of tank wall thickness readings from 2002 (original thickness) to Dec. 13/05.

The three-tier construction of the wall has plate thicknesses of 0.4375 inch (1.11 cm) at the lowest course and two 0.375 inch (0.953 cm) plates above. As shown in Figure 3, the wall thickness in 2005 in the wet/dry (tidal) zone between the 8 foot (2.44 m) and 18 foot (5.49 m) levels lost between 95 mils (2.41 mm) and 115 mils (2.92 mm) in the 3 years since the tank was commissioned.

These results represent an alarming average loss of 32-38 mpy (0.81-0.97 mm/yr). The consistent thickness losses year-to-year indicate that the data is reliable and no anomalies were observed.

In Figure 3, the most severe loss occurred in the first year of operation. From tank commissioning in 2002 to the first UT measurement on June 24, 2003, approximately 45 to 50 mils (1.14-1.27 mm) were lost in the wet/dry zone (i.e. 8 foot to 18 foot level). A high loss rate is also observed between the 0 to 8 foot (0 to 2.44 m) level (i.e. submerged zone) in the 24/6/2003 survey as compared to subsequent years. The very high corrosion rate during this initial period may be due to the new steel having yet to establish a passive layer. As the passive layer developed, corrosion slowed marginally but remained at an unacceptable accelerated rate.

Significant corrosion between the August 17, 2005 survey and the December 13, 2005 survey is depicted in Figure 3. The nominal NOX level was fairly low during that period (Figure 5), fluctuating between 50 and 100 ppm most of the time, with some high level excursions. In 2006, the NOX level started increasing to a higher and sustained level and by March of that year, the NOX level was 100-150 ppm. As evidenced by the undetectable wall thickness loss in the April 2006 survey, the AP system was still effective.

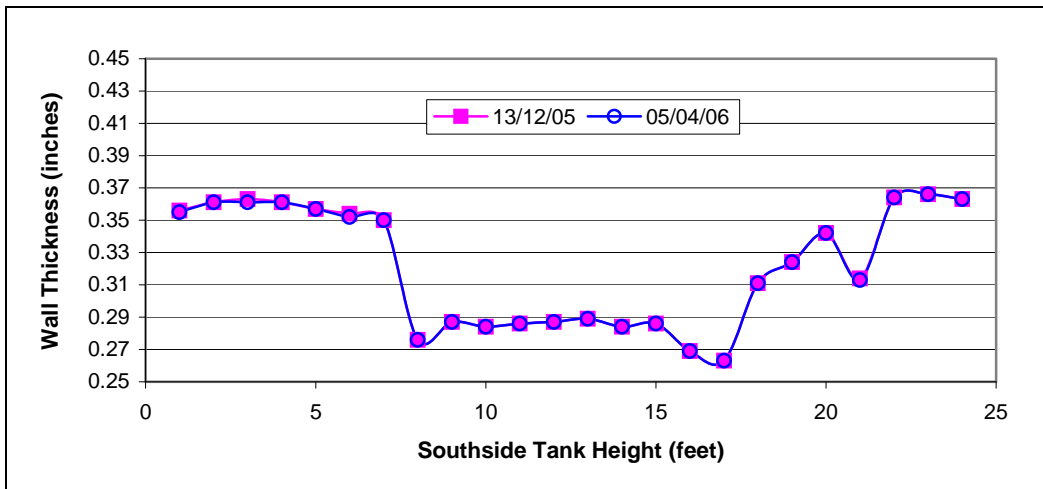
Figure 4. Tank wall thickness readings before and after energizing the anodic protection (AP) system on January 5, 2006. The lines overlap because no corrosion was detectable between the 2 surveys on December 13, 2005 and April 5, 2006.

The AP system remained effective through the Spring of 2006, at which time another wall thickness survey was conducted. The results in Figure 4 show that AP has halted the corrosion of this NOX contaminated sulphuric acid storage tank (including the tidal zone). The plotted data overlap because no significant difference in wall thickness was detected between the readings taken on December 13, 2005 and on April 5, 2006.

To ensure that AP was in fact effective in the presence of NOX contamination, daily NOX concentration data was collected. In Figure 5, one year of NOX data from July 10, 2005 to July 10, 2006 are presented. While the NOX level is seen to increase from March to June 2006, Figure 4 indicates that the AP was effective in mitigating corrosion during the same period.

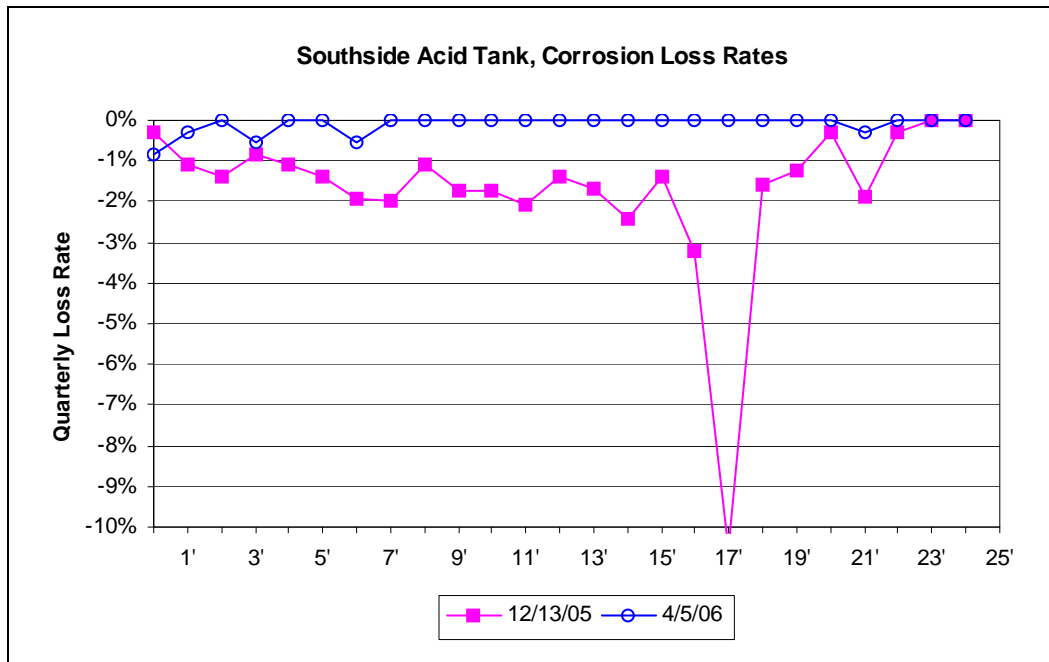
Figure 6. The April 5/06 wall thickness readings show that corrosion was halted after AP was energized in January 2006. No further corrosion in the tidal zone (8' to 18' level).

The benefit of AP to the tidal zone of acid tanks has long been a topic of discussion and speculation. Although low iron contamination data in AP protected tanks suggests that corrosion in the tidal zone is also mitigated, no direct proof was available. No definitive direct measurement prior to and after the energization of an AP system had been undertaken. This trial reveals that tidal zone corrosion is in fact mitigated. In Figure 6, the May 4, 2006 thickness survey should no corrosion was detectable in the tidal zone (8' to 18' level) after AP was installed. Small amount of corrosion detected in the submerged zone could be due to noise and reading errors.
