AC CORROSION - CASE HISTORIES, TEST PROCEDURES, & MITIGATION

R.G. Wakelin, R.A. Gummow, and S.M. Segall
Correng Consulting Service Inc.*
369 Rimrock Road
Downsview, Ontario, Canada M3J 3G2

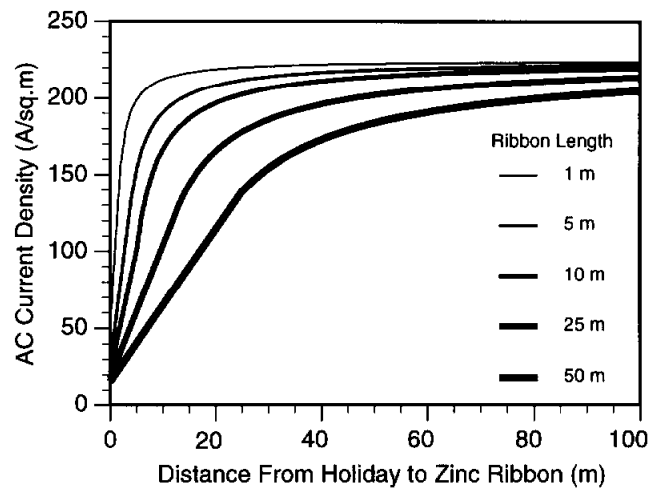
Using Equation (9), the AC current densities at the holiday in Example N° 1 are plotted in Figure 10 at various distances from the zinc ribbon, for a number of different zinc ribbon lengths. Note that the current densities at a distance of 0 m have been calculated as being equal to the zinc ribbon current density, and that the current densities between 0 m and the distance at which Equation (5) becomes applicable have been interpolated.

FIGURE 10 - Effect of Zinc Ribbon on AC Current Density (Example N° 1)

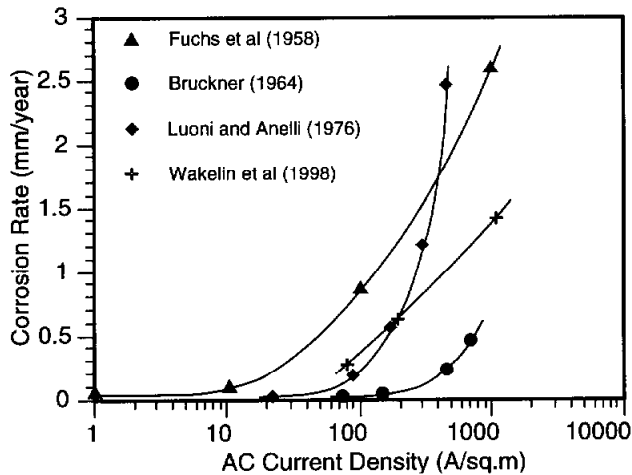
and this relationship is consistent with the findings of previous studies on unprotected steel samples^[13], as shown in Figure 11.

FIGURE 11 - Corrosion Rate Versus AC Current Density

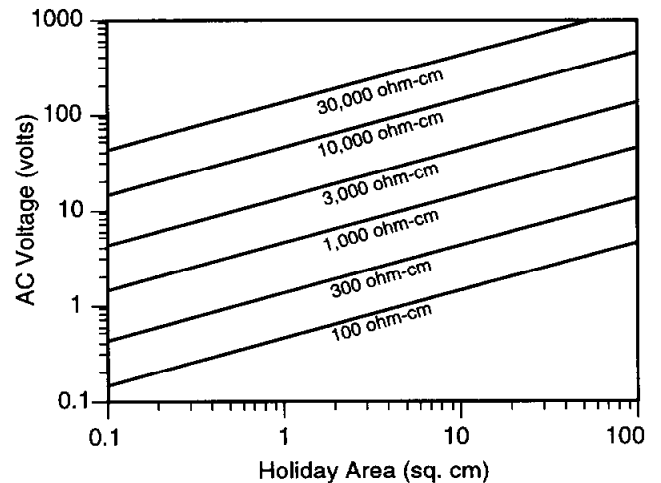
It is obvious that more data must be collected and shared from corrosion investigations occurring on pipelines exposed to induced AC interference, in order to more accurately identify instances of AC corrosion, and to understand the factors which affect AC corrosion rates. In the meantime, it would be prudent for pipeline operators to mitigate AC voltages below the levels shown in Figure 12^[14], to ensure that the risk of AC corrosion is minimized.

FIGURE 12 - AC Voltage Required to Produce an AC Current Density of 100 A/m²
