RESULTS FROM AN ECDA PLAN

R.G. Reid, P.Eng.
Union Gas Limited
A Duke Energy Company
50 Keil Drive North
Chatham, ON, Canada N7M 5M1

S.M. Segall, P.Eng.
R.A. Gummow, P.Eng.
Corrosion Service Company Limited
205 Riviera Drive
Markham, ON, Canada L3R 5J8

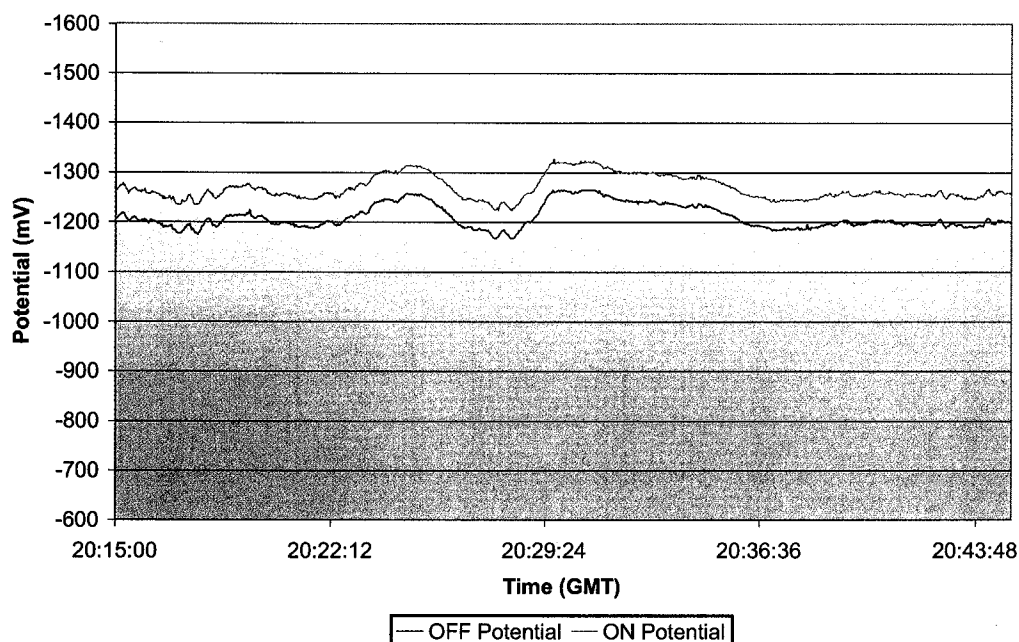
Figure 5. July 12. 8" Leamington Line. TP 7. Telluric Activity (30 Minute Sample)

Data loggers were installed up-stream and down-stream of each surveyed section to record the telluric activity. Moderate activity was recorded on July 12 and July 13 on the Leamington North line (see Figure 5) and the integrated survey results were subsequently tellurically compensated.
