# Electrochemical Corrosion Control of AL-6XN<sup>®</sup> Super-Austenitic Stainless Steel Flue Gas Desulfurization Scrubbers

**Winston W. Shim, P. Eng.**  
Corrosion Service Company Limited  
2-498 Markland St.  
Markham, Ontario L6C 1Z6  
CANADA

**Tom Henderson, PE**  
Santee Cooper  
Moncks Corner, SC 29461  
U.S.A.

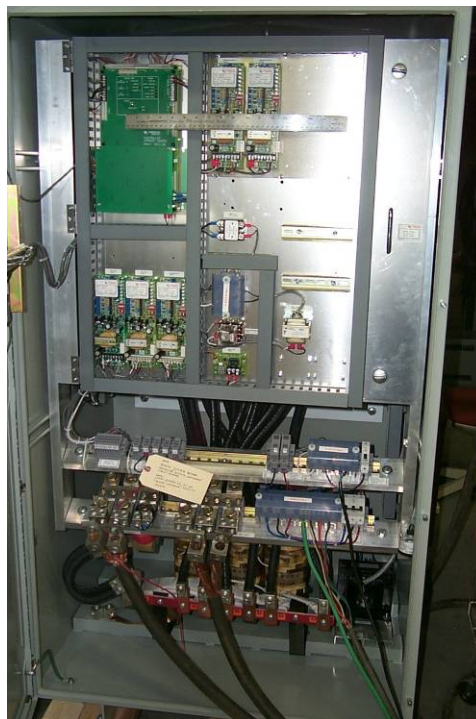
**Figure 4:** Internal of Custom Current Source

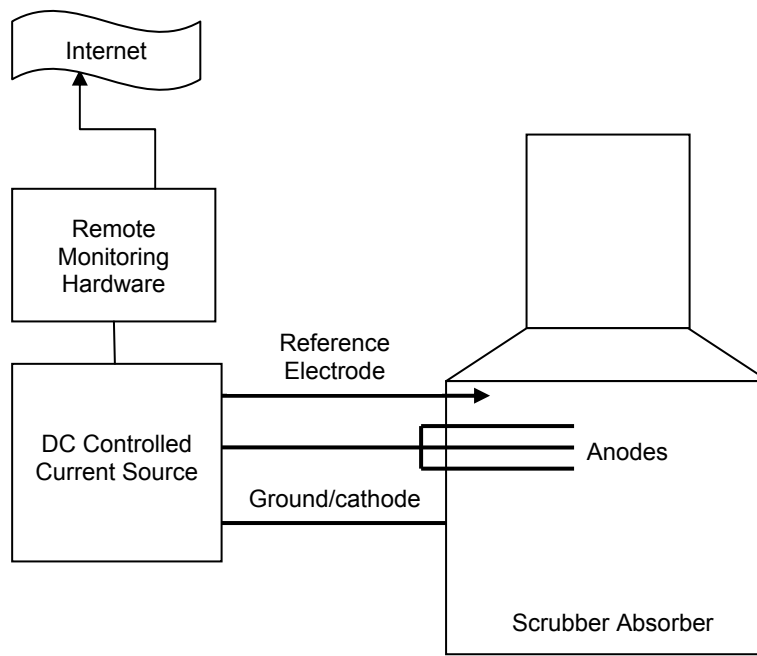
**Figure 5:** Schematic of PAP System Hardware with Remote Monitoring Equipment

During the scheduled plant outage in the Spring of 2009, PAP™ systems were installed in both scrubber Unit #1 and Unit #2. The design used six anodes in each scrubber. The anodes were supported by the existing air sparger headers which minimized the mechanical work required to support the anode assemblies. PAP™ current output was controlled by feedback potential from multiple reference electrodes in the scrubber. A PAP™ system schematic is shown in Figure 5. Prior to system installation, some wall and floor repairs were completed in the scrubbers to address the very severe pitting damage, however, no repairs were carried out on shallow pitting.

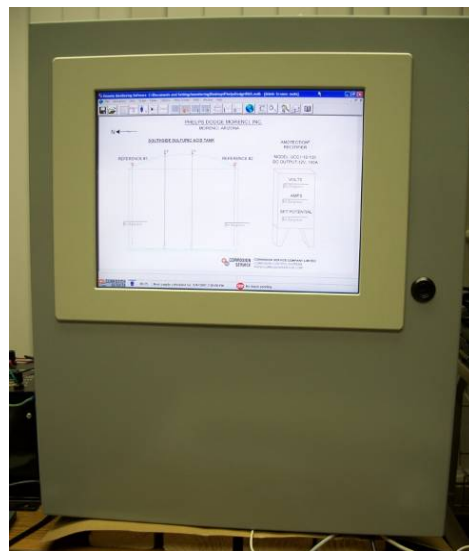
**Figure 6:** Typical Touch Screen Remote Monitoring Equipment

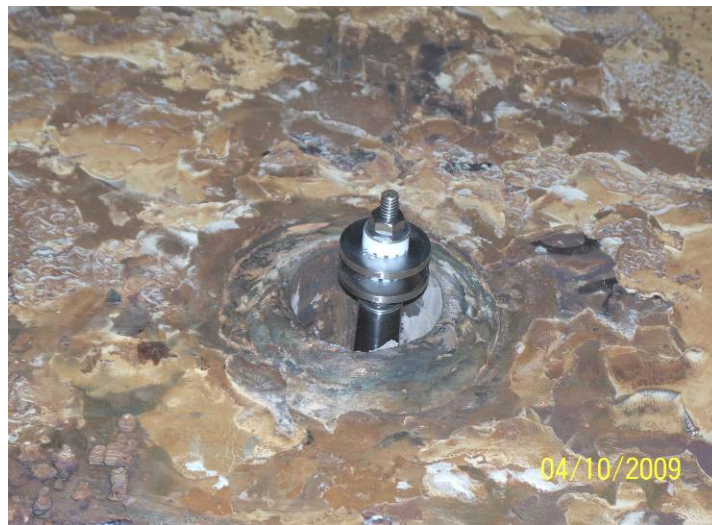
Over an 18 month period (from initial installation in the Spring of 2009 until the first outage in the Fall of 2010), the corrosion coupons were removed from the scrubbers via retractable probes every 15-60 days. Coupon monitoring allowed the effectiveness of the PAP™ system to be assessed prior to vessel entry. All coupons used at Winyah station were the slotted-disk type, with the non-metallic slots simulating crevices. Each set of coupons removed from the scrubber after a predetermined exposure duration was then replaced with a new set of coupons for another monitoring cycle. Upon removal, the exposed coupons routinely displayed black/brown scaling which was carefully cleaned to reveal the underlying condition. A typical coupon probe with the coupon head inside the scrubber is shown in Figure 7.

**Figure 7:** AL-6XN Coupons with Slotted Disk Installed to Gauge System Effectiveness during On-line Operation

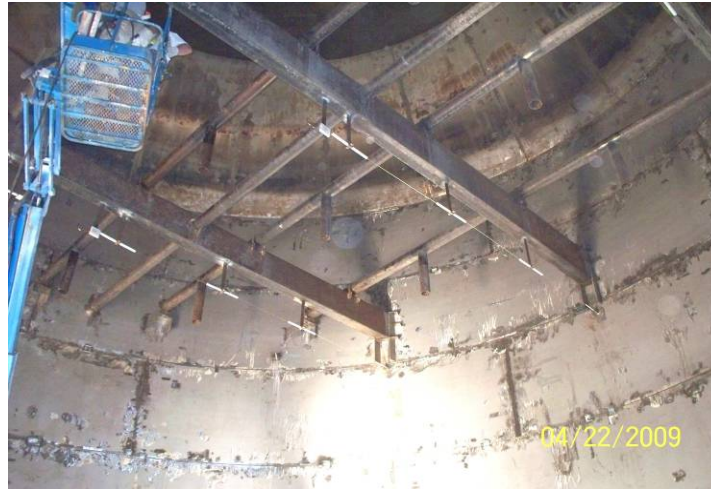
Figure 10 depicts the layout of the anodes below the air sparger support. The reference electrode tip is shown in Figure 11.

**Figure 10:** Anodes Installed beneath Air Sparger Support Steel.

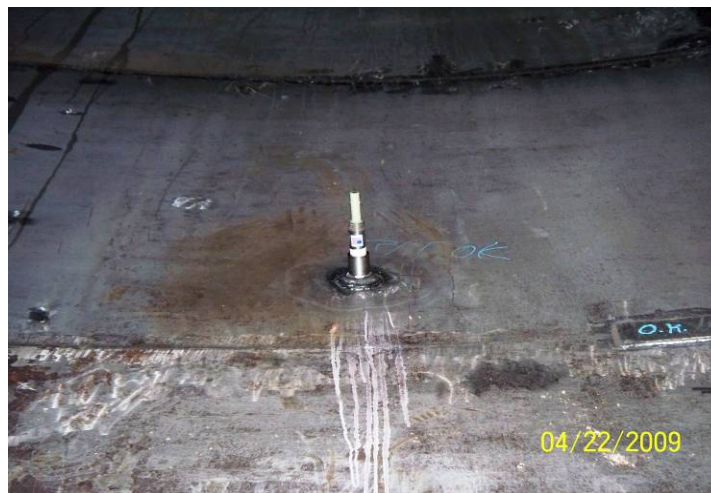
**Figure 11:** Reference Electrode Installation
